GENESIS CONCENTRATOR TARGET PARTICLE CONTAMINATION MAPPING AND MATERIAL IDENTIFICATION. M.J. Calaway¹, M.C. Rodriguez², and J.H. Allton³: (1) Jacobs (ESCG) at NASA Johnson Space Center, Houston, TX; (2) Geocontrol Systems (ESCG) at NASA Johnson Space Center, Houston, TX; (3) NASA, Johnson Space Center, Houston, TX; michael.calaway-1@nasa.gov.

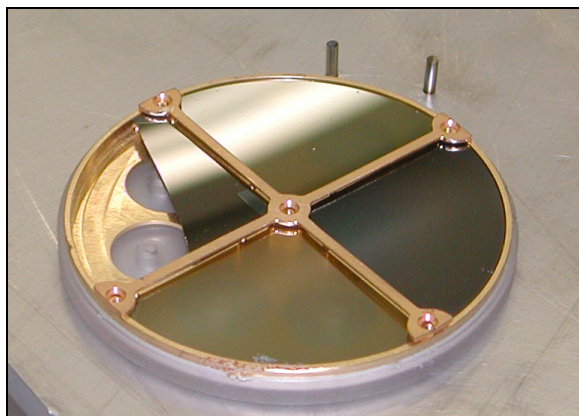
Figure 1 shows that all three targets imaged in this report are fully intact and do not show any signs of material fractures. However, due to the SRC hard landing, each target has experienced varying degrees of impacts, scratches, and particle debris from the spacecraft and Utah impact site. In addition, previous ellipsometry results and overview imaging of both flown SiC targets show a solar wind irradiation gradient from the center focal point to the outer edge [3, 4].

Fig. 1: Genesis Concentrator Target after Landing. In the above image, SiC target quadrants are on the top and bottom (60001 and 60003 respectively). The CVD target (60002) is on the right and the partial DOS target fragment is on the left.

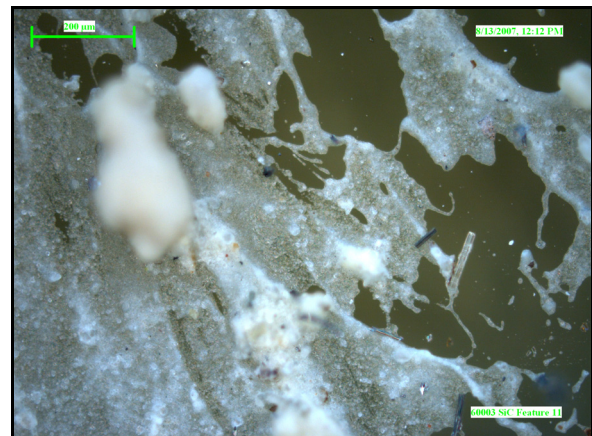
with a Leica DM6000M automated microscope using 5X, 10X, and 50X objective lens. Feature locations were then mapped to an overview mosaic image. Figure 2 shows an image example of a salt deposit on SiC target 60003. The salt deposit is probably a dried mixture of halite and other sediments from the lacustrine environment at the Utah Test and Training Range. Black carbon-carbon fibers, Al fragments, and other SRC materials can be visibly identified mixed within the salt matrix. Figure 3 shows an example of microspheres contamination, most likely from the super-light ablator (SLA) material from the SRC.

Fig. 2: SiC 60003 salt feature using a 10X objective lens. Scale bar is 200 μ m.

Chemical cleaning techniques with Xylene and HF in an ultrasonic bath are currently being investigated for removal of small particles by the Genesis science team as well as ultra-pure water megasonic cleaning by the JSC team [5]. Removal of organic contamination from target materials is also being investigated by the science team with the use of UV-ozone cleaning devices at JSC and Open University [6].

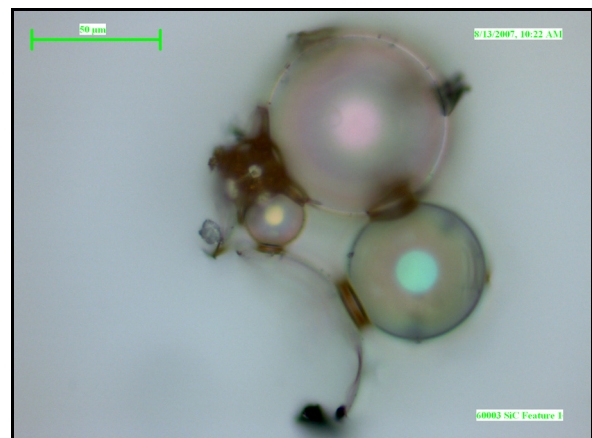
Fig. 3: SiC 60003 microspheres feature at 50X objective lens. Scale bar is 50 μ m.

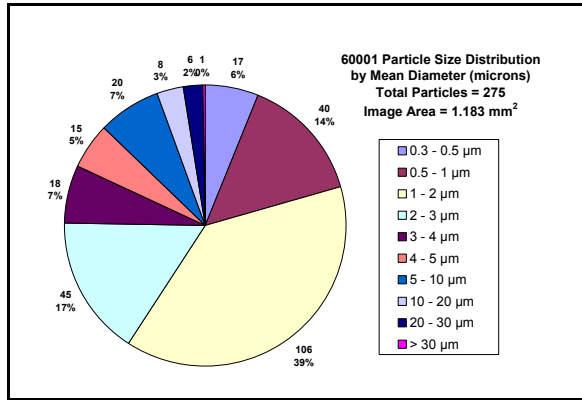
Fig. 4: SiC 60001 above target graph shows that 88% of the particles are $< 5 \mu\text{m}$ in diameter and 59% are $< 2 \mu\text{m}$ in diameter.

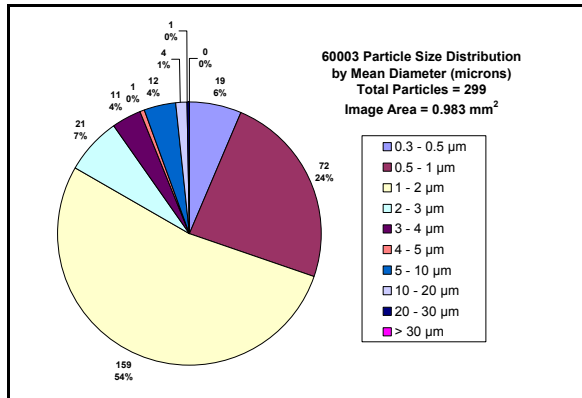
Fig. 5: SiC 60003 above target graph shows that 95% of the particles are $< 5 \mu\text{m}$ in diameter and 84% are $< 2 \mu\text{m}$ in diameter.

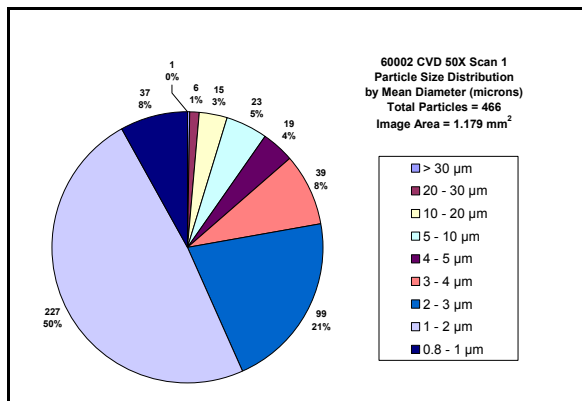
Fig. 6: CVD 60002 above target graph shows that 91% of the particles are $< 5 \mu\text{m}$ in diameter and 58% are $< 2 \mu\text{m}$ in diameter.

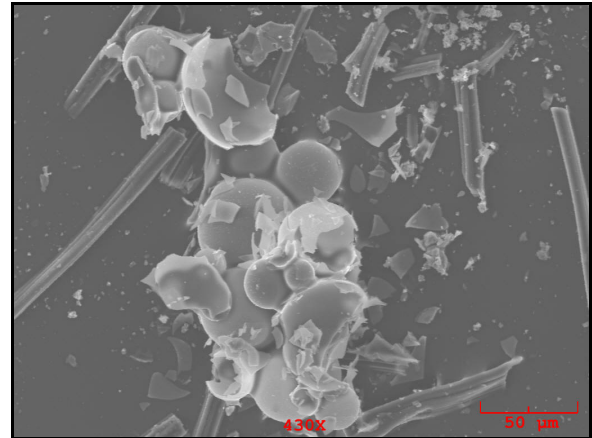
instrument induced contamination, EDS analysis of surface particle contamination from the flown acceleration grid was studied and compared with particles on the flown targets. Figure 7 shows a backscatter image of microsphere fragments probably from the SLA material on the SRC.

Fig. 7: SEM image of microsphere particle contamination as well as long carbon fibers on the acceleration grid. Scale bar is $50 \mu\text{m}$.
