METEOROID AND DEBRIS IMPACT FEATURES DOCUMENTED ON THE LONG DURATION EXPOSURE FACILITY

A Preliminary Report

Compiled by Members
of the LDEF Meteoroid
and Debris Special
Investigation Group

August 1990

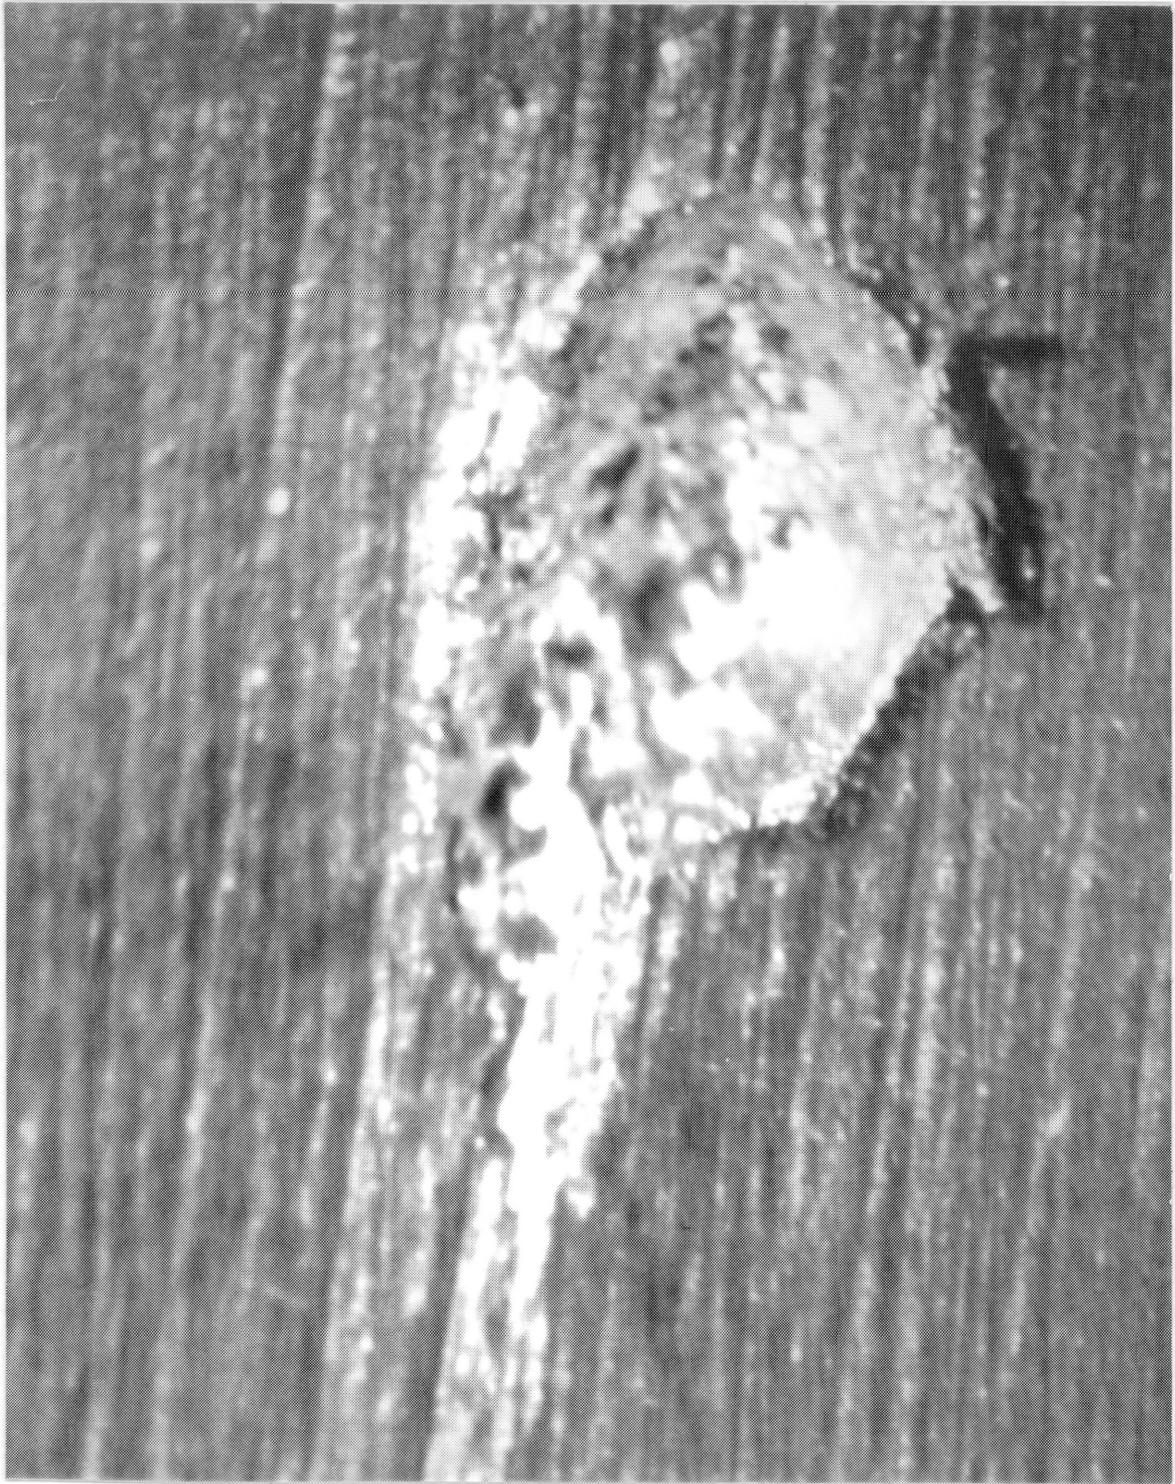
Figure 5. Photograph of an elongate feature in an aluminum surface, probably from an extremely low-angle ($<5^\circ$) or oblique impact. View measures approximately 1.5 cm across.

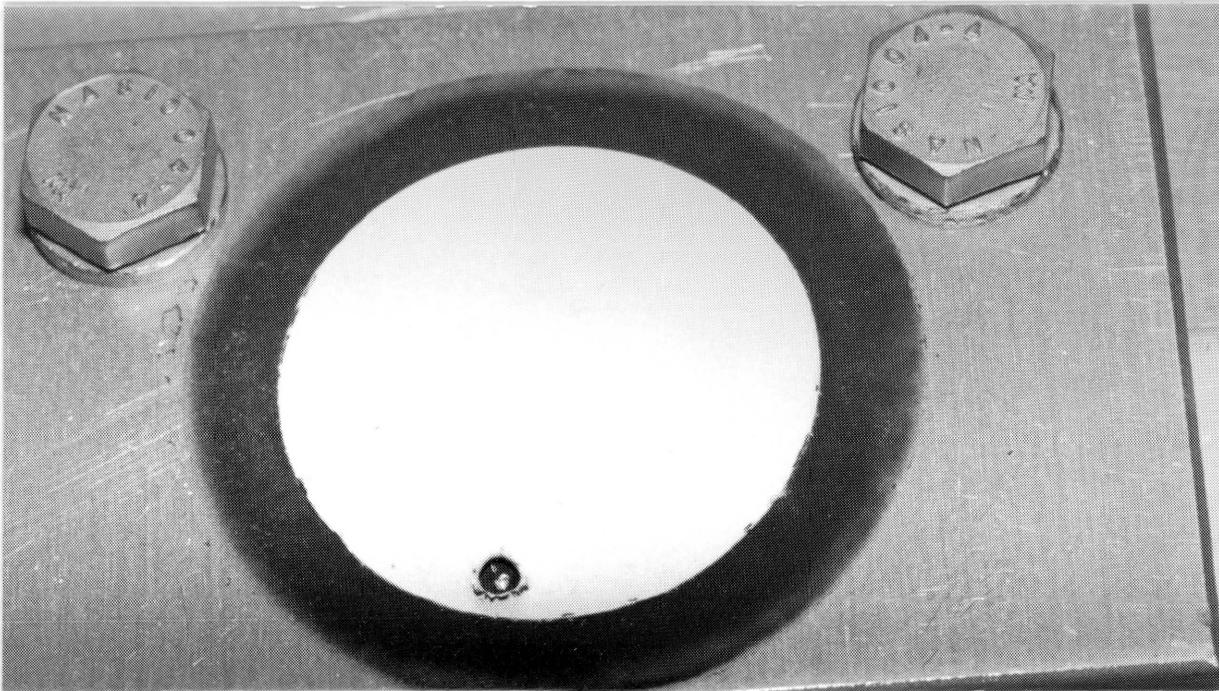
Figure 9. Impact into one of the paint specimens on an experiment-tray clamp. This particular feature was the largest impact feature found on the numerous tray clamps. View measures approximately ~6.5 cm across.

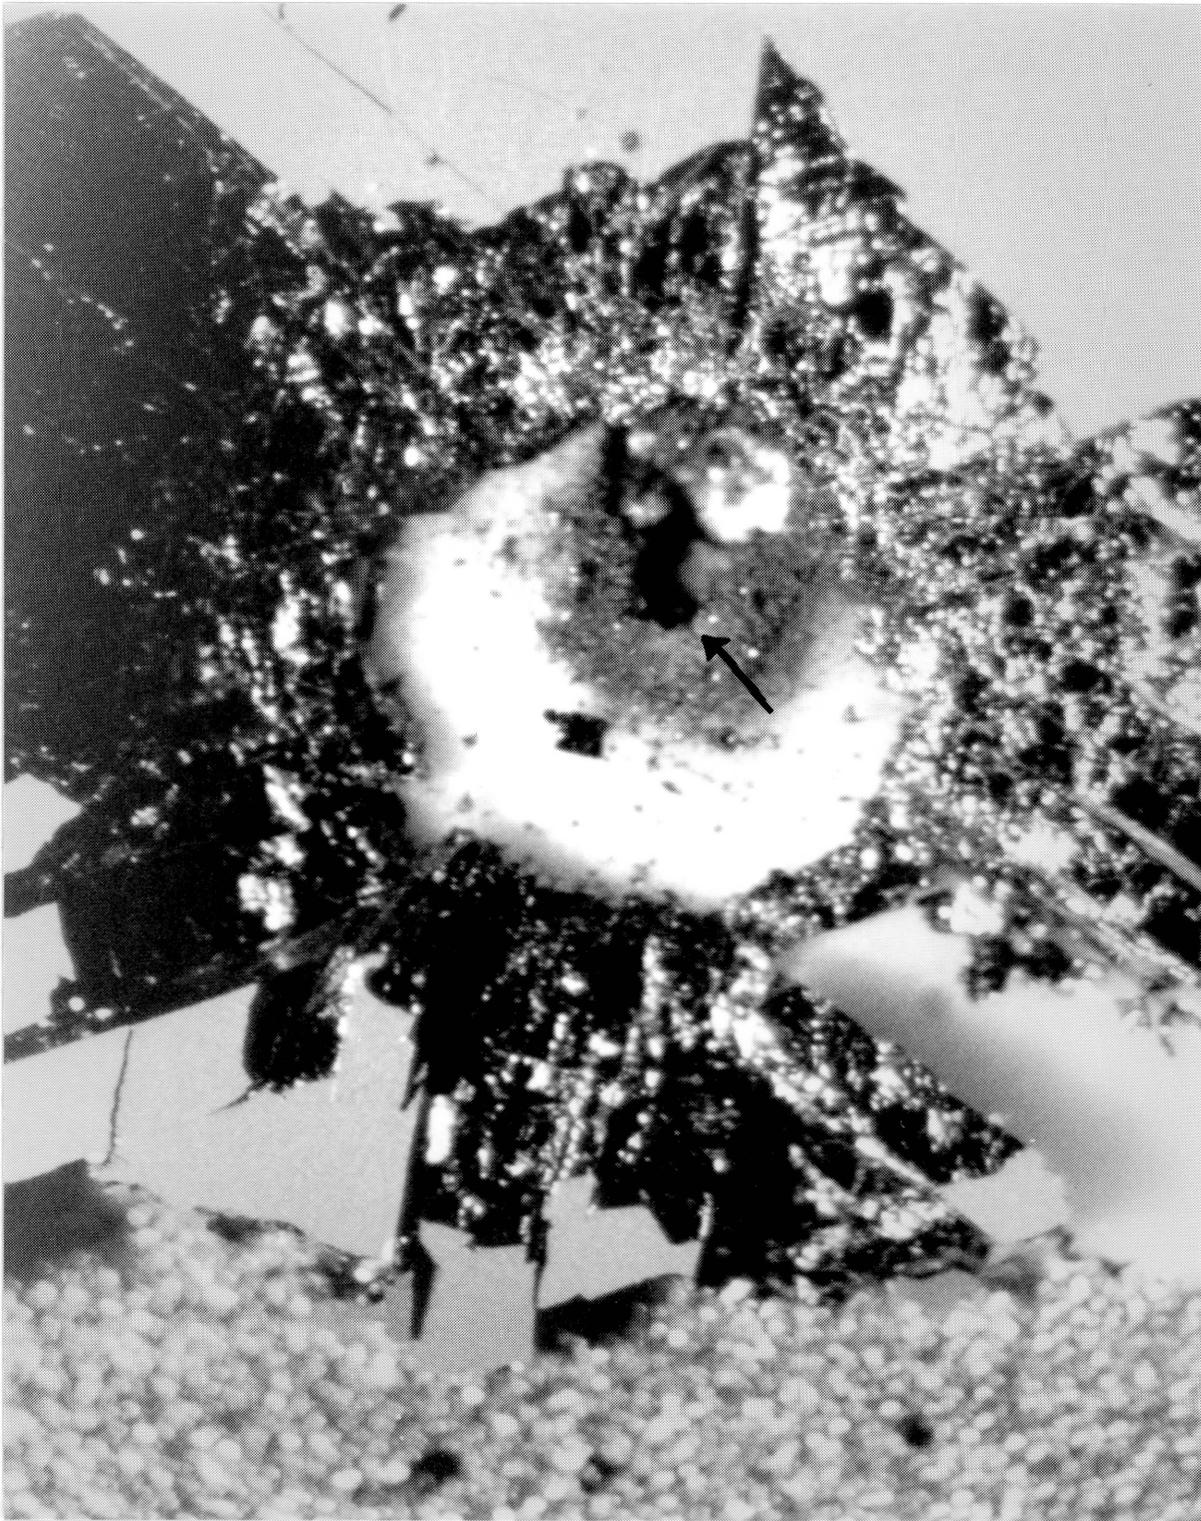
Figure 11. Photograph of an impact feature in one of the metal-oxide-silicon (MOS) detectors of the Interplanetary Dust Experiment (A0201; Bay B12). A central penetration hole (arrowed) is surrounded by a crater and extended fracture zone. View measures approximately 1 mm across. The same feature at a lower magnification can be seen in Figure B12-2.

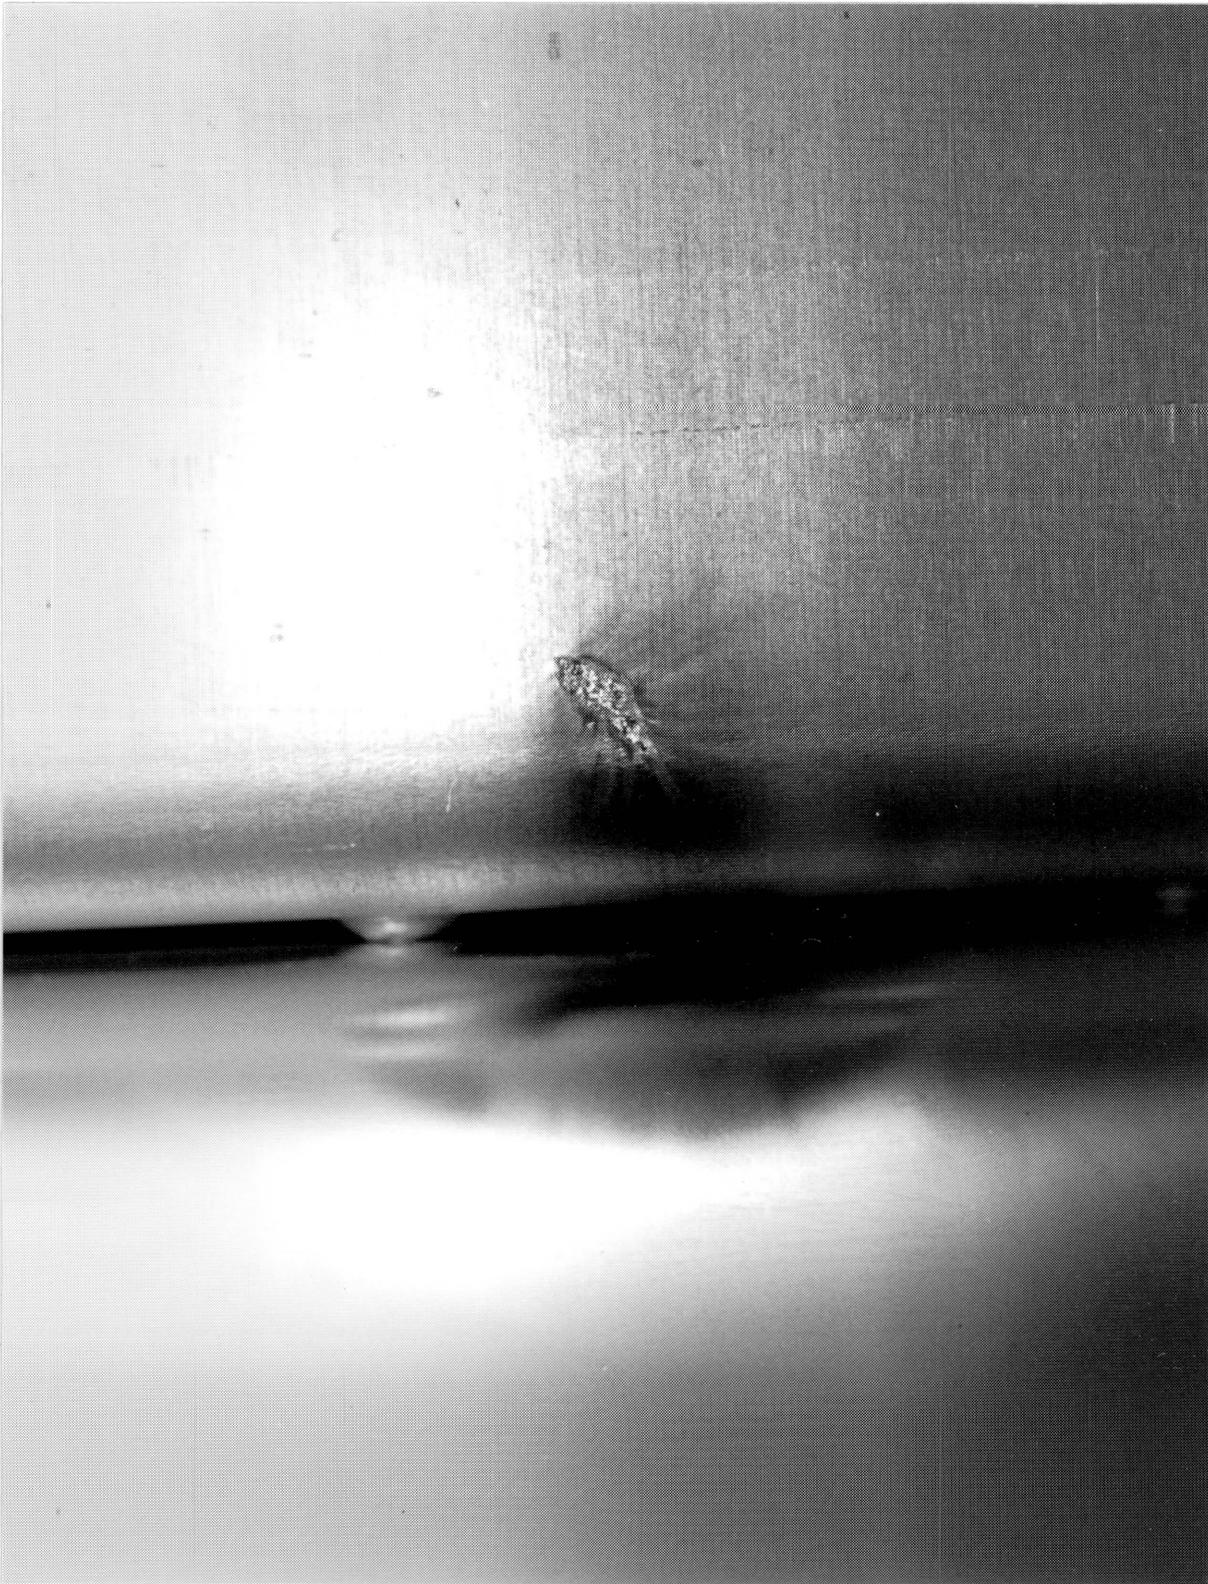
Figure 14. Photograph of an oblique feature on the experiment-tray flange of an A0178 tray. The complex inner morphology of this feature may indicate that it is the result of a multiple-impact event, or an impact from a poorly indurated particle. Note presence of associated (red) debris surrounding the impact site.

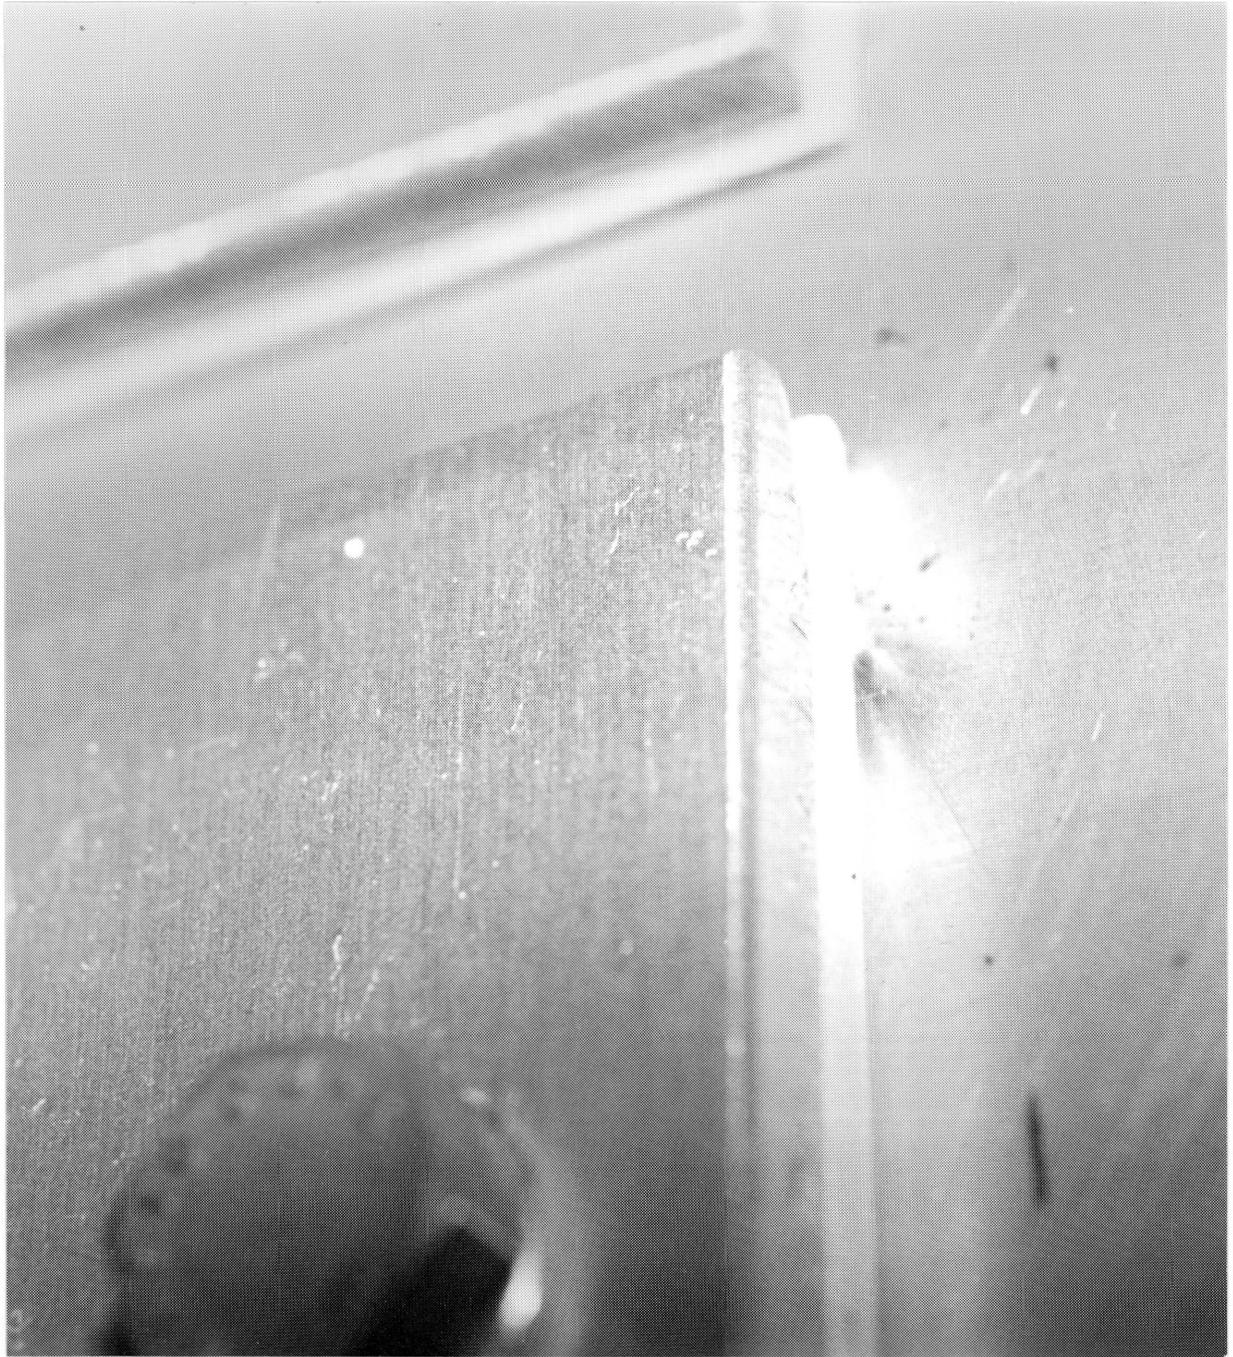
Figure 17. Impact (and associated debris) into the edge of a clamp shim. Features such as these which could be damaged or destroyed during the deintegration of the experiment trays from LDEF were one of the primary reasons for conducting the pre-deintegration survey.
