# EXAMPLES OF OPTICAL ASSESSMENT OF SURFACE CLEANLINESS OF GENESIS SAMPLES

M.C. Rodriguez<sup>1</sup>, J.H. Allton<sup>2</sup>, P.J. Burkett<sup>3</sup> and C.P. Gonzalez<sup>3</sup>. 1 Geocontrol Systems- ESCG at NASA/Johnson Space Center, Houston, TX 77058; melissa.rodriguez-1@nasa.gov, 2 NASA/Johnson Space Center, Houston, TX 77058, 3 Jacobs- ESCG at NASA/Johnson Space Center, Houston, TX 77058.

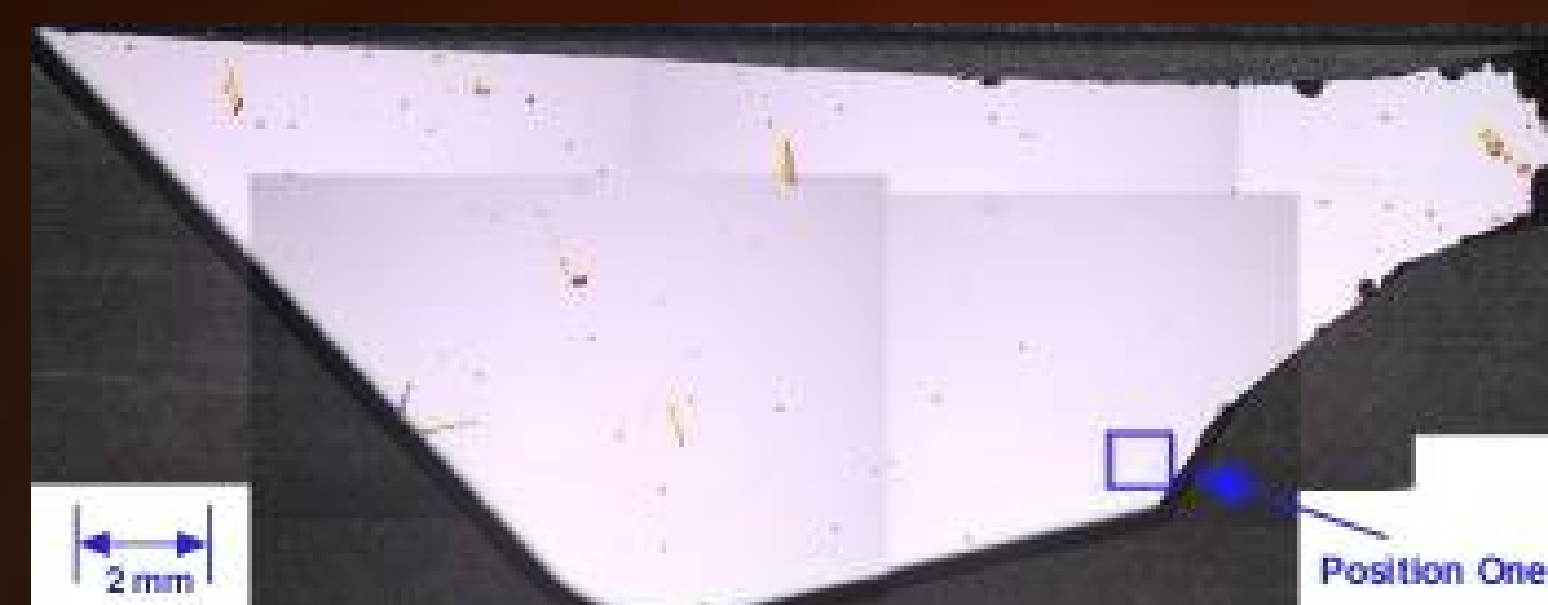
Fig. 1. Features present at the time of allocation are in yellow. Features present after PI return are in red. The area bounded by the square was scanned at higher magnification (position 1).

Sample has been exposed to UPW cleaning (5 min., 3000RPM, 40°C) and UV ozone cleaning. Additional surface cleaning was done in HCL bath after allocation. An overview scan (Fig. 1) shows that small features were subsequently added to the sample surface. Fig. 2. displays an inset of data for position 1.

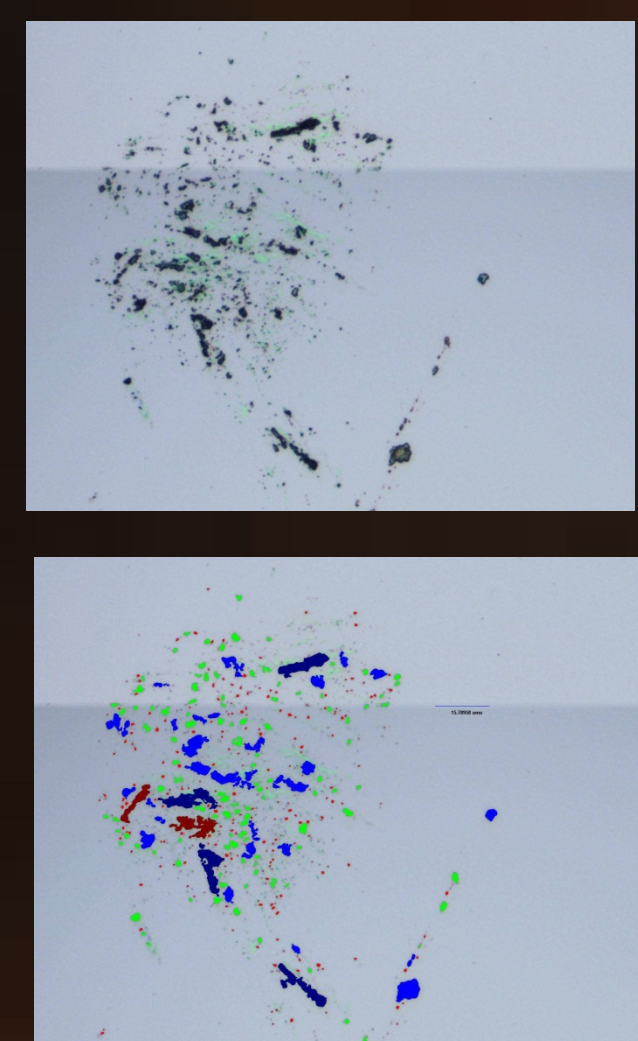
Fig. 2. Sample 60326. This inset displays 413 objects detected by the software Image Pro Plus. The area is 0.02 mm<sup>2</sup>. The bottom image has been classified into colored size bins.

Class	Objects	% Objects
1	456	98.275864
2	4	0.956895
3	2	0.43103448
4	1	0.21551724
5	1	0.21551724

Example of colored size binning for sample 60326 using Image Pro Plus.

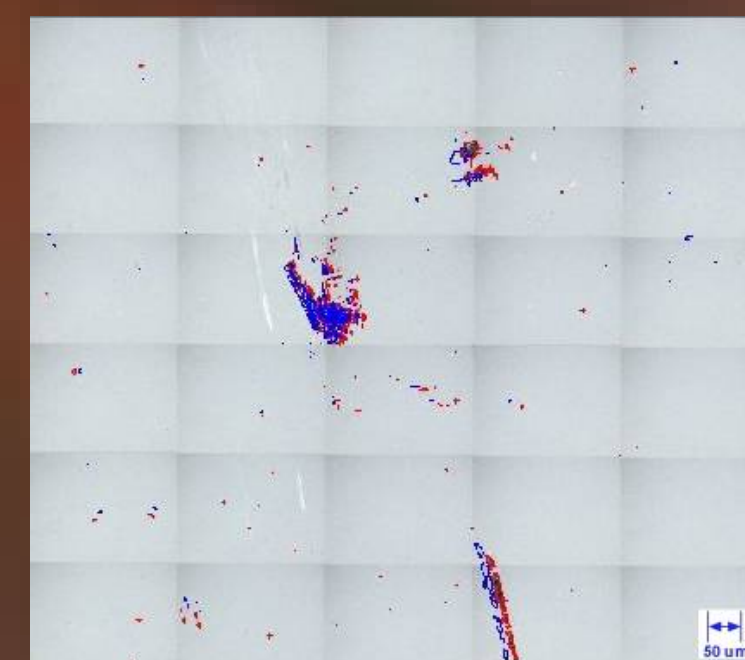
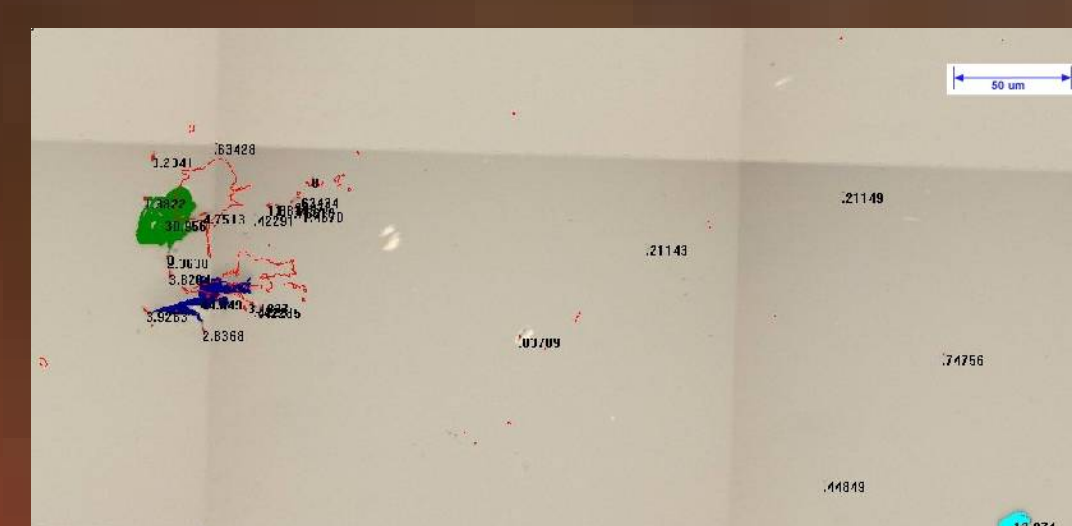
The sample has been UPW cleaned (5min, 3000RPM, 40°C) and exposed to UV ozone cleaning. Additional surface cleaning was done by CO<sub>2</sub> snow exposure after allocation. The sample was imaged before allocation and after its return. 464 objects were detected after its return to JSC, compared to 321 objects observed at the time of its allocation.

Sample 61052 Position1, image on the right. Features present at the time of allocation are in red. Features present after PI return are in blue. The field of view is ~1mm<sup>2</sup>.

Inset of sample 61052 Position 1. The sizes (in µm) of detected features are displayed. Objects outlined in red were present before PI return (these do not have measurements displayed). The field of view is ~0.1mm<sup>2</sup>.

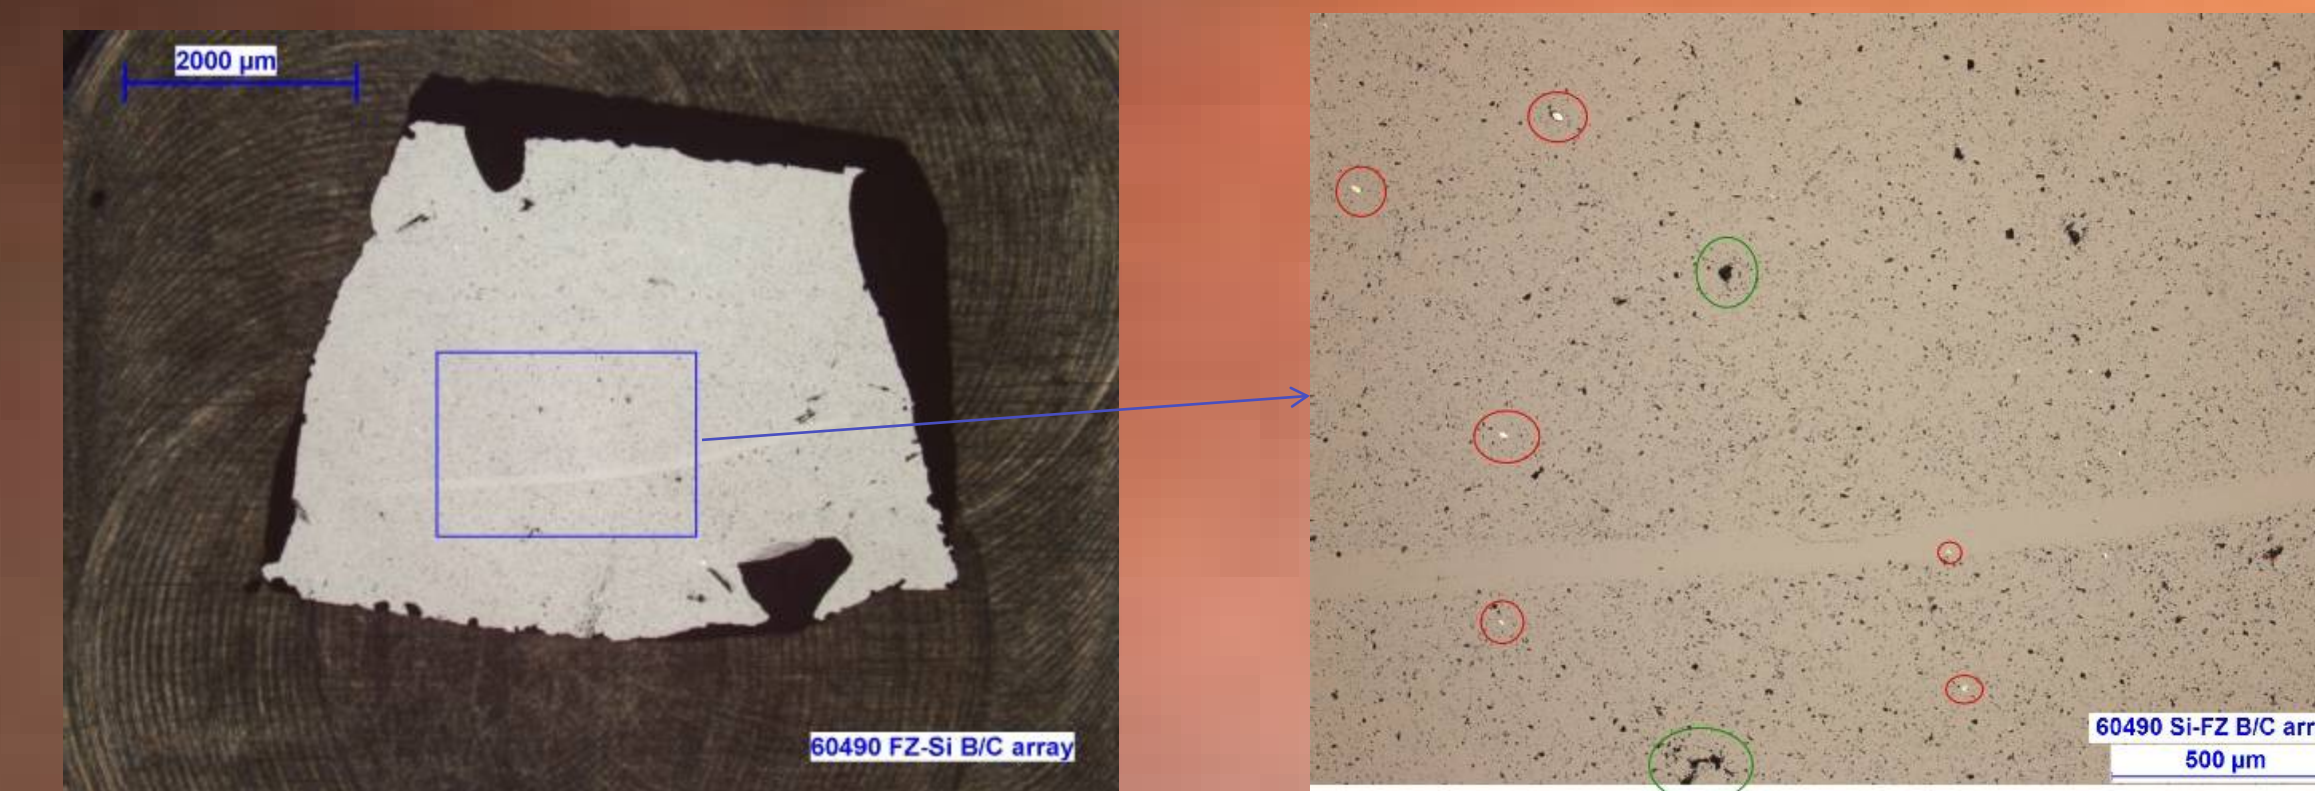
From comparing the before and after pictures: Green circles show same features and red circles indicate white ovals.

Before allocation: Images were taken before the sample had any exposure to cleaning treatments. White ovals can be seen in the image to the right.

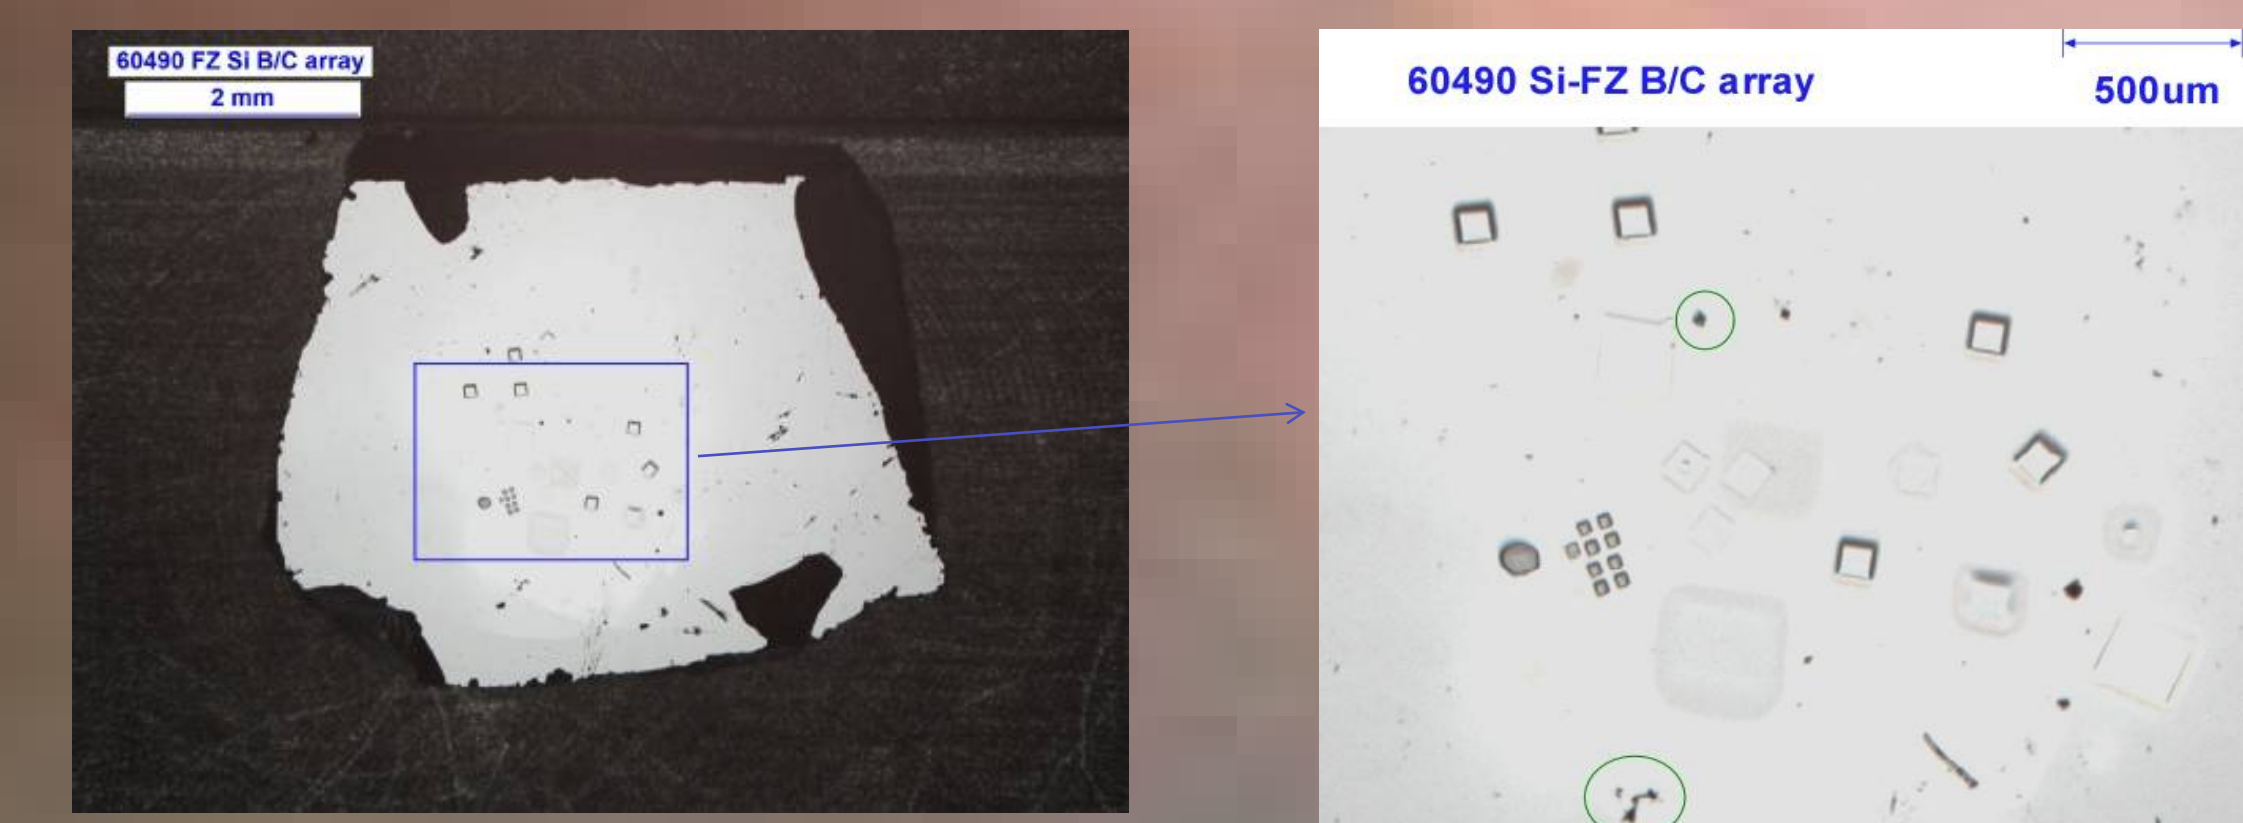
After allocation: Images were taken after 80 hours of aqua regia cleaning plus RCA cleaning. No white ovals can be seen.

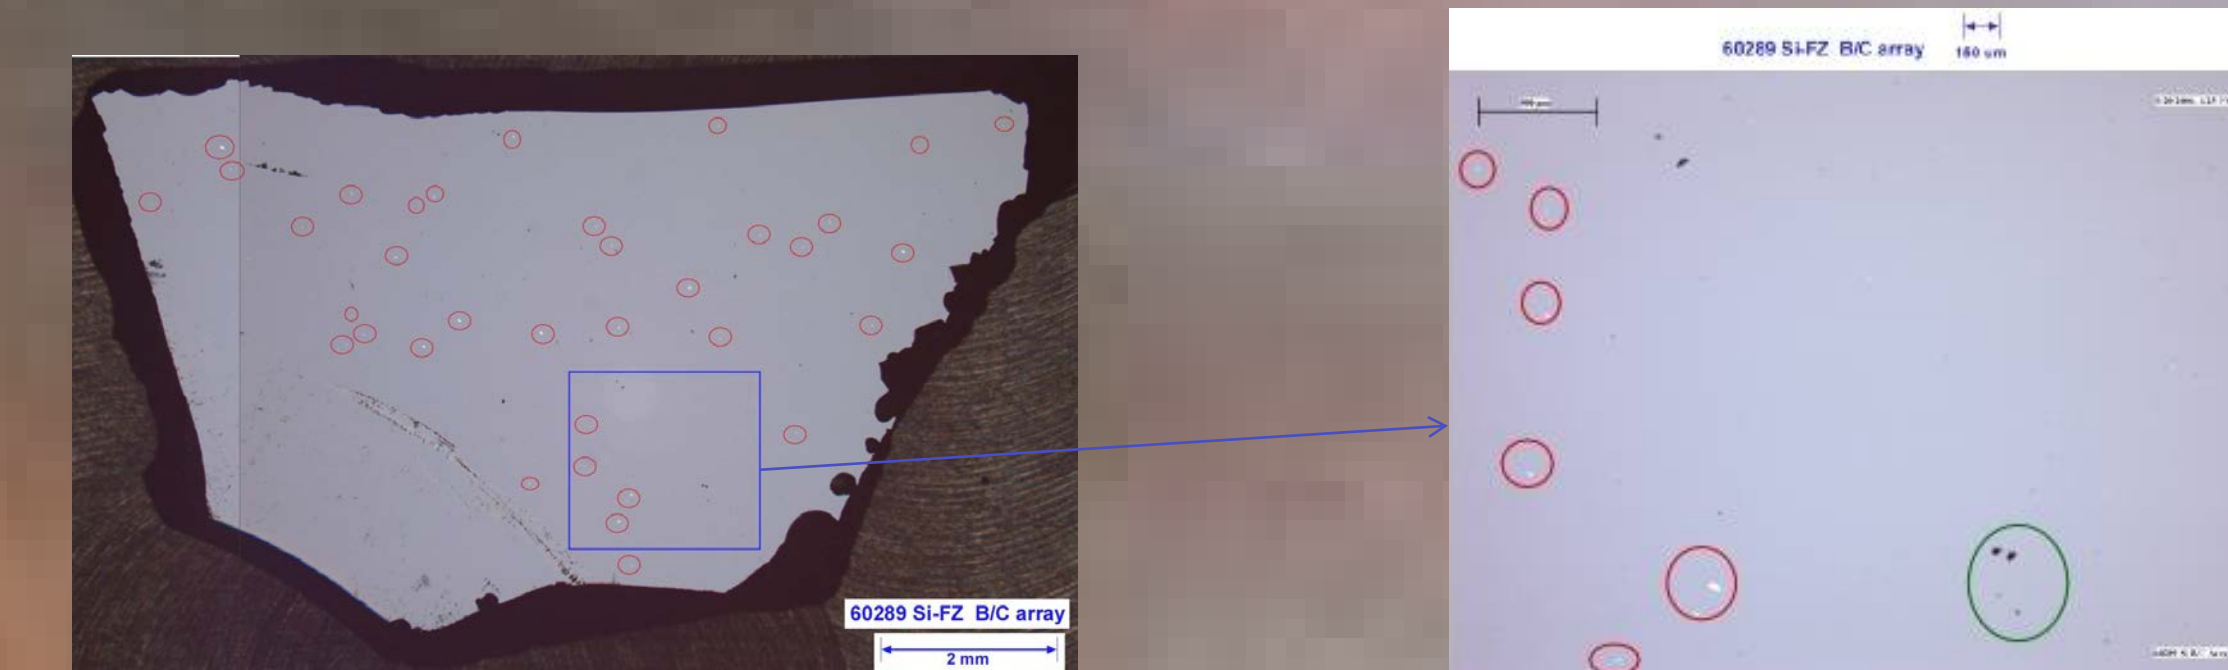
Before allocation: Sample was UPW cleaned for 1 min at 40°C. Several white ovals can be seen in the before images.

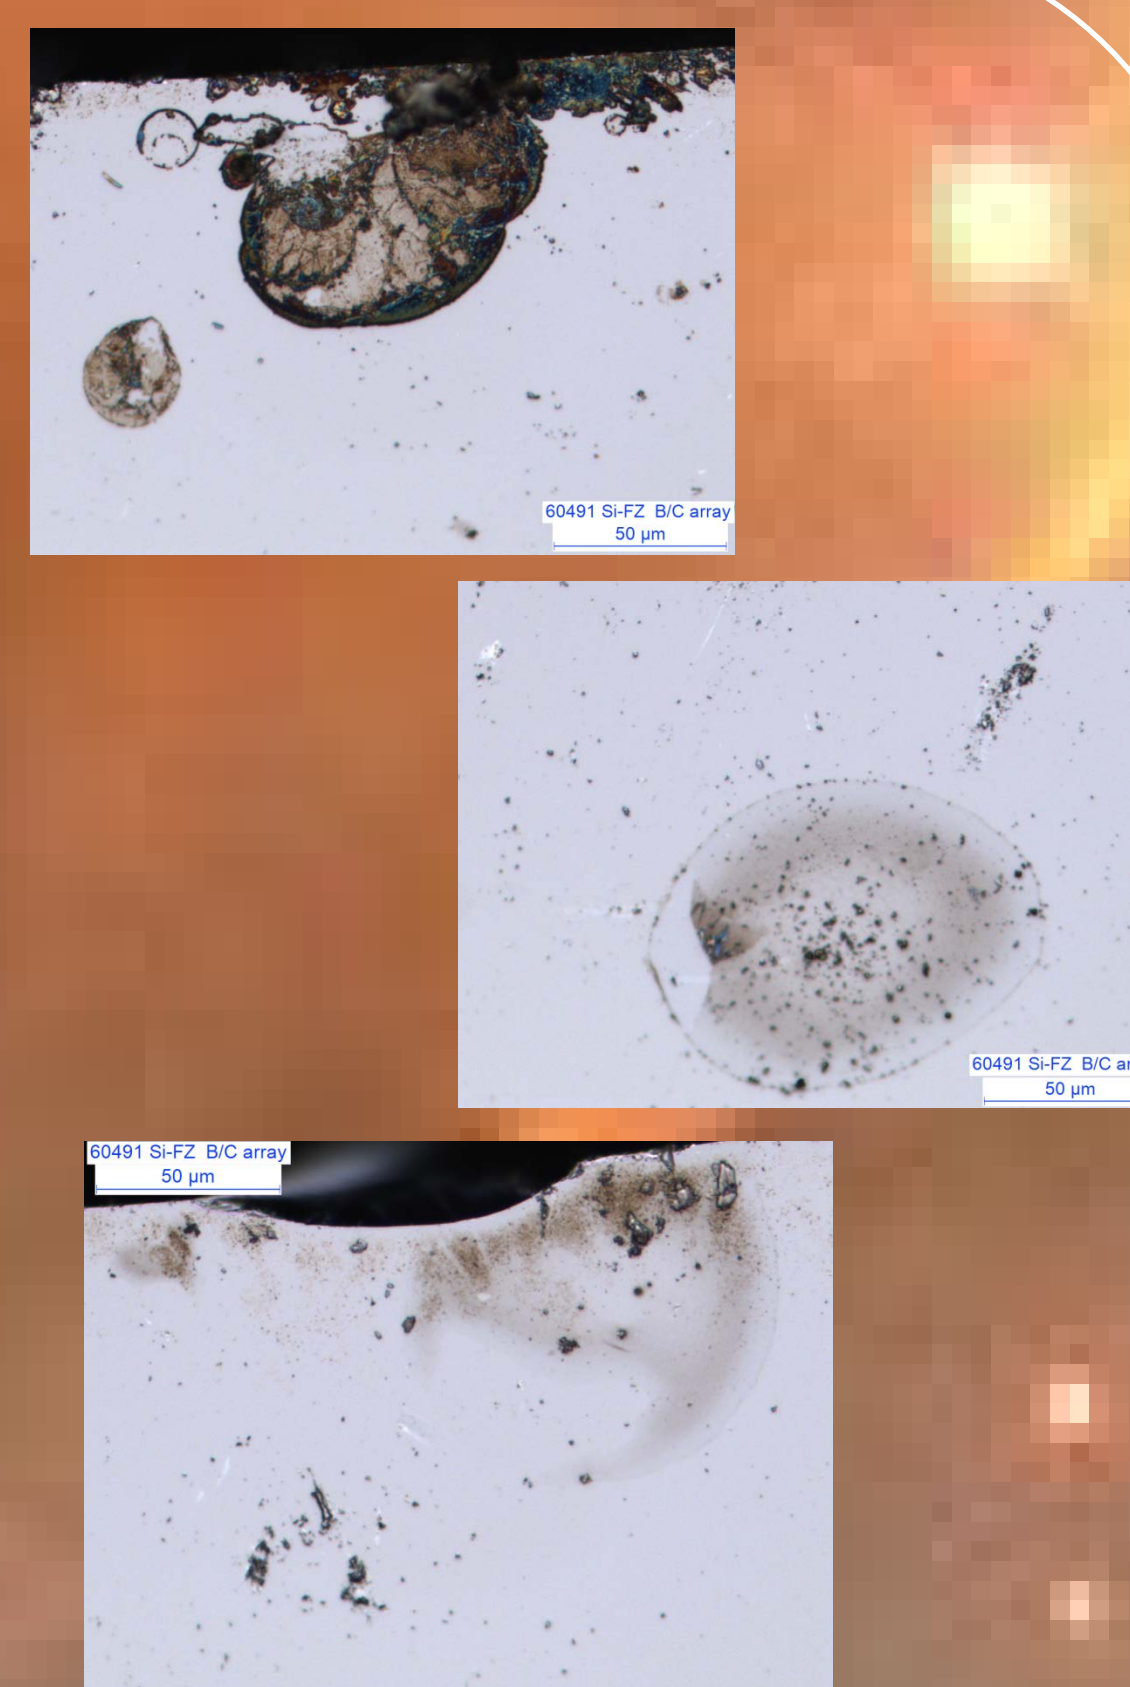
Sample has been exposed to Li Implant, UPW cleaning and XPS analysis. Images were taken after its second Li Implant. Brown stains appeared after XPS analysis.

Top three images are 50X magnification of single shots from interesting features (brown stains) of sample 60491 (Fig. 3.).

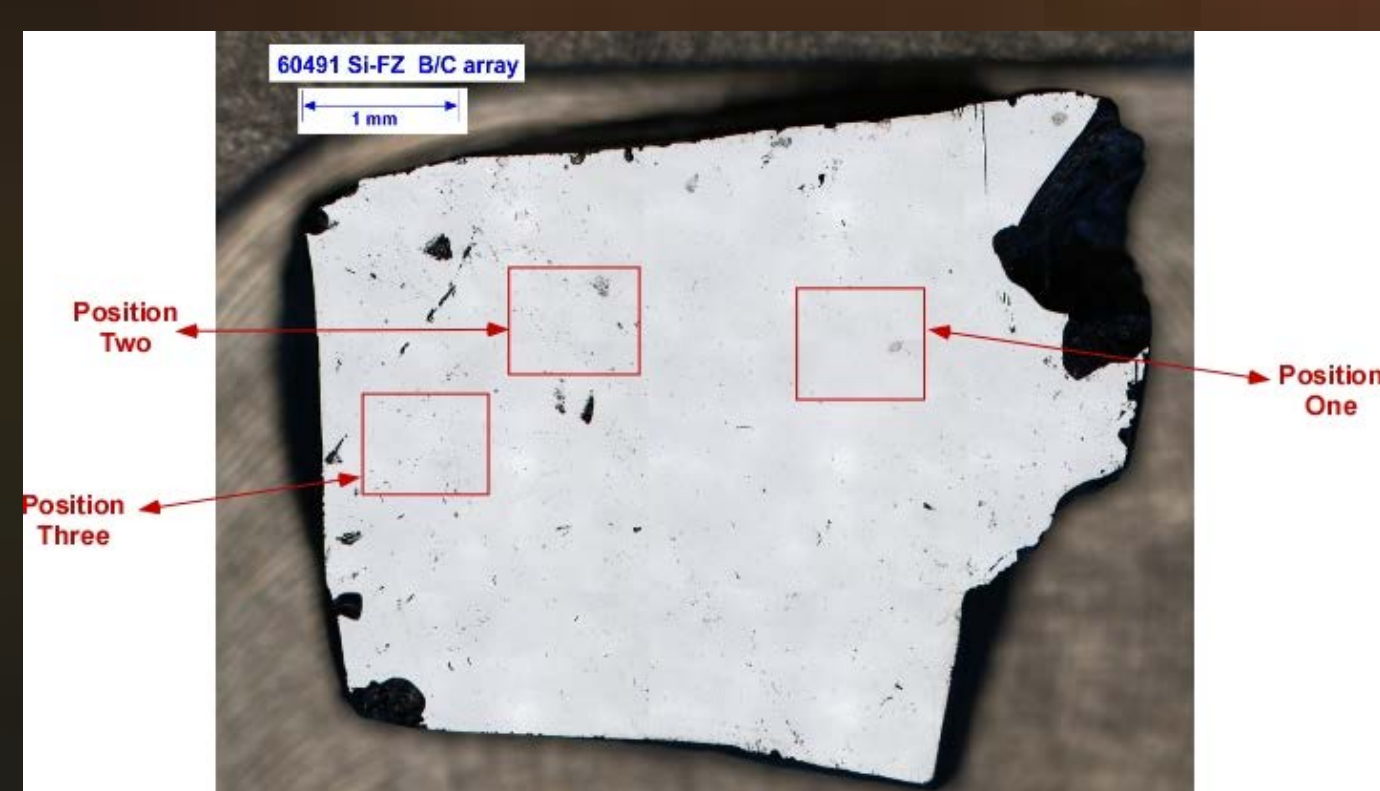
Fig. 3. A 5X magnification of mosaic scan of the sample 60491. The areas bounded by the squares were imaged at higher magnification.

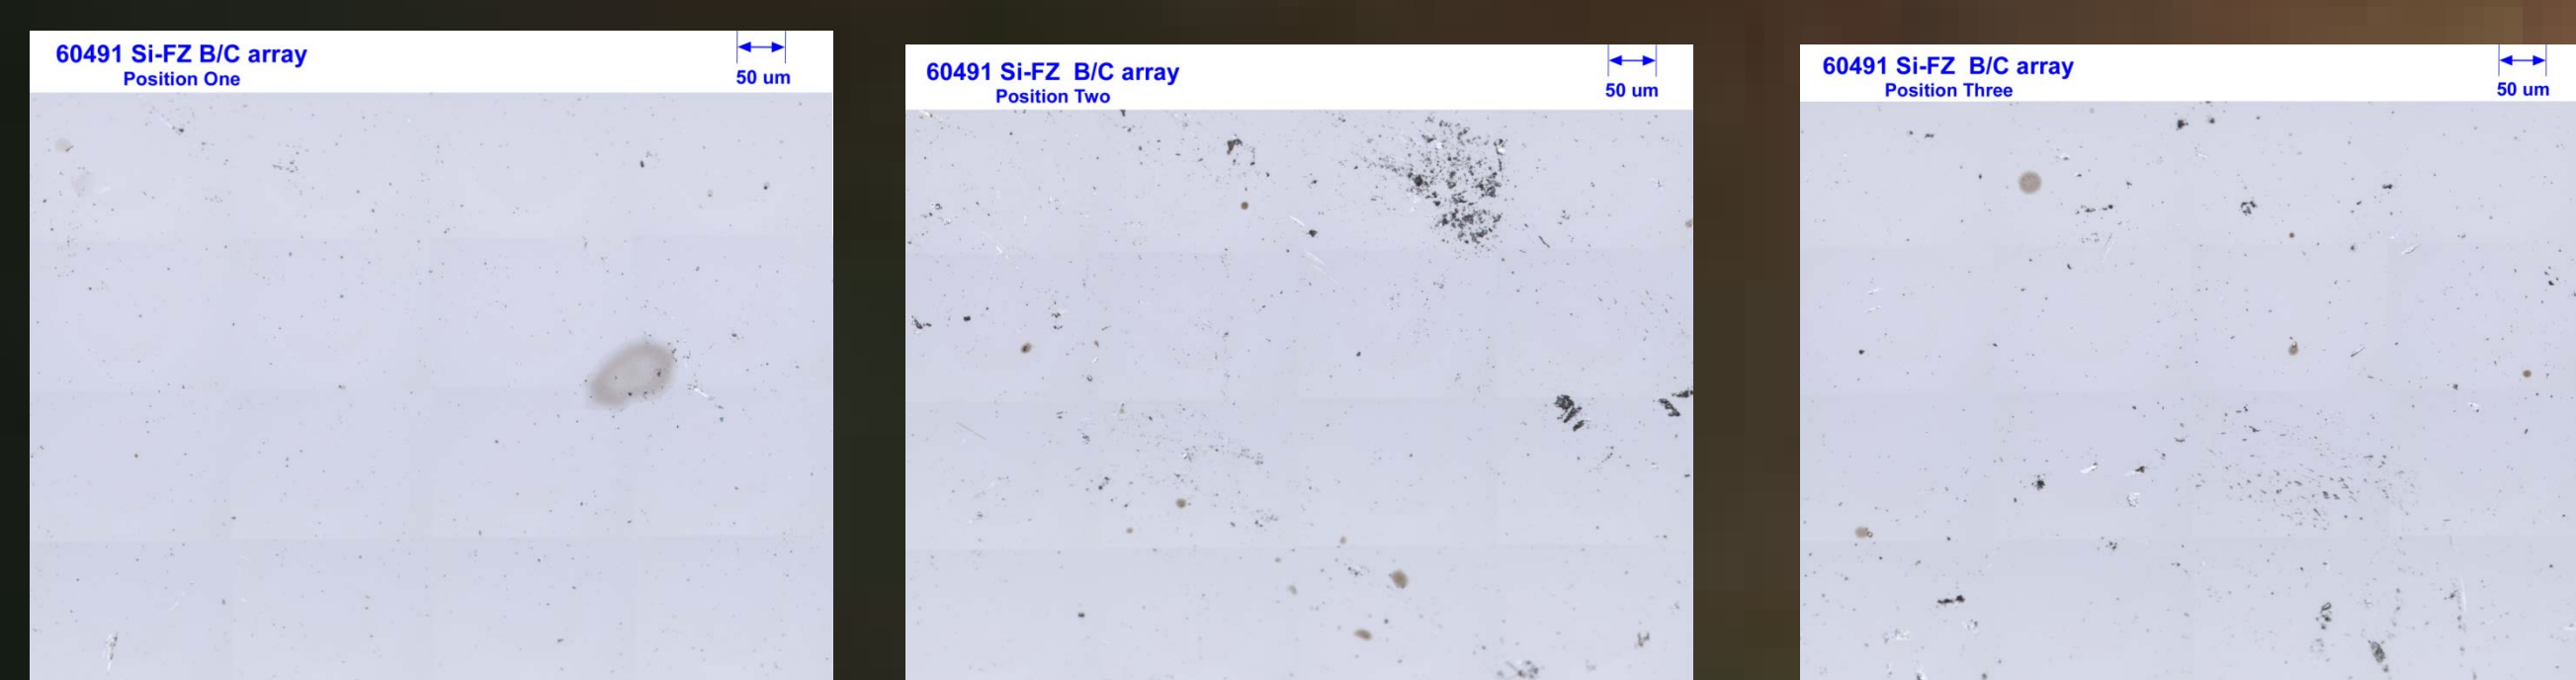
Position 1, Position 2, and Position 3 are 50X magnification of mosaic scans from selected areas in Fig. 3. Brown stains can be seen in several parts of the sample.

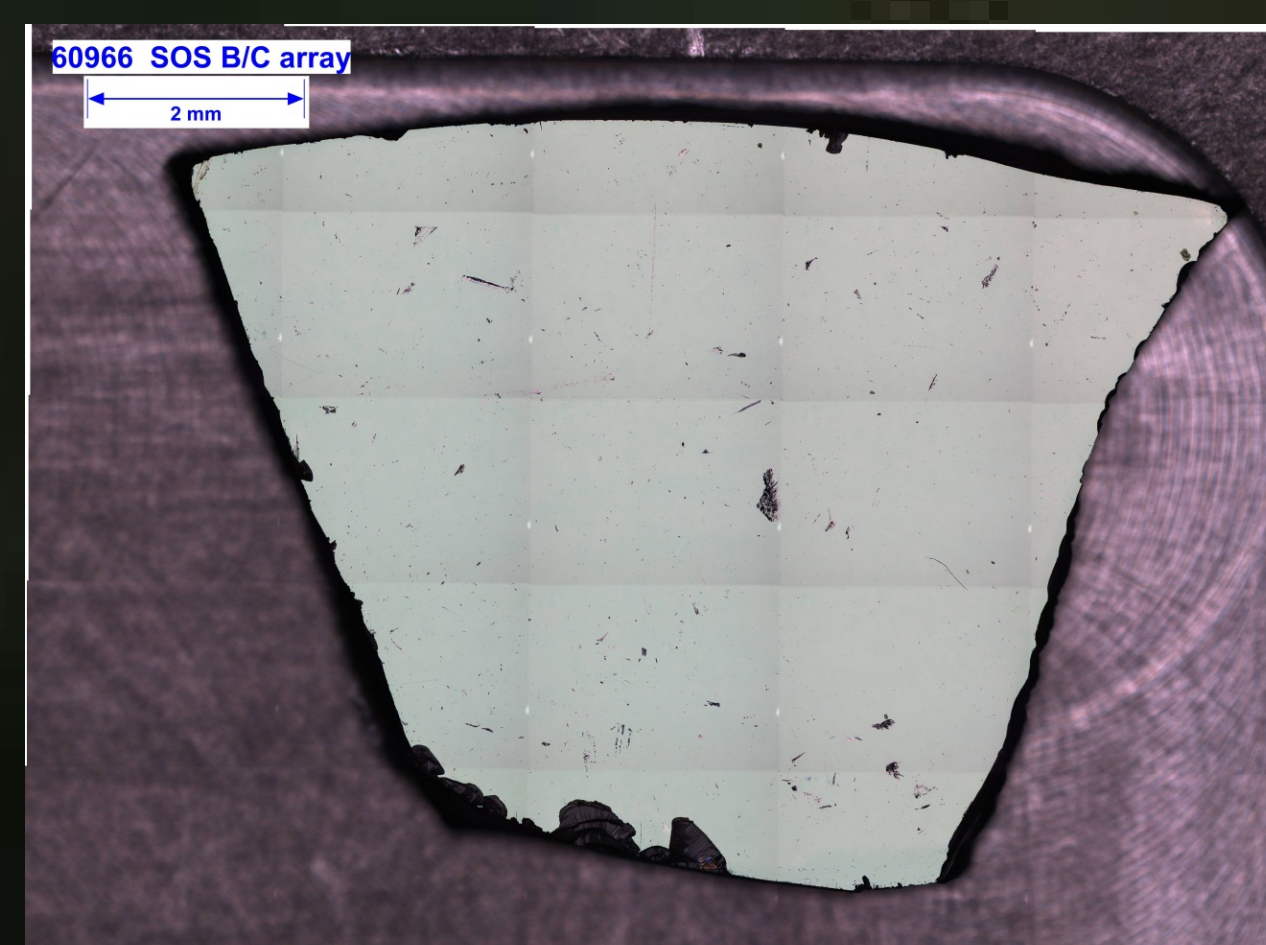
First image: Sample was exposed to UPW cleaning, CO<sub>2</sub> snow cleaning, HCL/HF cleaning, HNO<sub>3</sub> cleaning, and TRXRF analyses.

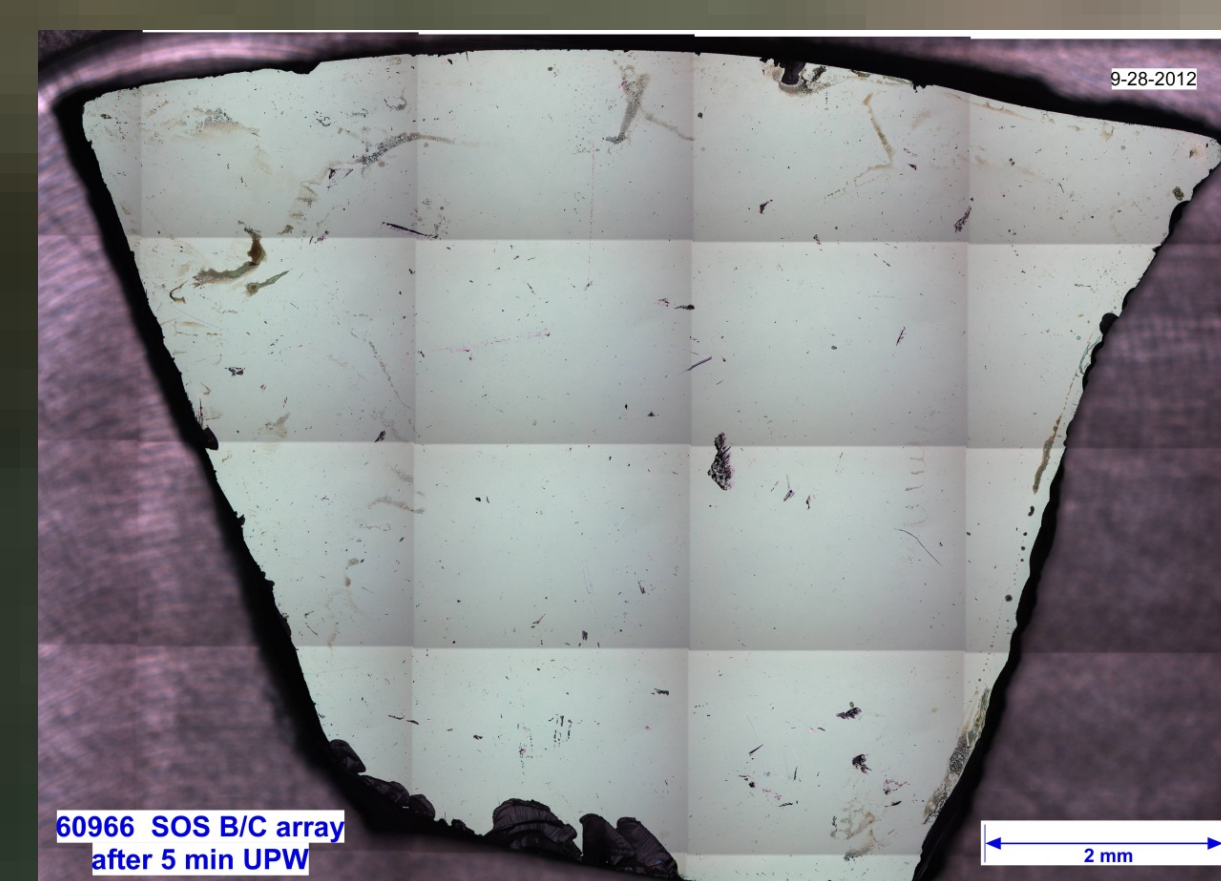
Then

Second image: Acetone residue can be seen after replica peels and acetone rinse. Image was taken after 5 min. of UPW cleaning.

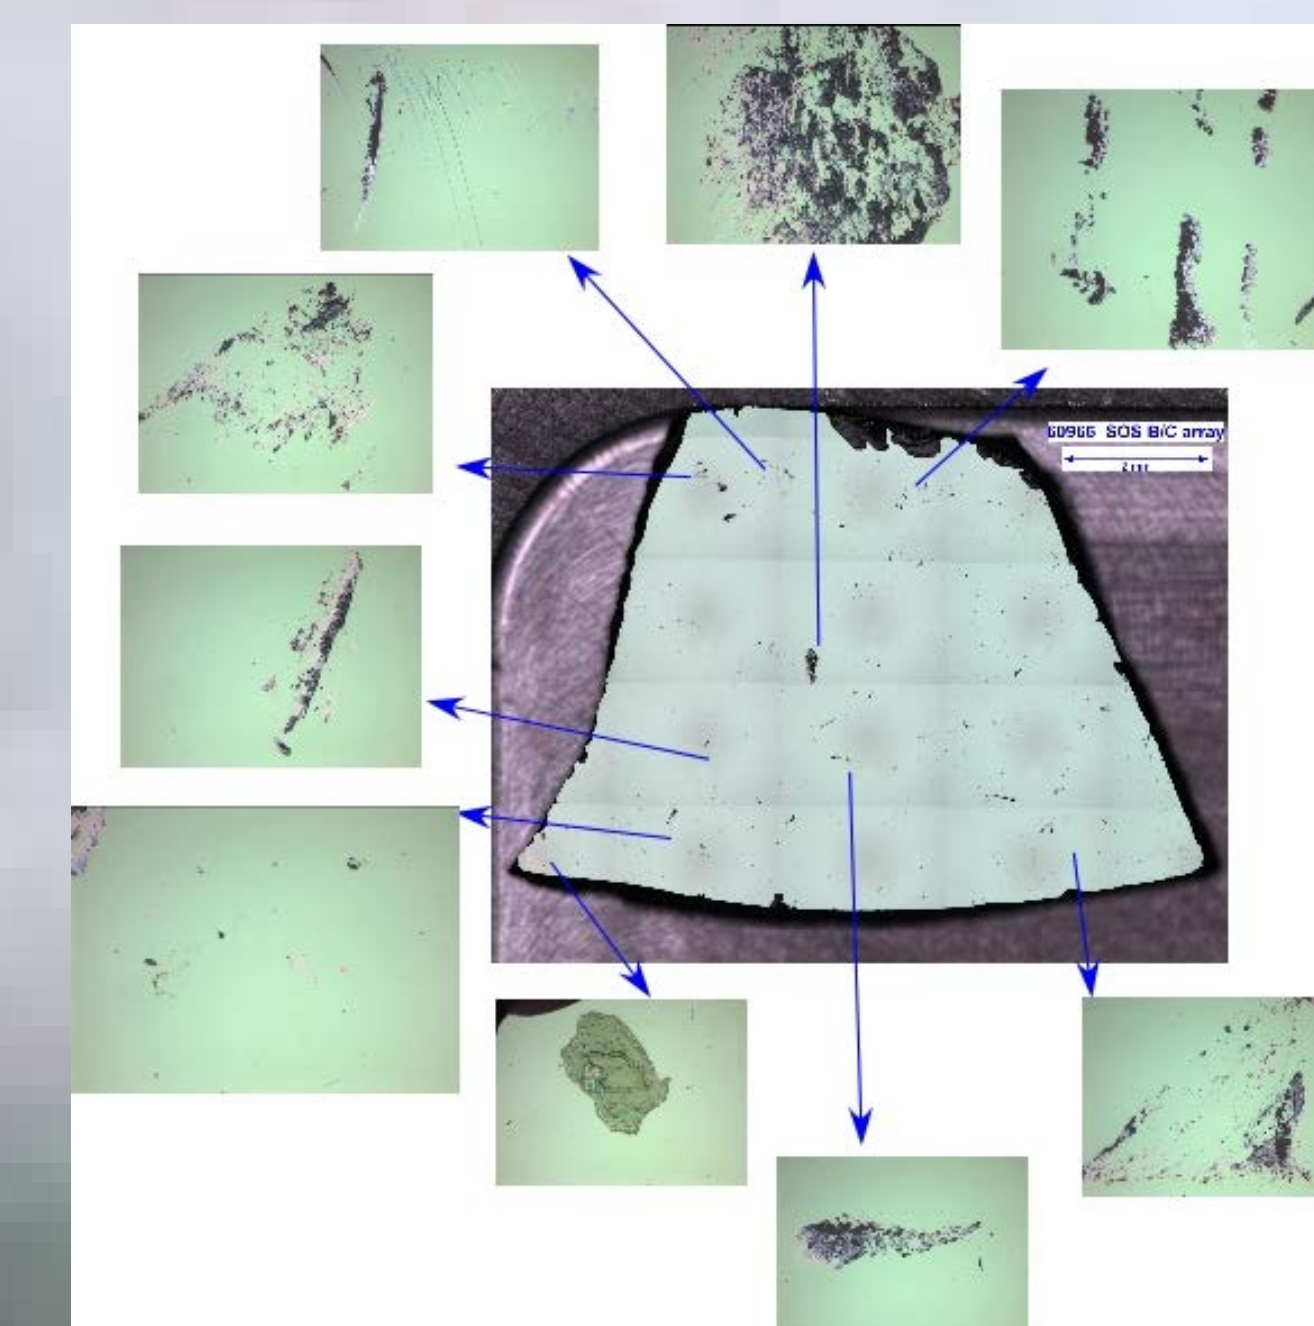
Final

Third image: Pictures were taken after 30 seconds of IPA application and 20 minutes of additional UPW cleaning. Smaller images indicate material that was added to the sample after replica peels and acetone rinse which was not removed by UPW cleaning.
