# GENESIS SPACECRAFT SCIENCE CANISTER PRELIMINARY INSPECTION AND CLEANING.

J. D. Hittle<sup>1</sup>, M. J. Calaway<sup>1</sup>, J. H. Allton<sup>2</sup>, J. L. Warren<sup>1</sup>, C. M. Schwarz<sup>3</sup> and E. K. Stansbery<sup>2</sup>,  
<sup>1</sup>Jacobs Sverdrup/ESC, Houston, TX, <sup>2</sup>NASA/Johnson Space Center, Houston, TX, <sup>3</sup>MEI Technologies/ESC, Houston, TX.  
 judith.h.allton@nasa.gov

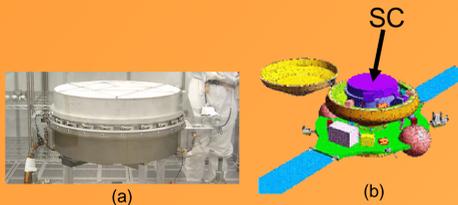
Pre-flight Configuration (a) and location (b) of the Genesis Science Canister (SC) inside the Spacecraft Return Capsule (SRC).

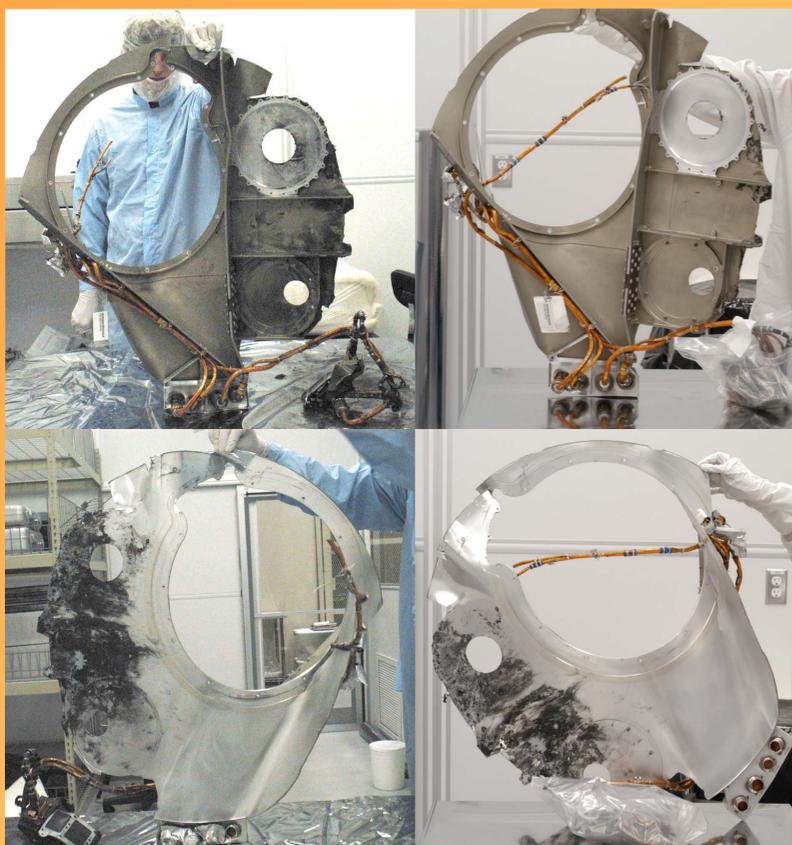
Exterior (above) and interior (below) views of the science canister base before cleaning (left) and after cleaning (right).

The circular openings in the base, beginning with largest, were sites for mounting the concentrator, filter, and array deployment mechanism.

The cleaning process consisted of gentle sweeping and vacuuming of fine particles.

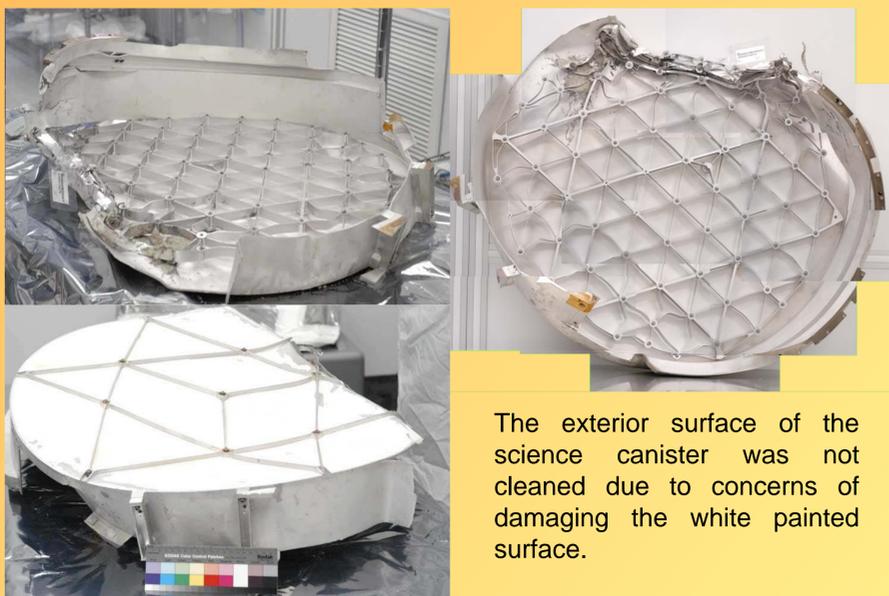
Interior (above) and exterior (below) views of the science canister cover before cleaning (left) and after cleaning (right).

The array grid inside the canister was the B-array frame which, during flight, held an assortment of semiconductor collector surfaces.

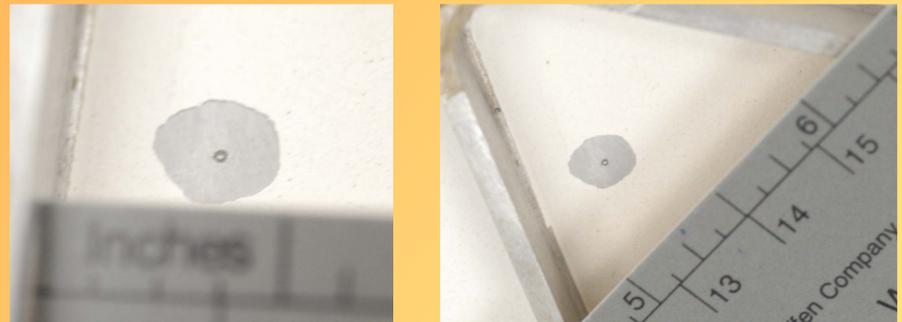
400µm Micrometeorite Impact

One crater, with morphology of typical micrometeorite impact craters, was observed. The crater, approximately 400 µm in diameter, is surrounded by a dark halo. The apparent impact may have resulted in removal of white paint surrounding the impact site.

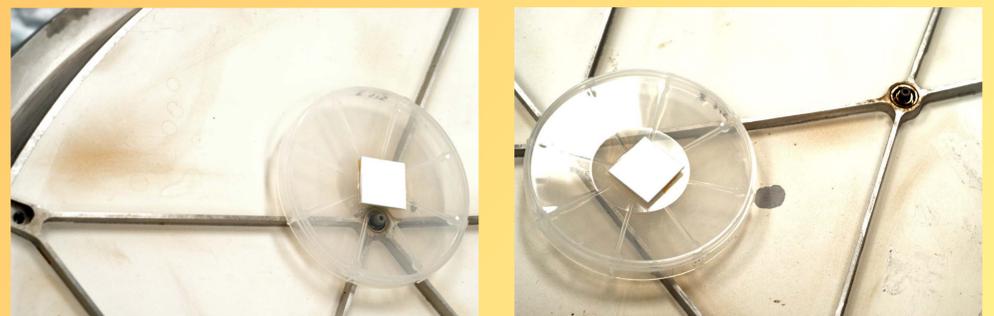
Gradient of Discoloration of the painted surface of the spacecraft

Discoloration appears around rib "shadows". Accurately mapping and analyzing the distribution of discoloration may be useful. Interior parts of the canister, which are unpainted and unanodized aluminum, also have discoloration referred to as "brown stain" which is thought to be due to UV polymerization of a hydrocarbon or siloxane contaminant. However, it is unclear whether the two types of discolorations are due to related mechanisms. The white square, sitting in a 4-inch dish, is pre-flight reference material.

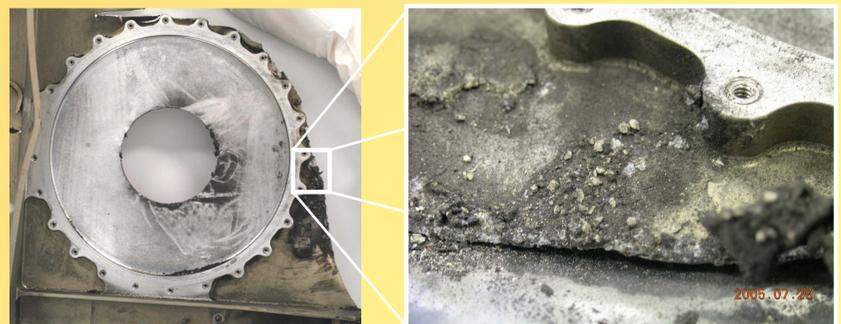
Dark Residue and White Spherical Matter

Dark, dusty residue can be seen on both sides of the canister base. Located near the filter site, larger white spherical particles are admixed with the dark residue. These white spheres are thought to be filter media debris. Potential sources of the dark dust are filter debris, heat shield debris, or ablation products. Tape pull samples of the dark material were obtained from these areas for analysis.

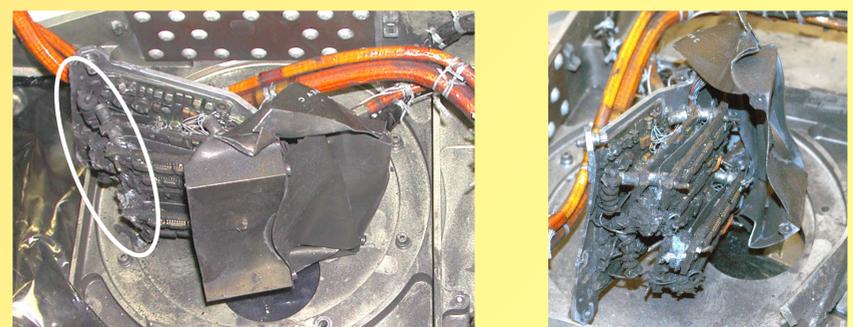
Deformation of Circuit Components

In addition to mechanical damage from the hard landing, a few printed circuit board components exhibit plastic deformation, perhaps due to thermal damage.
