SiC Concentrator Targets, Genesis Samples 60001 and 60003 Contamination Documentation

This report represents the completion of initial image documentation of the two flown SiC Genesis concentrator targets 60001 (serial number: U0639-14) and 60003 (serial number: L0760-08) and should help facilitate target selection.

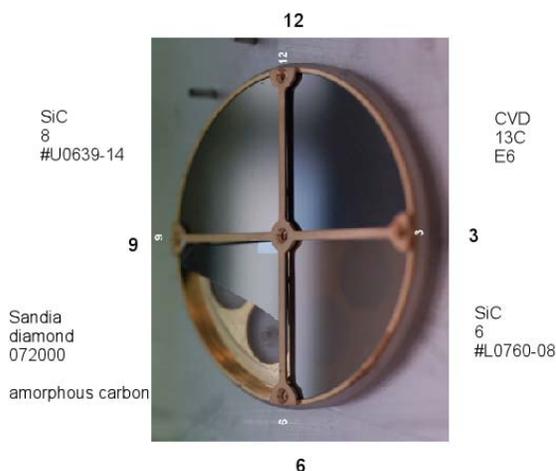
Fig. 3. Mounted targets, post-recovery, showing cross arm clocking designation.

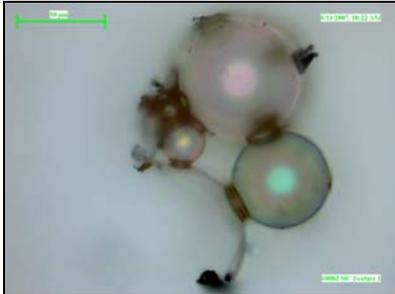
Unknown origin: The most intriguing features, which are not observed on wafer fragments, are the clusters of transparent spheres. These “bubbles” appear to be thin-wall structures, based on spherical reflections from numerous small fragments of broken bubble shells (Figs.5 & 6). Many of the small size transparent debris fragments may be derived from these bubbles. We speculate on cleaning/polishing slurries, space-environment substrate alteration or crash-derived condensates as possible sources for these features.

Fig. 5. Cluster of transparent spheres (60003).

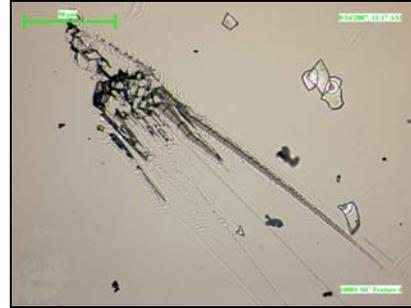
Fig. 6. Particle with trails (left) and “bubble” fragments (right)(60001).

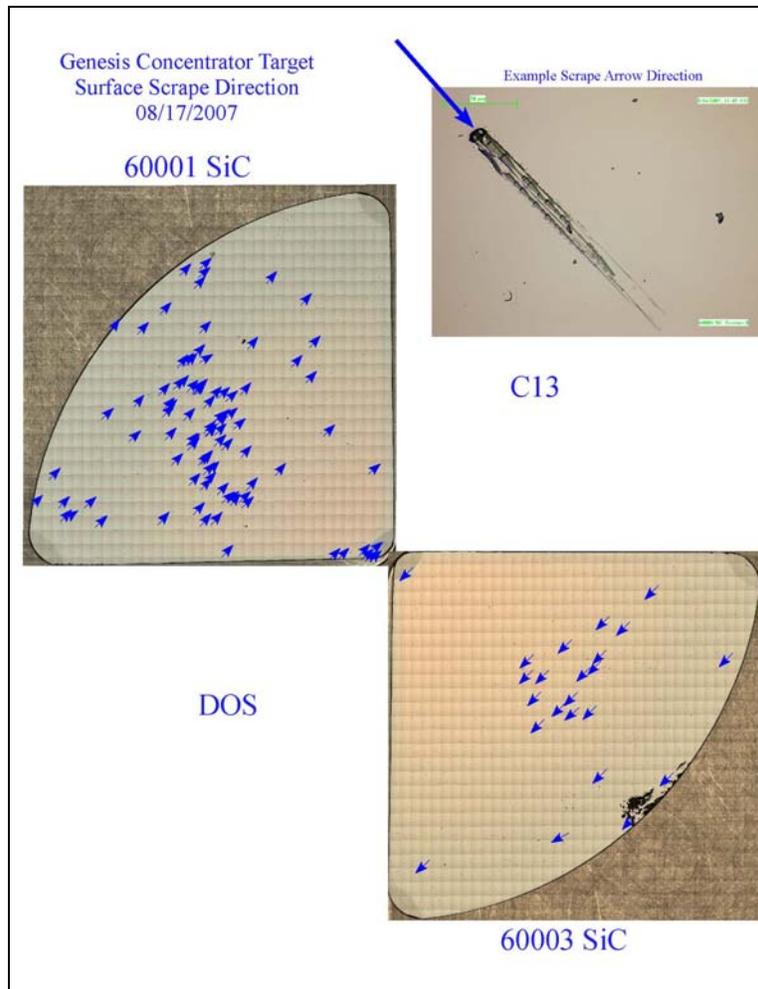
Pre-flight effects: Commonly observed are a class of features that we attribute to pre-flight quadrant preparation. These are dark spheres or elliptical shapes associated with trails (scratches). Fig. 4 shows that these features are oriented the same direction, as would be expected from a lapping procedure. In addition, some of these features occur beneath the protected corners of the cross. Similar features are observed on non-flight quadrant 3SiC01847 (see details in Appendix 2).

Fig. 4. Direction of trailing “scratch” in class of features with trail.

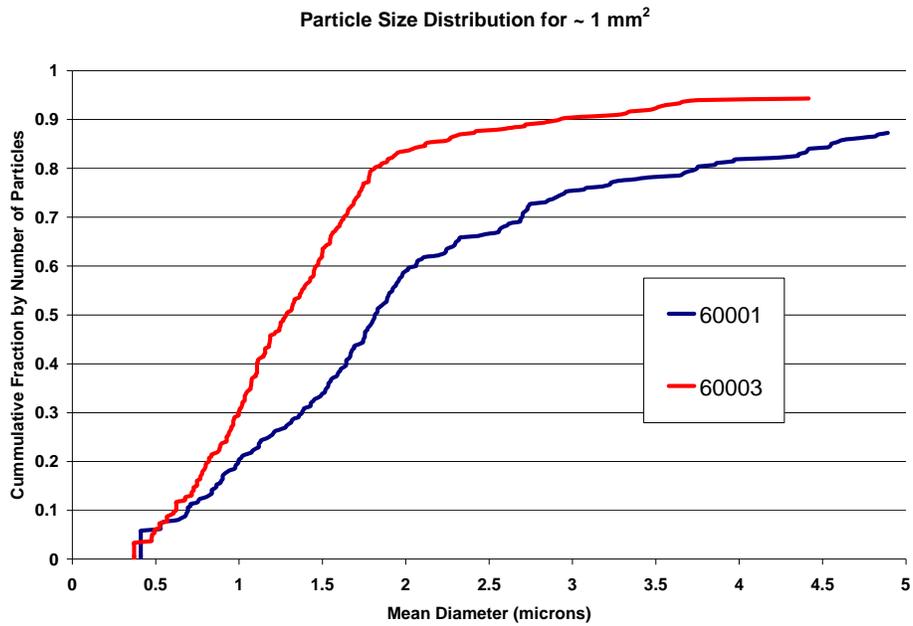
Particle size distributions: In the smaller particle size range, cumulative particle counts at 50X on 1mm² area indicate that 60003 is cleaner than 60001 (Fig. 7). Extended detail on particle size distributions is included in the body of this report.

Fig. 7. Cumulative fraction of particles, by number, vs. particle mean diameter in micrometers. The break in slope occurs at about 2 μm .

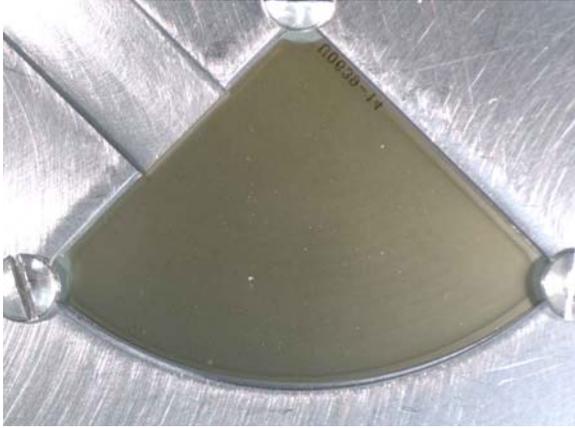
60001 overview image

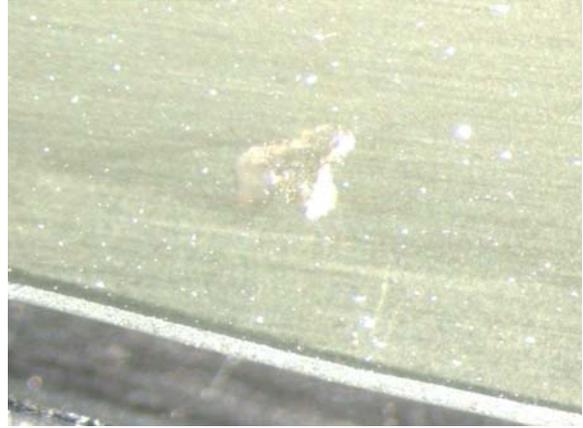
60001 (feature 1)

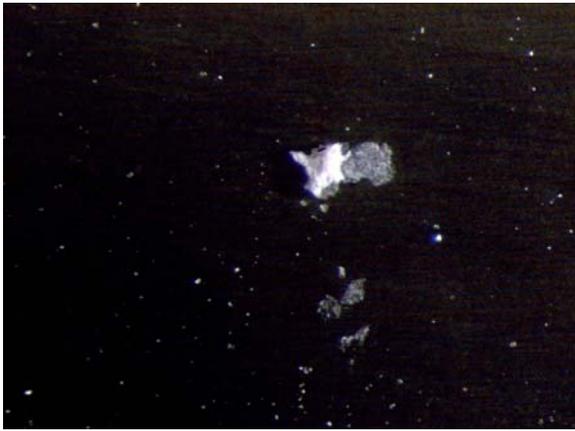
60001 small dried salt/mud area

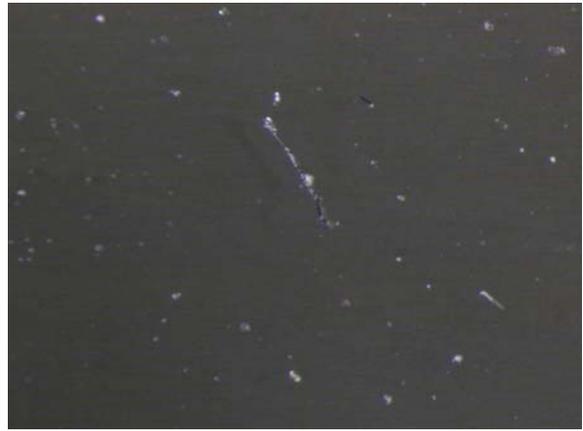
60001: black fiber

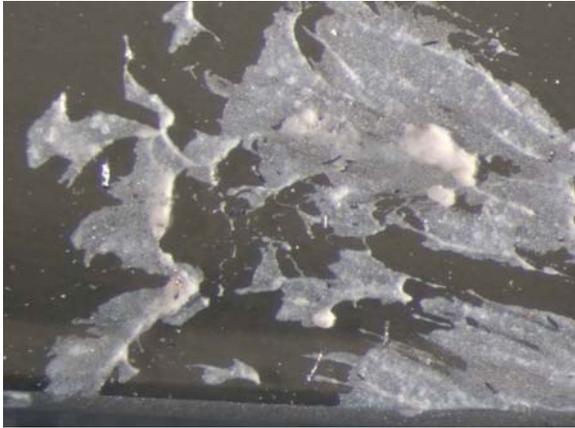
60003: salt/mud smear

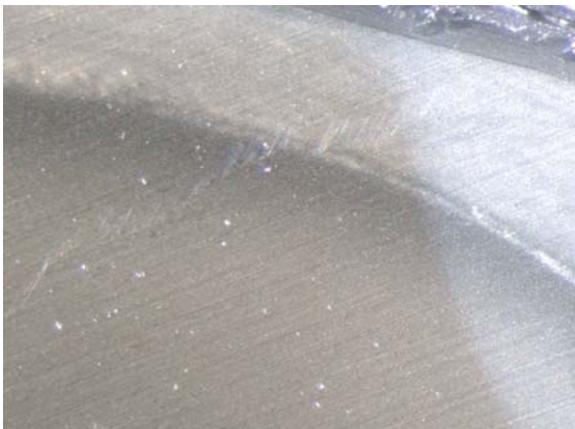
60003: row of scratches

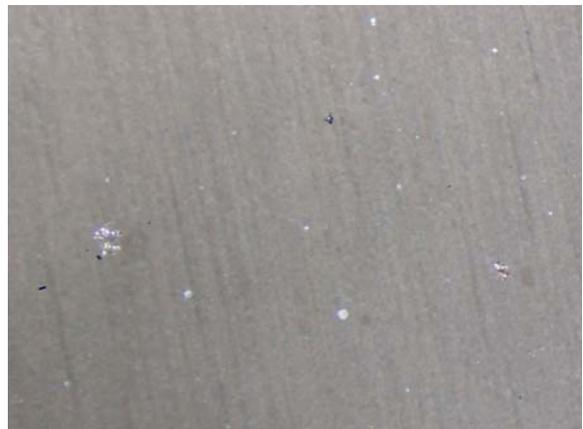
60003: fine particles and two bubble clusters

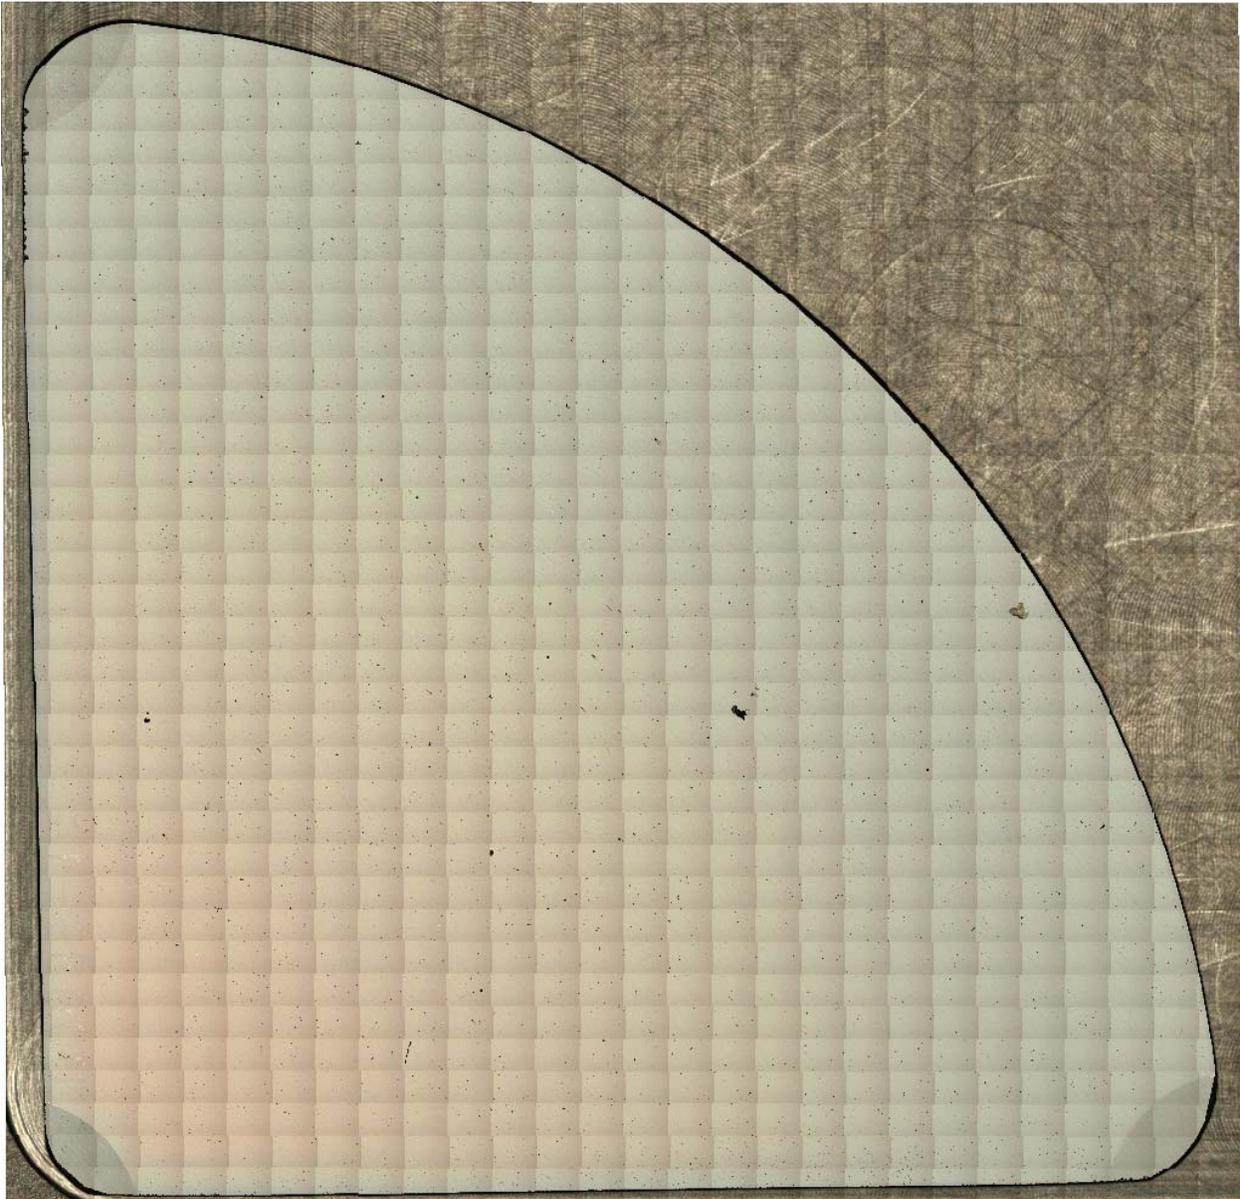
The radial color gradient observed in the mosaic images is real. We are in the process on quantifying the gradient.

60001 bright-field mosaic microscope image, 5X objective. Each square is an individual image that can be viewed at a high resolution. The ~ 50 MB bitmap image (not attached in this report) can be used to zoom into various locations and highlight an area for viewing. The mosaic contrast was not on auto and remained constant for all frames; thus, this color variation, with radial distance from focal point, is real.

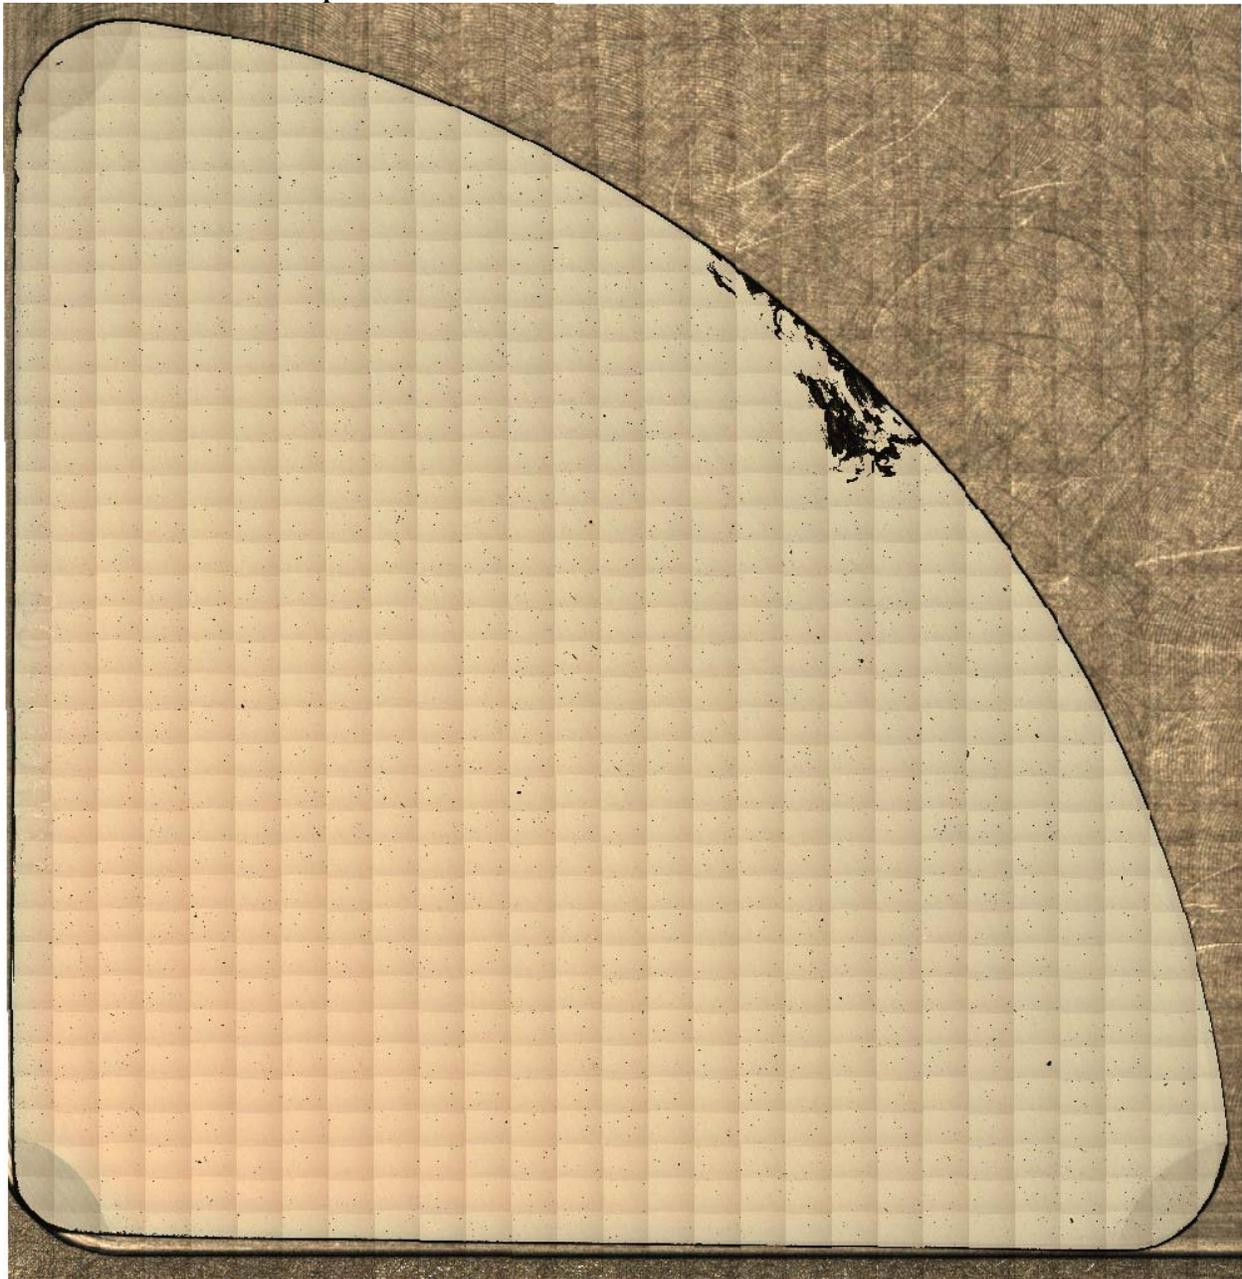
60003 bright-field mosaic microscope image, 5X objective. Each square is an individual image that can be viewed at a high resolution. The ~ 50 MB bitmap image (not attached in this report) can be used to zoom into various locations and highlight an area for viewing. The mosaic contrast was not on auto and remained constant for all frames; thus, this color variation, with radial distance from focal point, is real.

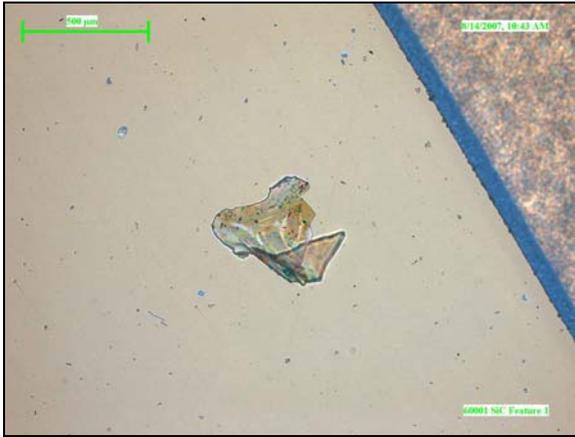
Feature 1: Thin transparent film fragment on surface of SiC target (looks like Kapton tape). Scale bars 500 μm and 50 μm.

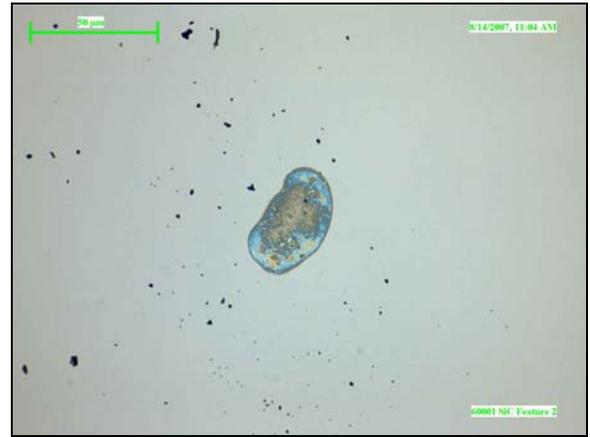
Feature 2: Transparent blue/gray area on SiC target shielded corner (under cross). Scale bars 500 μm and 50 μm.

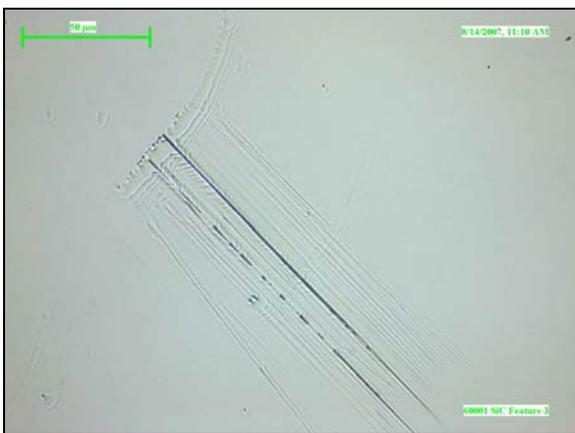
Feature 3: Two examples from a cluster of four scratches on SiC target corner. Scale bars 50 μm.

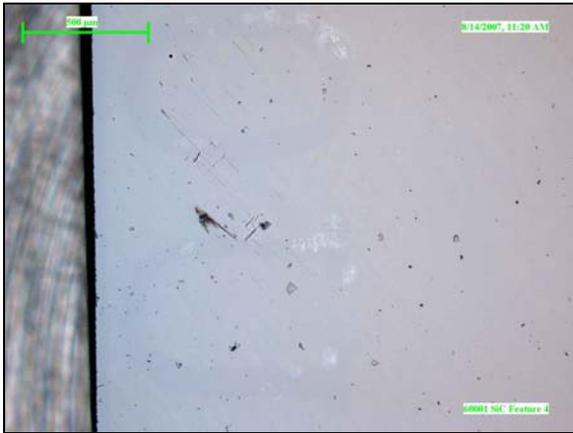
Feature 4: Angular scratch near edge of SiC target, nearby transparent debris with spherical reflection/refraction. Scale bars 500 μm and 50 μm.

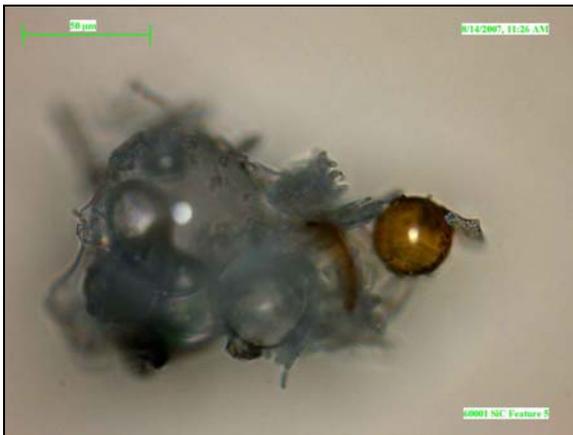
Feature 5: These objects appear close together at 10X. Image at left shows detail of debris cluster, amber-colored transparent sphere attached to a light colored fibrous mass. Additional images of this mass reveal additional colorless bubble-like spheres among fibers. Image at right is a common flat circular form. Discrete colored edge and interior visibly different from bubble-like objects. Scale bars 50 μm.

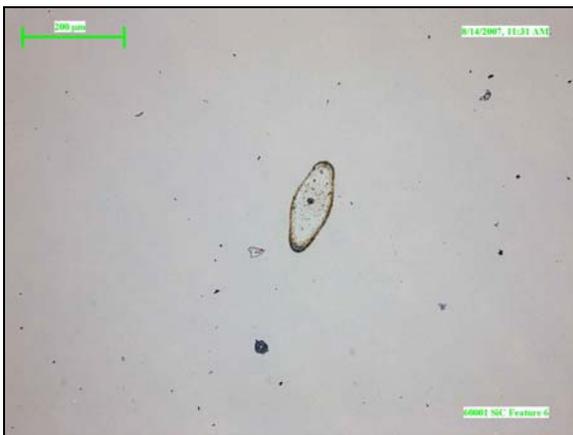
Feature 6: Unique form, transparent with clear edge definition. Interior particles are uniform in color. Scale bars 200 μm and 50 μm.

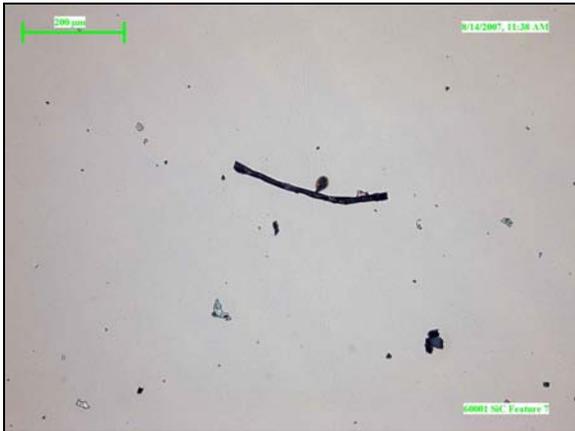
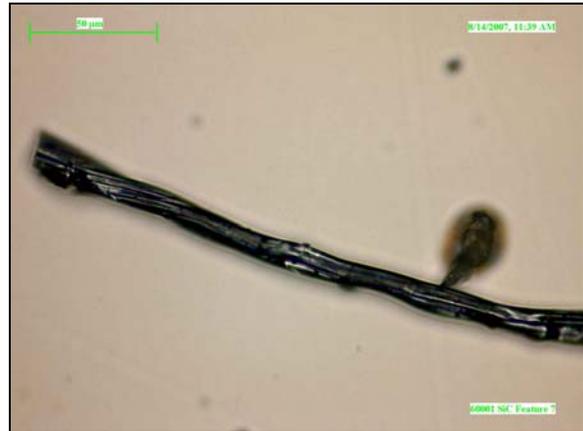
Feature 7: These dark fibers appear on both SiC targets; they vary in length. Striations appear reflective in image at left. A brown particle appears to be surrounding the end of a small “frayed branch” of the fiber. Additional images show transparent particulate contamination attached directly to fibers. Scale bars 200 μm and 50 μm.

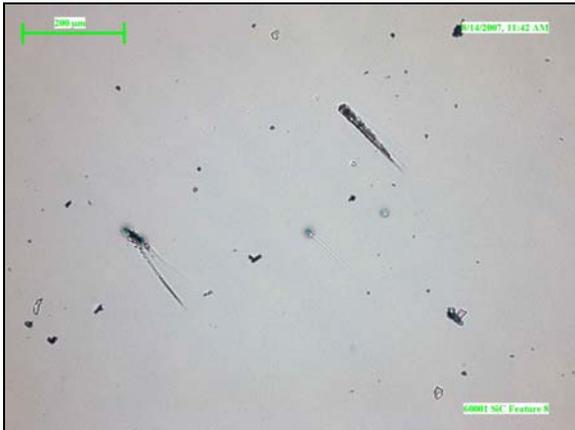
Feature 8: One example from a cluster of four scratches on SiC target. Image at right shows a small spherical feature with trail. Scale bars 200 μm and 50 μm.

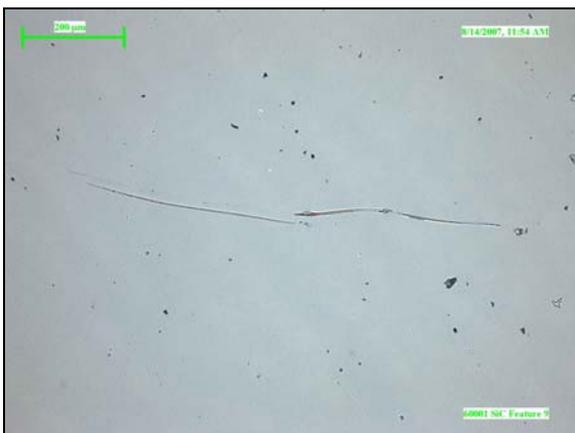
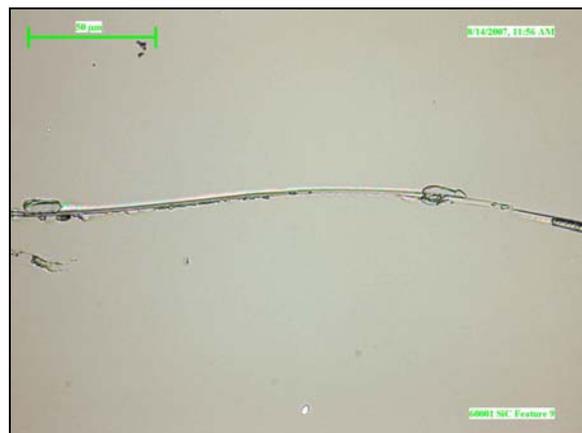
Feature 9: Long thin scratch, made in two parts. Scratch edges appear very rough, with various fracture marks. Particulate debris observed at various points along the length of the scratch at higher magnification. Scale bars 200 μm and 50 μm.

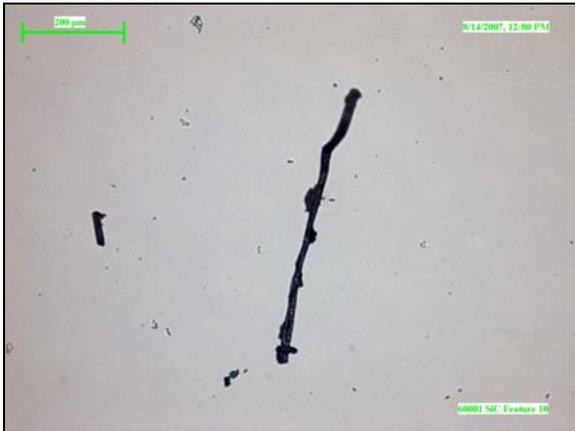
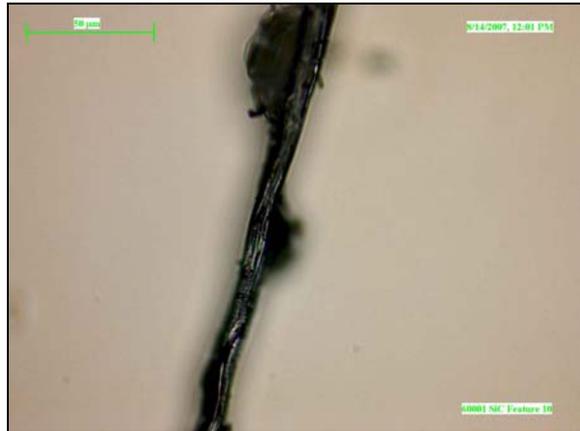
Feature 10: Dark fiber, similar striations, metallic luster and particulate attachments as seen in feature 7. Scale bars 200 μm and 50 μm.

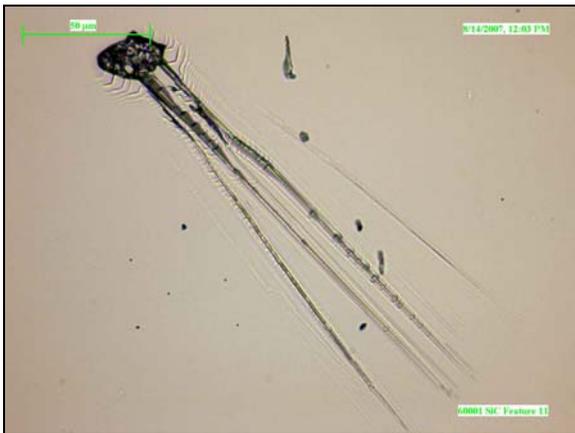
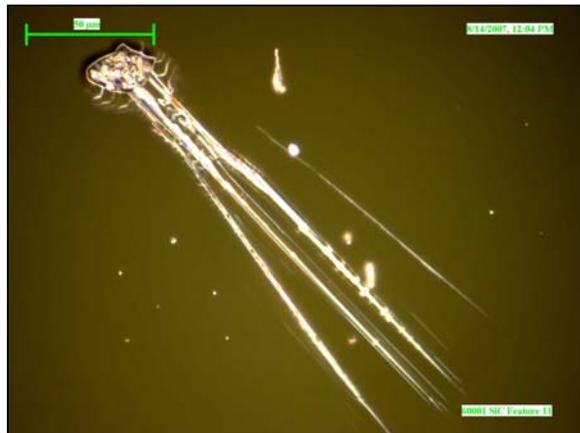
Feature 11: Bright and dark field images at show an irregularly shaped imbedded particle with trails. Stress/fracture markings observed surrounding particle and trail. Scale bars 50 μm.

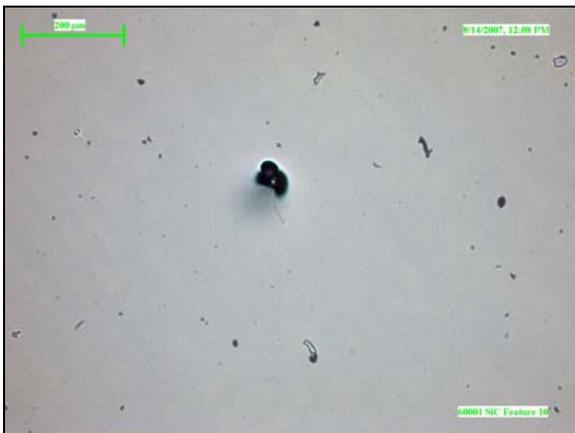
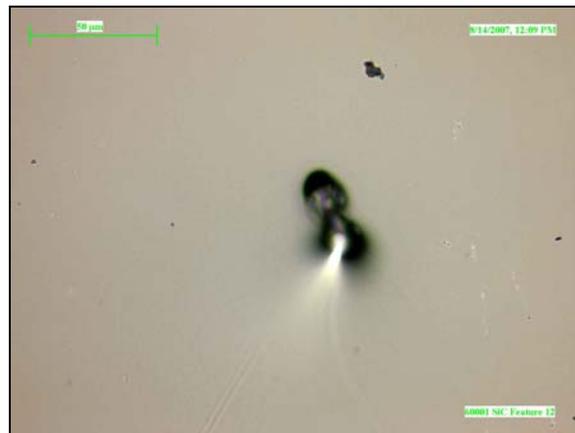
Feature 12: Feature, 300 μm top to bottom dimension. Light is reflected directionally. Scale bars 200 μm and 50 μm.

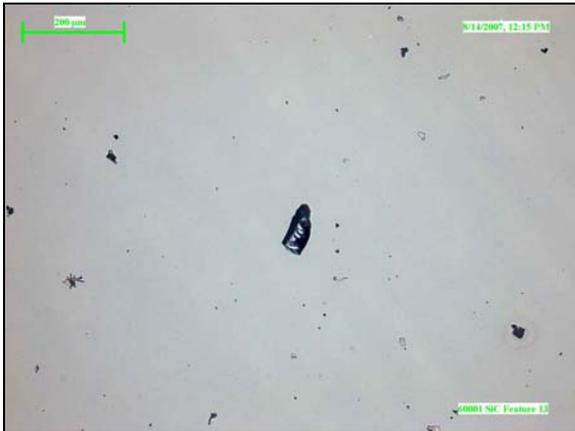
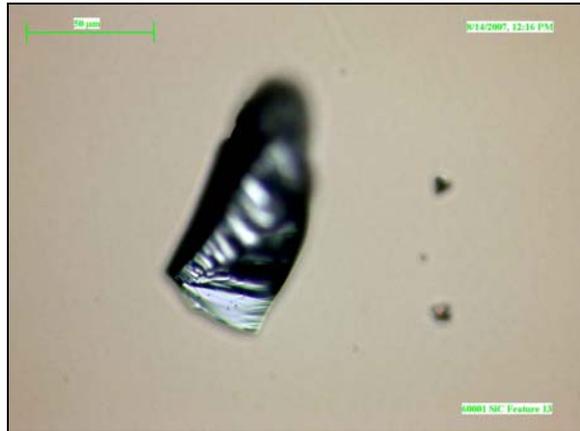
Feature 13: Dark flake on surface of SiC target; looks like a Si collector fragment. Fracture/chipping effects clearly seen on particle edge. Scale bars 200 μm and 50 μm.

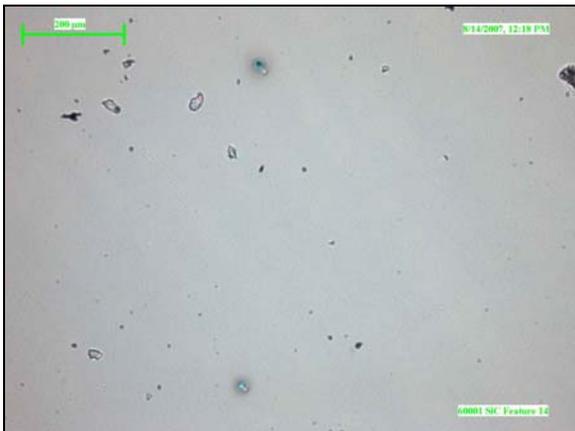
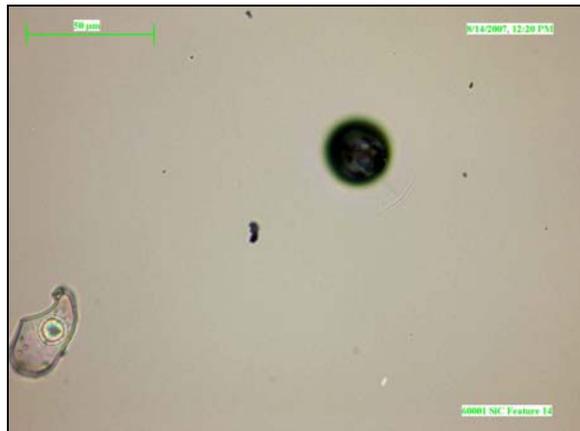
Feature 14: At left, area with three spherical features, seen among transparent particulate contamination. Close-up of 50 μm dark spherical feature with measured top to bottom dimension of 150 μm. Scale bars 200 μm and 50 μm.

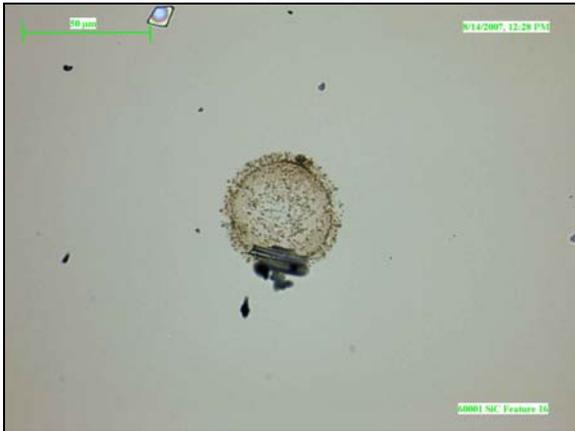
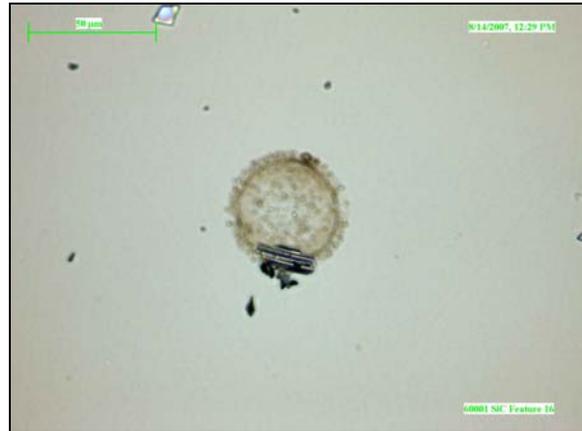
Feature 16: Images show debris fragment on top of a flat circular form. Debris fragment has reflective striations common to dark fibers found throughout target surfaces. Scale bars 50 μm .

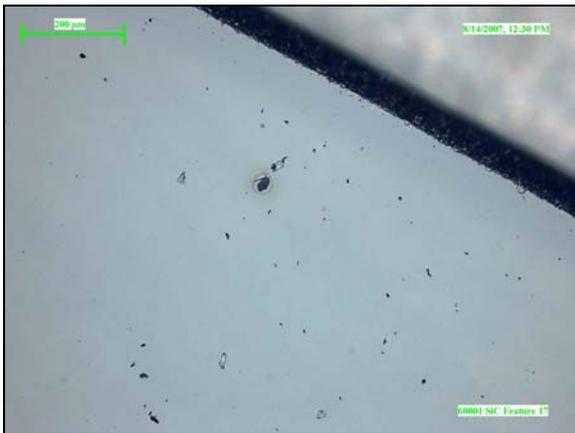
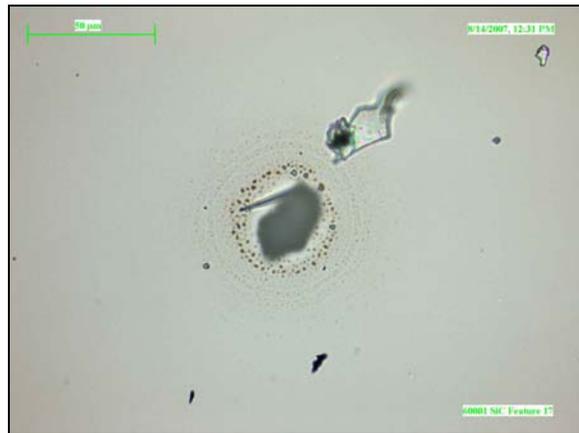
Figure 17: Evaporation rings visible surrounding particle at 10X. Rings consist of fine brown colored droplets, decreasing in size away from particle. Scale bars 200 μm and 50 μm .

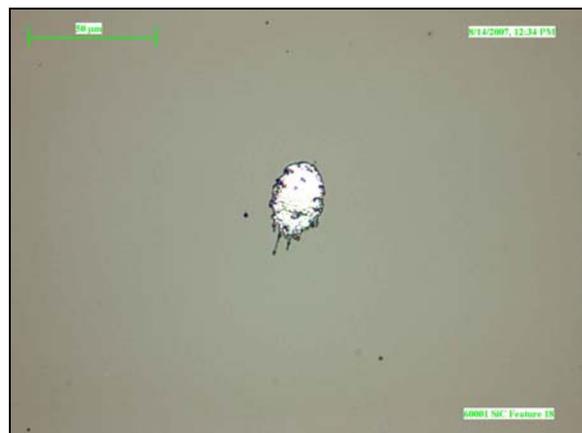
Feature 18: Light and dark field images of a reflective, irregular shaped mass. Smaller dark particles rest on top of the layered mass. Scale bars 50 μm .

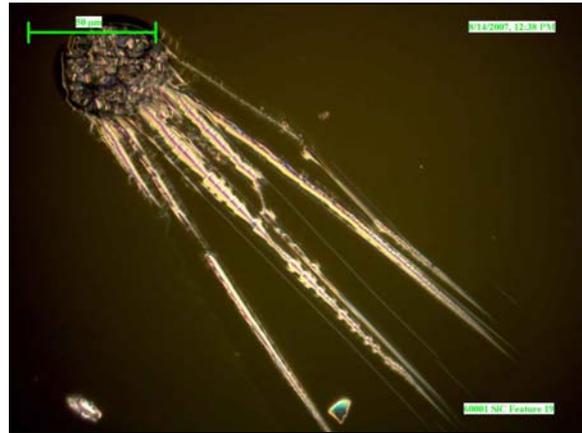
Figure 19: Bright and dark field images of a feature with segmented trails. Scale bars 50 μm .

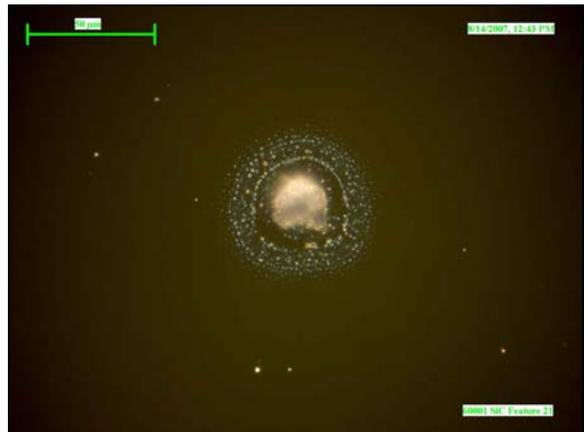
Feature 21: Light and dark field images of large particle (approx 20 μm in height) surrounded by evaporation rings. The images show similar coloring and droplet dispersion seen in feature 17. Scale bars 50 μm .

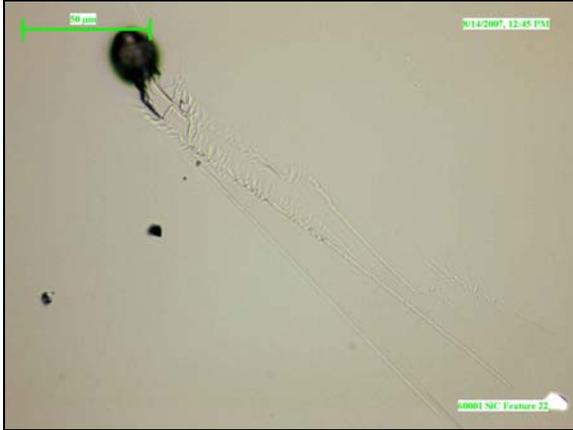
Feature 22: Irregularly shaped round particle (approx. 60 μm from top to bottom) and trail. Stress/fracture markings observed surrounding particle and trail. Scale bar 50 μm .

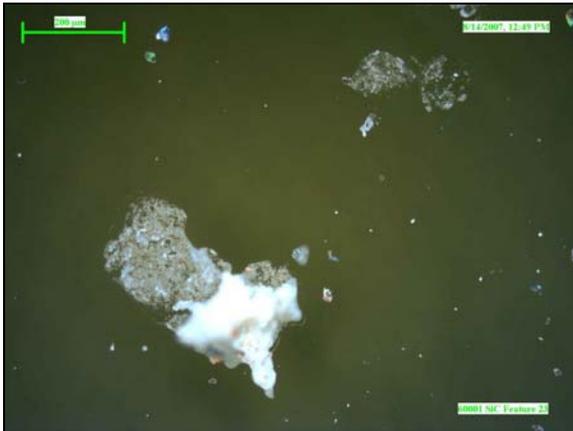
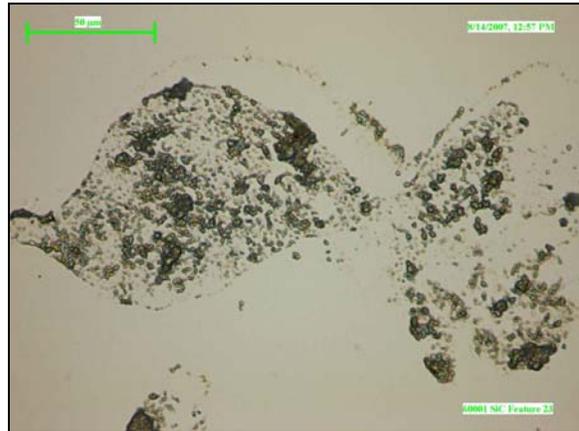
Feature 23: At left, dark field image of an area with salt/mud/debris clump. A light-colored mass covers one end of lower deposit, the mass appears dark in color in bright field view. At right, bright field image of possible remnants of salt/mud/debris clump. Scale bars 200 μm and 50 μm .

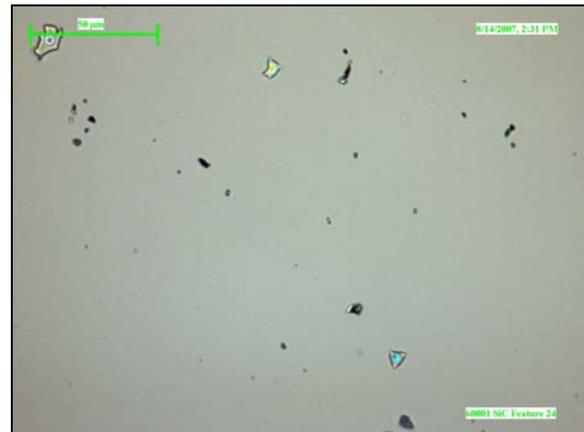
Feature 24: Particulate contamination on SiC quadrant edge. The particle density appeared to increase toward the center of the target along this edge. The particles are very small; most appear to be transparent shards and flakes on target surface (bubble remnants?). Scale bars 500 μm and 50 μm .

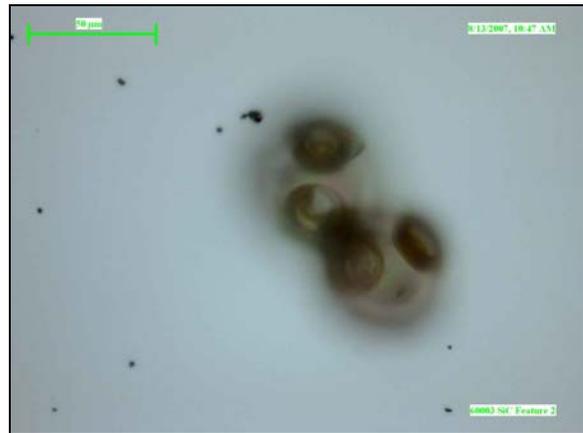
Feature 2: Cluster of two bubble-like spheres. A different focus (at right) shows other adhesion material locations. Scale bars 50 μm.

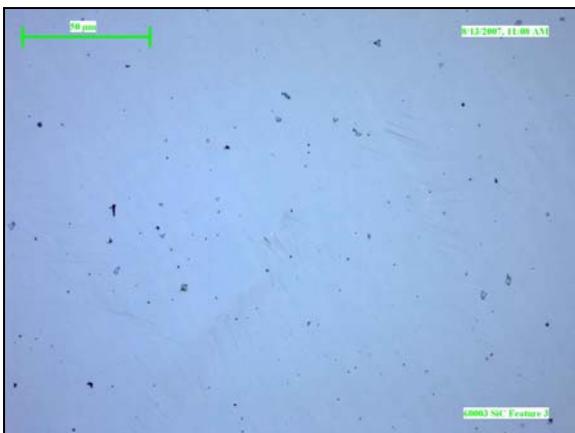
Feature 3: Area of faint, featherlike scratches surrounded by sparse particulate contamination. Scale bars 500 μm and 50 μm.

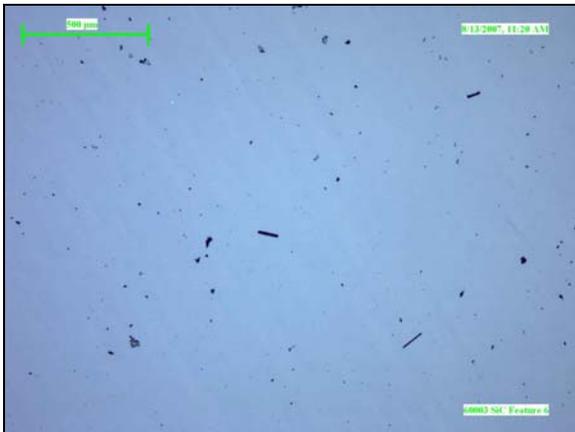
Feature 6: Area of dark fibers among particulate contamination. Shiny striations and blunt ends on fiber are visible at higher magnification. Fiber diameter about 20 μm. Scale bars 500 μm and 50 μm.

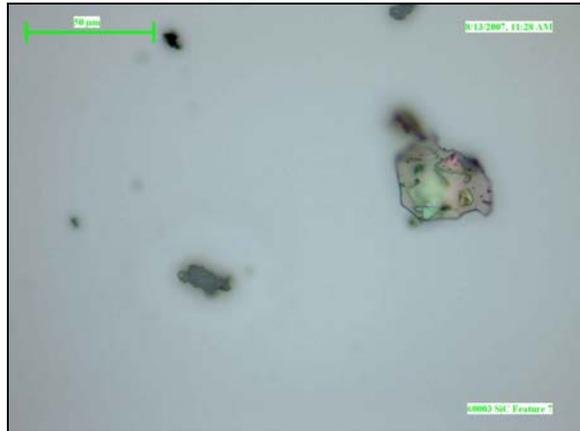
Feature 7: Area shows a particle surrounded by faint evaporation rings (image at left) and a large transparent convex fragment. The convex fragment is similar to the partial bubble-like form seen in feature 1. Scale bars 50 μm

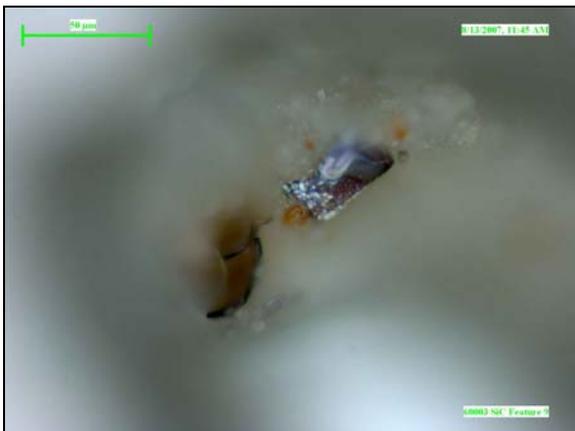
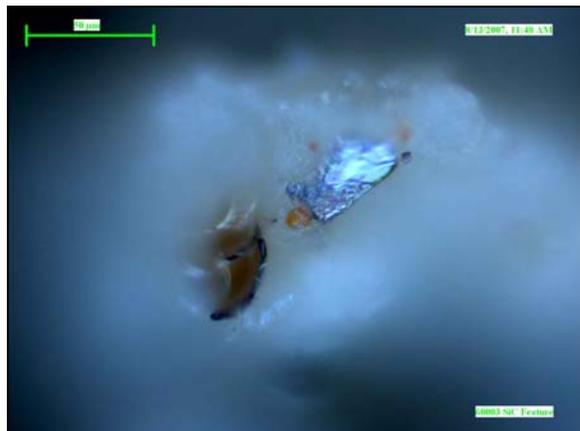
Feature 9: Bright and dark field images of two reddish fragments embedded at the top of salt/mud/debris deposit shown in feature 9 above. Scale bars 50 μm

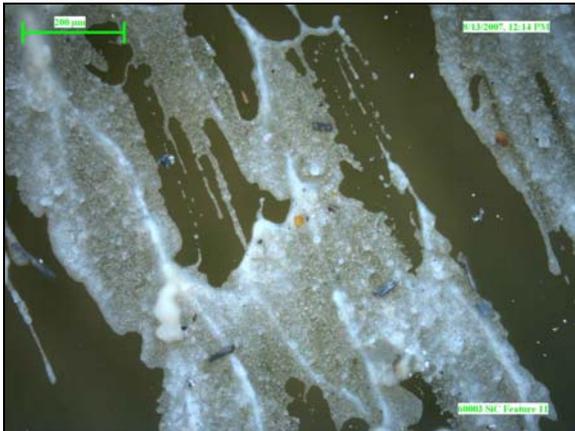
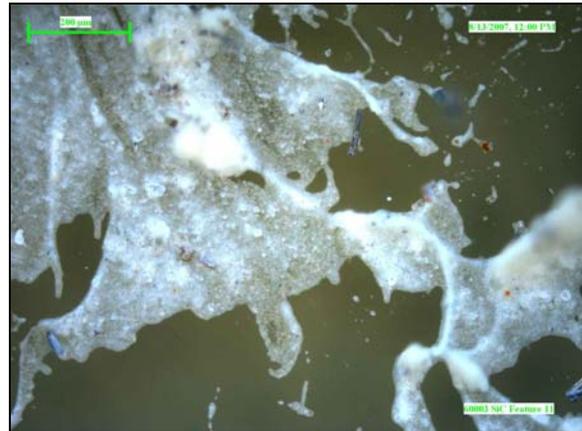
Feature 11: Dark field images of salt/mud/debris deposit shown in feature 11 above. Hydrophobic tension with the target surface is observed at deposit edges. Reddish particles and dark fibers are seen within mass. Scale bars 200 µm.

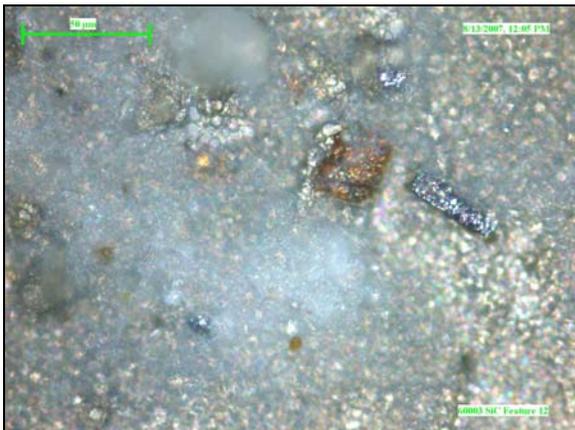
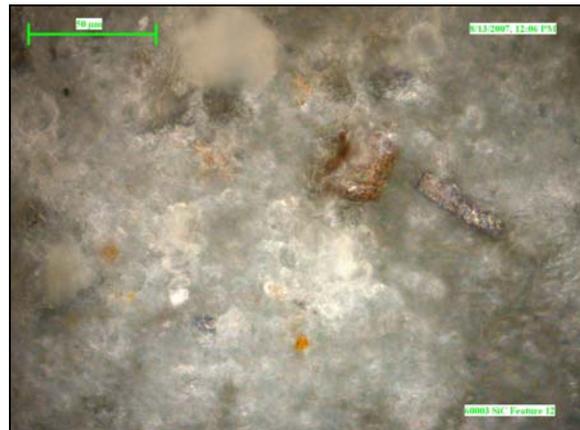
Feature 12: Salt/mud/debris area of feature 10 & 11 above shown at higher magnification. Detail of embedded debris and contour of matrix particles is improved in this view. Scale bars 50 µm

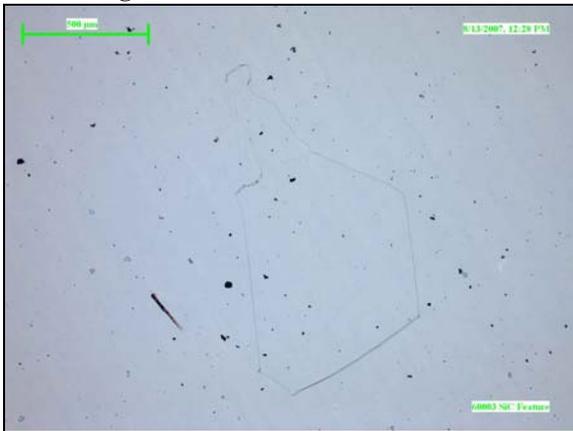
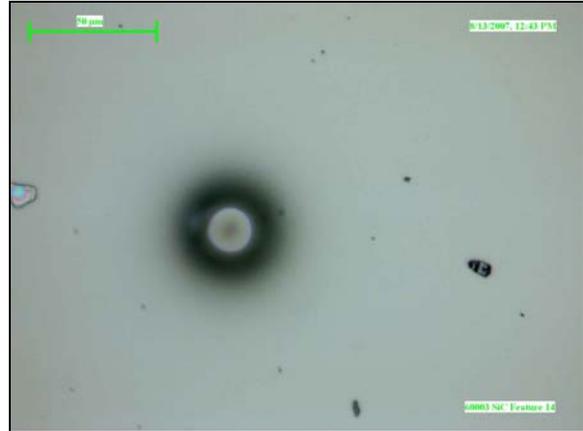
Feature 13: Area of an irregular fracture or surface imperfection or deformation. Scale bar 500 μm. Many of the transparent fragments (above left, at high zoom) exhibit the spherical reflection/refraction from curved surfaces (broken bubbles?). **Feature 14** (above, left): Spherical feature (also in feature 13 field of view) of approximate 200 μm top to bottom dimension. Scale bar 50 μm.

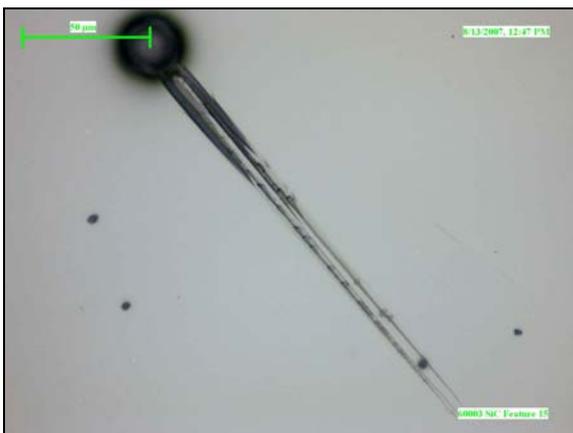
Feature 15: Spherical feature with trailing streak/scratch. Scale bars 50 μm

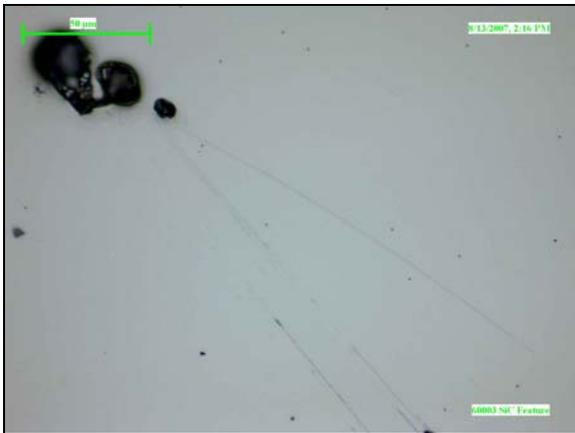
Figure 18: Area of three adjacent spherical features with trailing scratches. The interiors of the spherical features exhibit faceted surfaces. Scale bars 50 μm

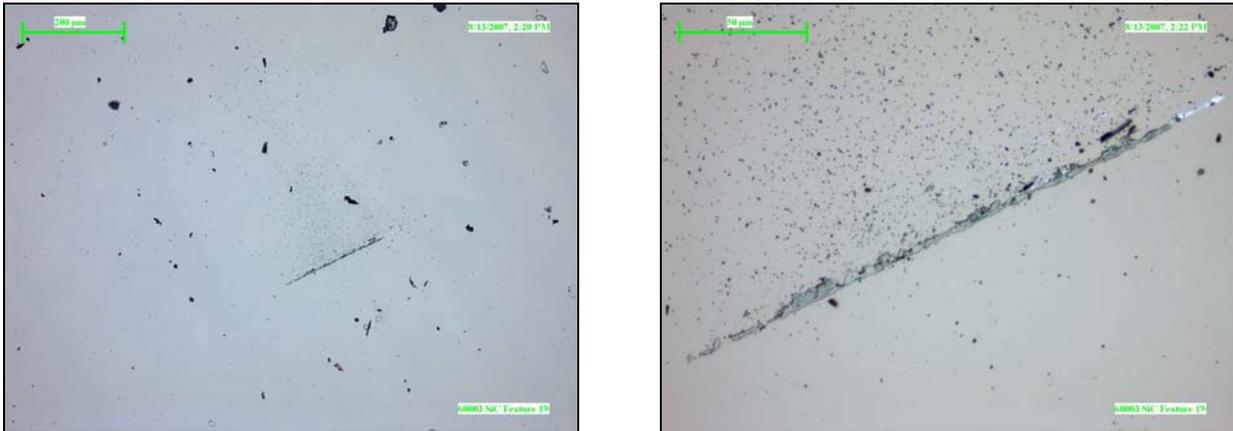
Figure 19: Straight scratch with jagged edges. Fine particulates are smeared in one direction from this scratch. Many of the transparent fragments in left view (at high zoom) exhibit the spherical reflection/refraction from curved surfaces (broken bubbles?). Scale bars 200 μm and 50 μm

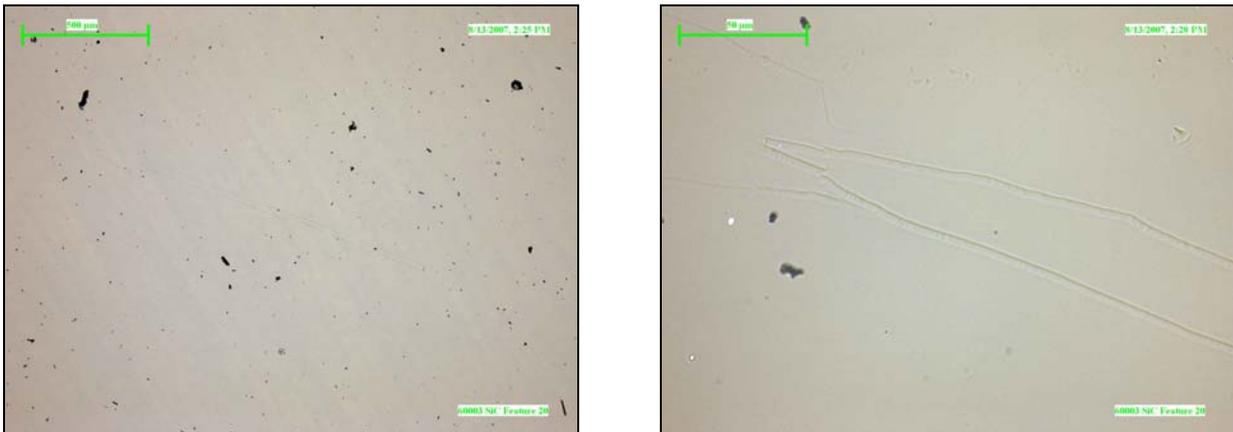
Figure 20: Area of a fracture or surface imperfection similar to feature 13. Scale bars 500 μm and 50 μm
