SiC Concentrator Targets, Genesis Samples 60001 and 60003 Contamination Documentation

This report represents the completion of initial image documentation of the two flown SiC Genesis concentrator targets 60001 (serial number: U0639-14) and 60003 (serial number: L0760-08) and should help facilitate target selection.

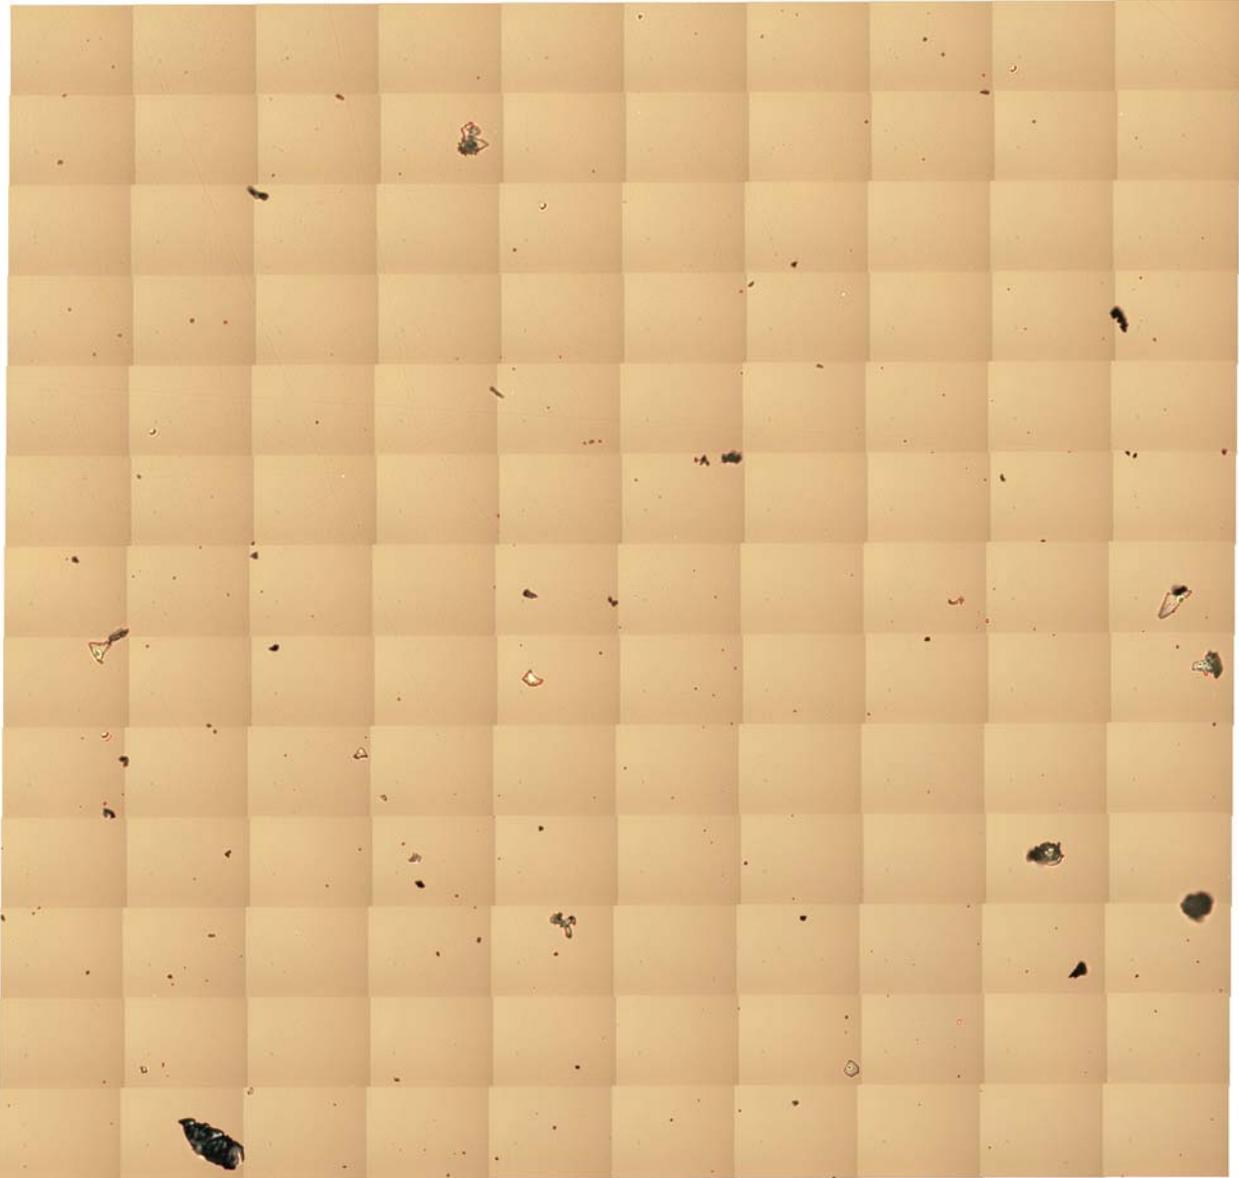
60001 50X objective mosaic scan particle map. Image area is 1.183 mm² with 275 particles identified > 0.3 microns. The red outline around an object is to mark where ImageProPlus has identified a particle. These particle outlines are shown below.

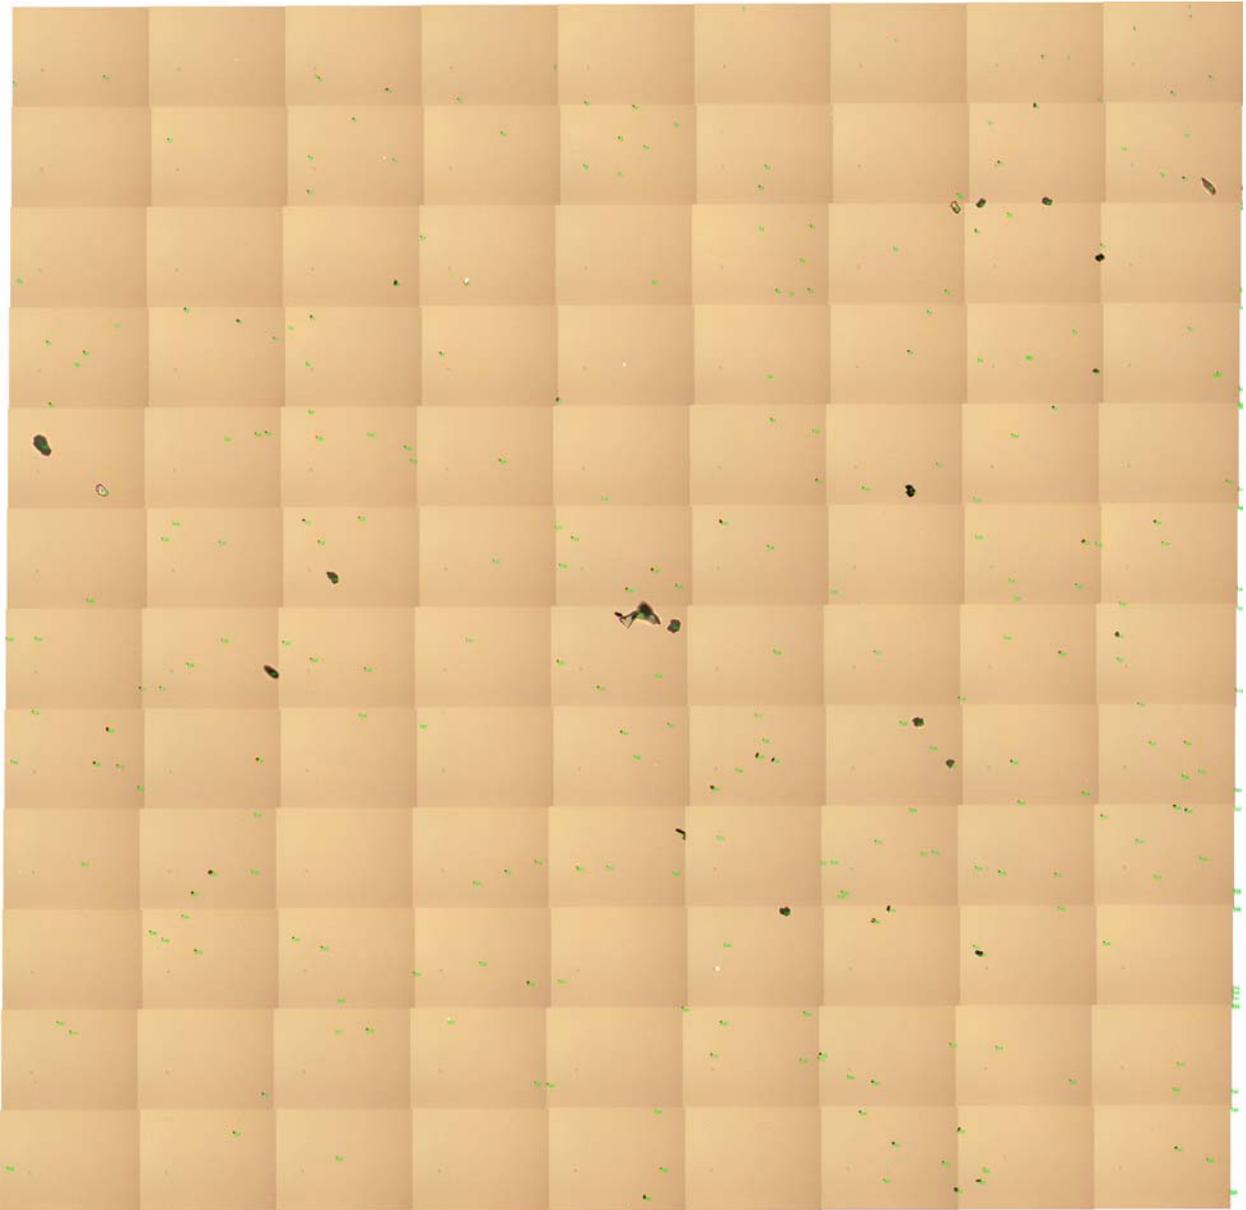
60003 50X objective mosaic scan particle map. Image area is 0.983 mm² with 299 particles identified > 0.3 microns. The red outline around an object and green number is to mark were ImageProPlus has identified a particle. These particle outlines are shown below.

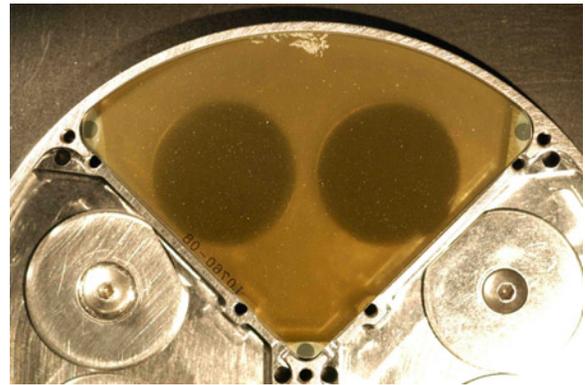
60003 Nikon D100 images in the non-flight stainless steel target holder.

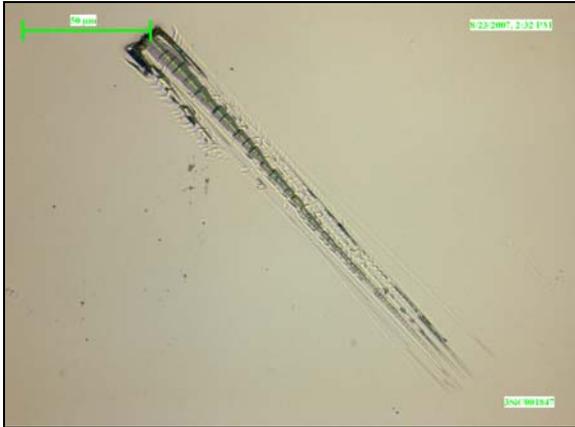
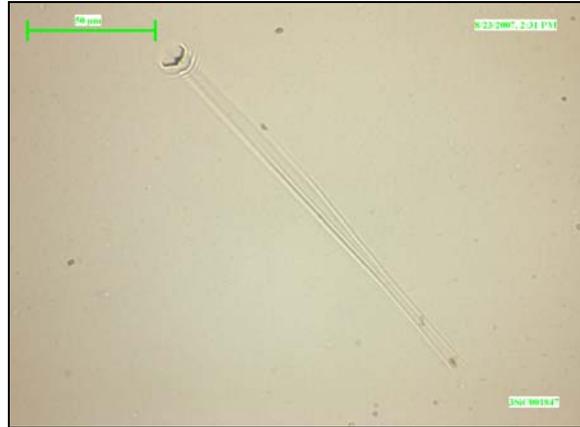
Two non-flight features similar to features 3, 4, 8 and 19 in SiC target 60001; and features 3,5, and 18 in SiC target 60003. Segmented scratches, faint trails, and stress markings are nearly identical in the three samples. Scale bars are 50 μm .

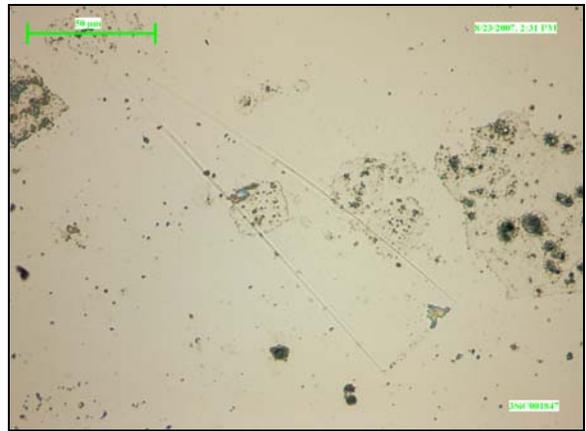
Non-flight fiber/rod feature. Scale bar 50 μ m.
