Stardust Foil C2125N,1 “Walton”

Survey of entire top surface of the foil to identify, locate, measure and count all hypervelocity impact features of 5 microns and larger.

Three impact features found: 1) 9.3 x 8.8 microns; 2) 2.4 microns and 3) 5.7 x 3.9 microns.

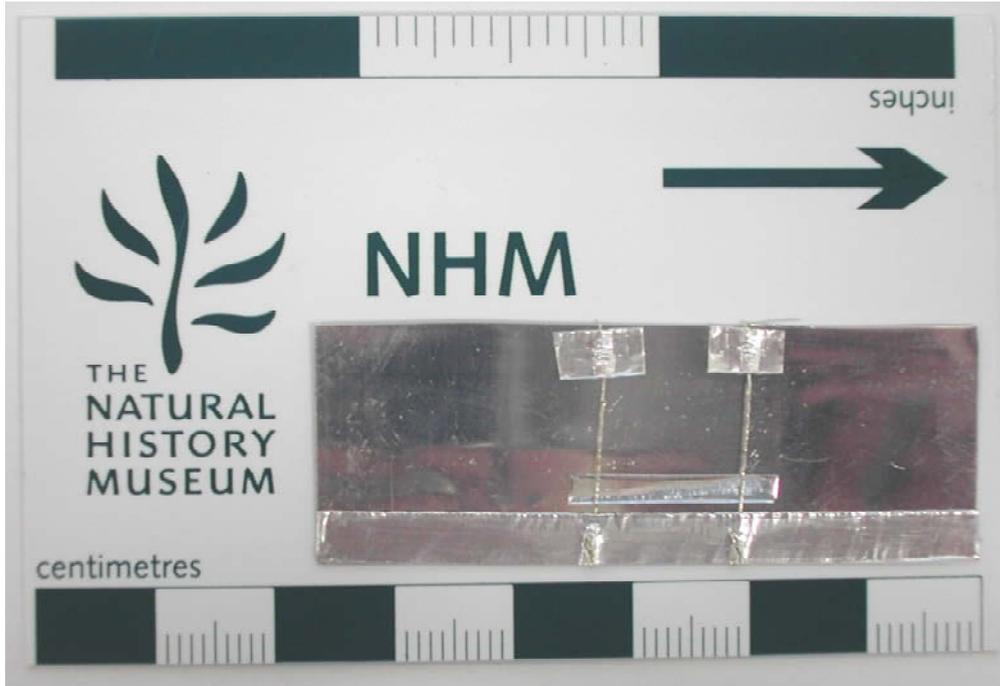
The 'Gulliver' method, using 250 μm thick 99.9999% Sn restraining wires, supported on a 99.99% Al sheet, for initial examination.

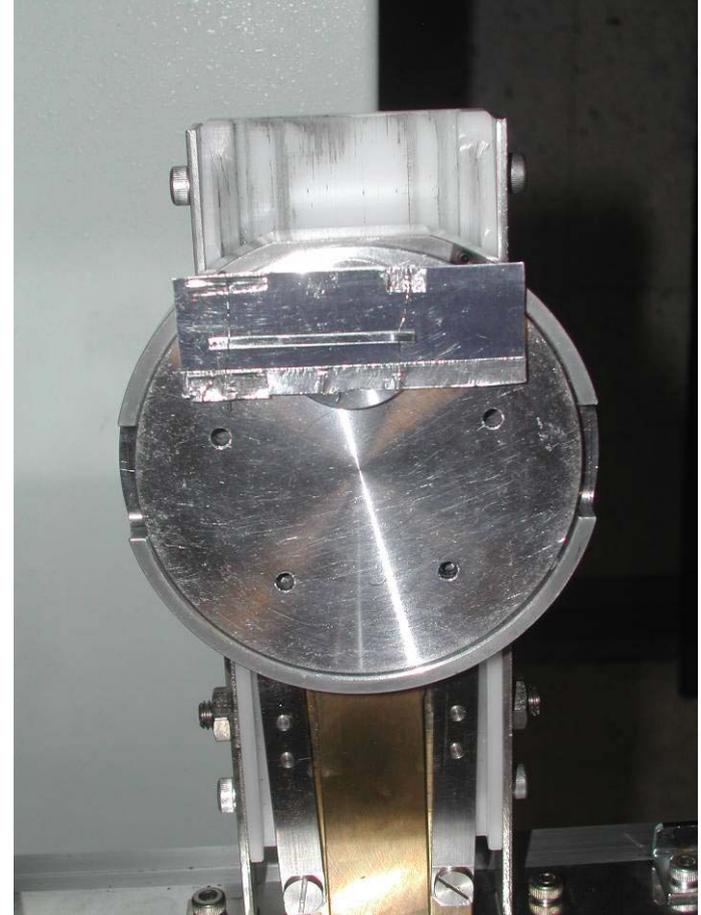
Test sample with two Sn wires.

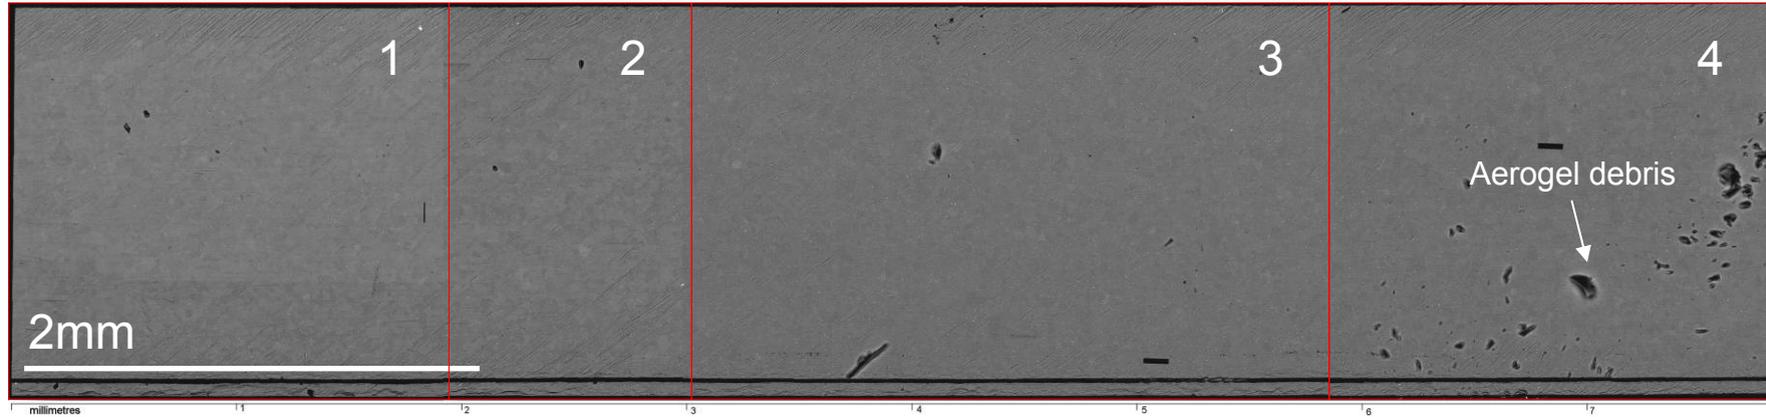
Example of four stitched high resolution Backscattered electron montages created by automated stage movement and image acquisition. Area in this image is c. 12.4 mm², pixel spacing in original images is less than 240nm. This area was searched for craters of 5 microns and greater diameter. None were found. Subsequent imaging of this area using secondary electrons found one crater of 2.4 microns diameter.

No unambiguous impact features of 5 microns or greater diameter were found in the 1500 frames comprising 12.4 square mm of BSE automated montages, acquired in four campaigns (c. 12 hours run) on the central (flat) part of the foil.

Automation of high magnification image acquisition from the curved ends of the foil could not be performed due to major differences in height (> 500 microns variation in working distance).

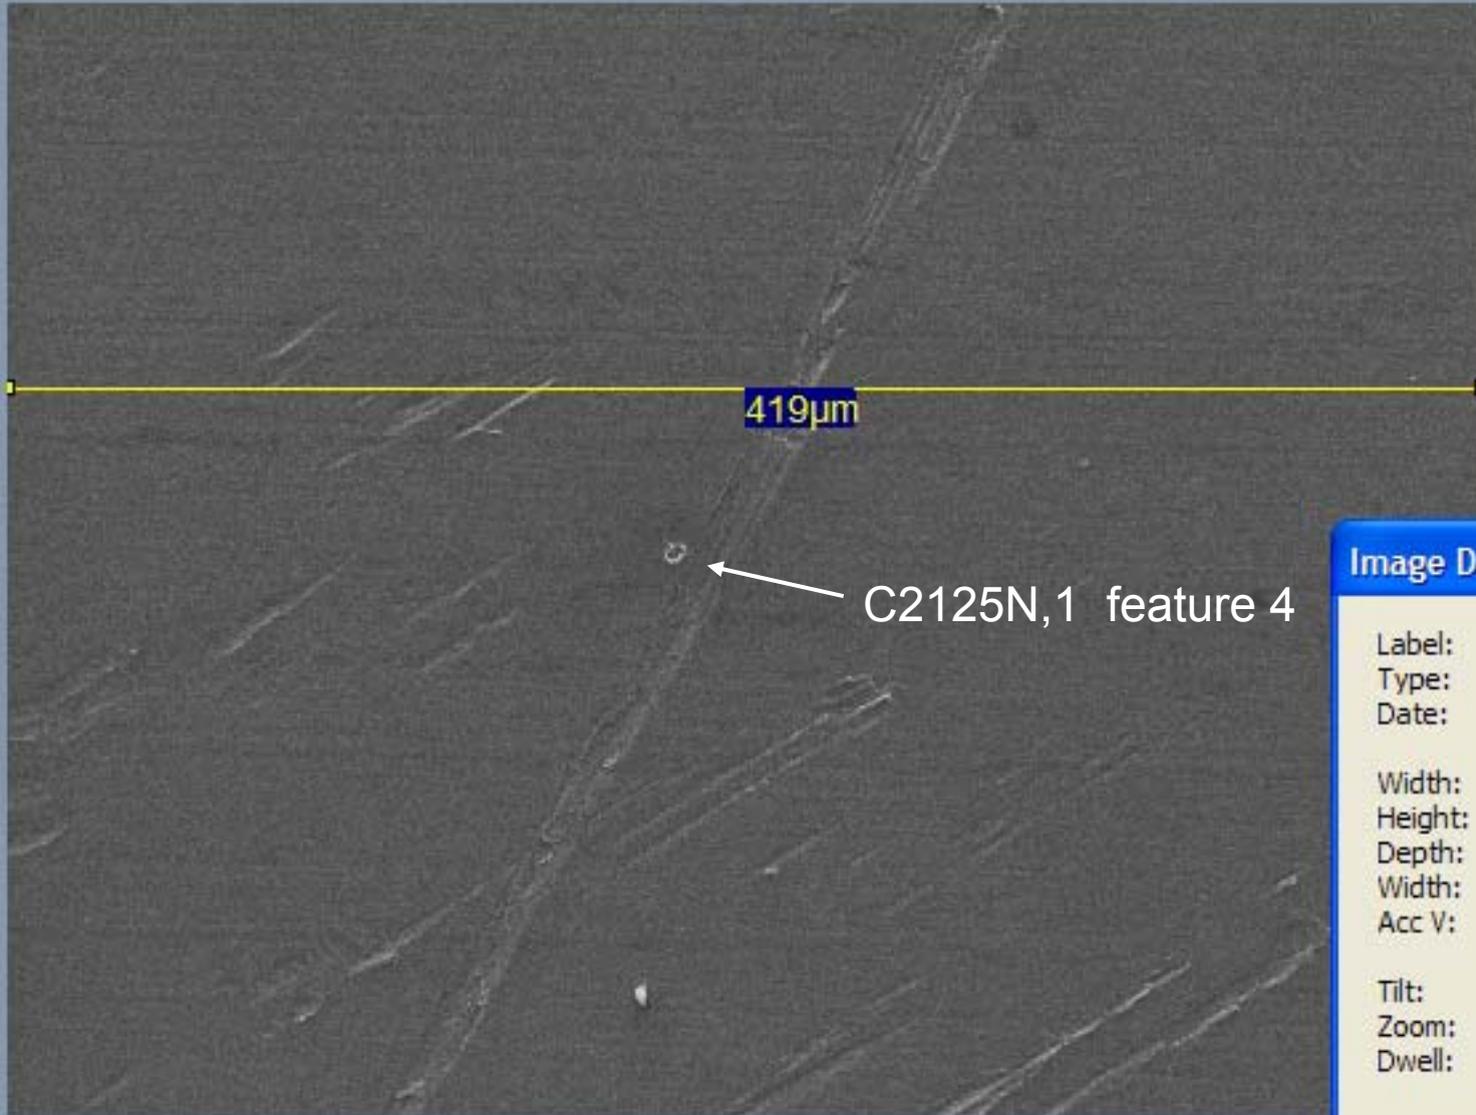
SEI low magnification survey image showing 5.7 by 4.0 micron crater.

Image is 419 microns, 2048 pixels wide with c.200nm pixel spacing.

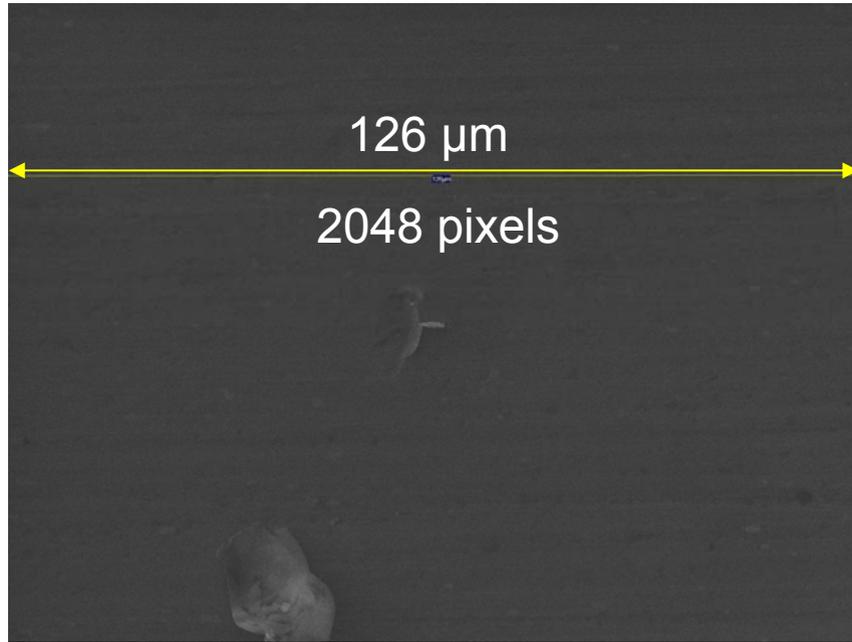
Full single image

High magnification (x1000) secondary electron images with a high pixel number (2048 pixels across 126 microns field of view) allow recognition of features as small as 200nm. The 'edge effect' of the crater rim makes hypervelocity impact craters easy to find.

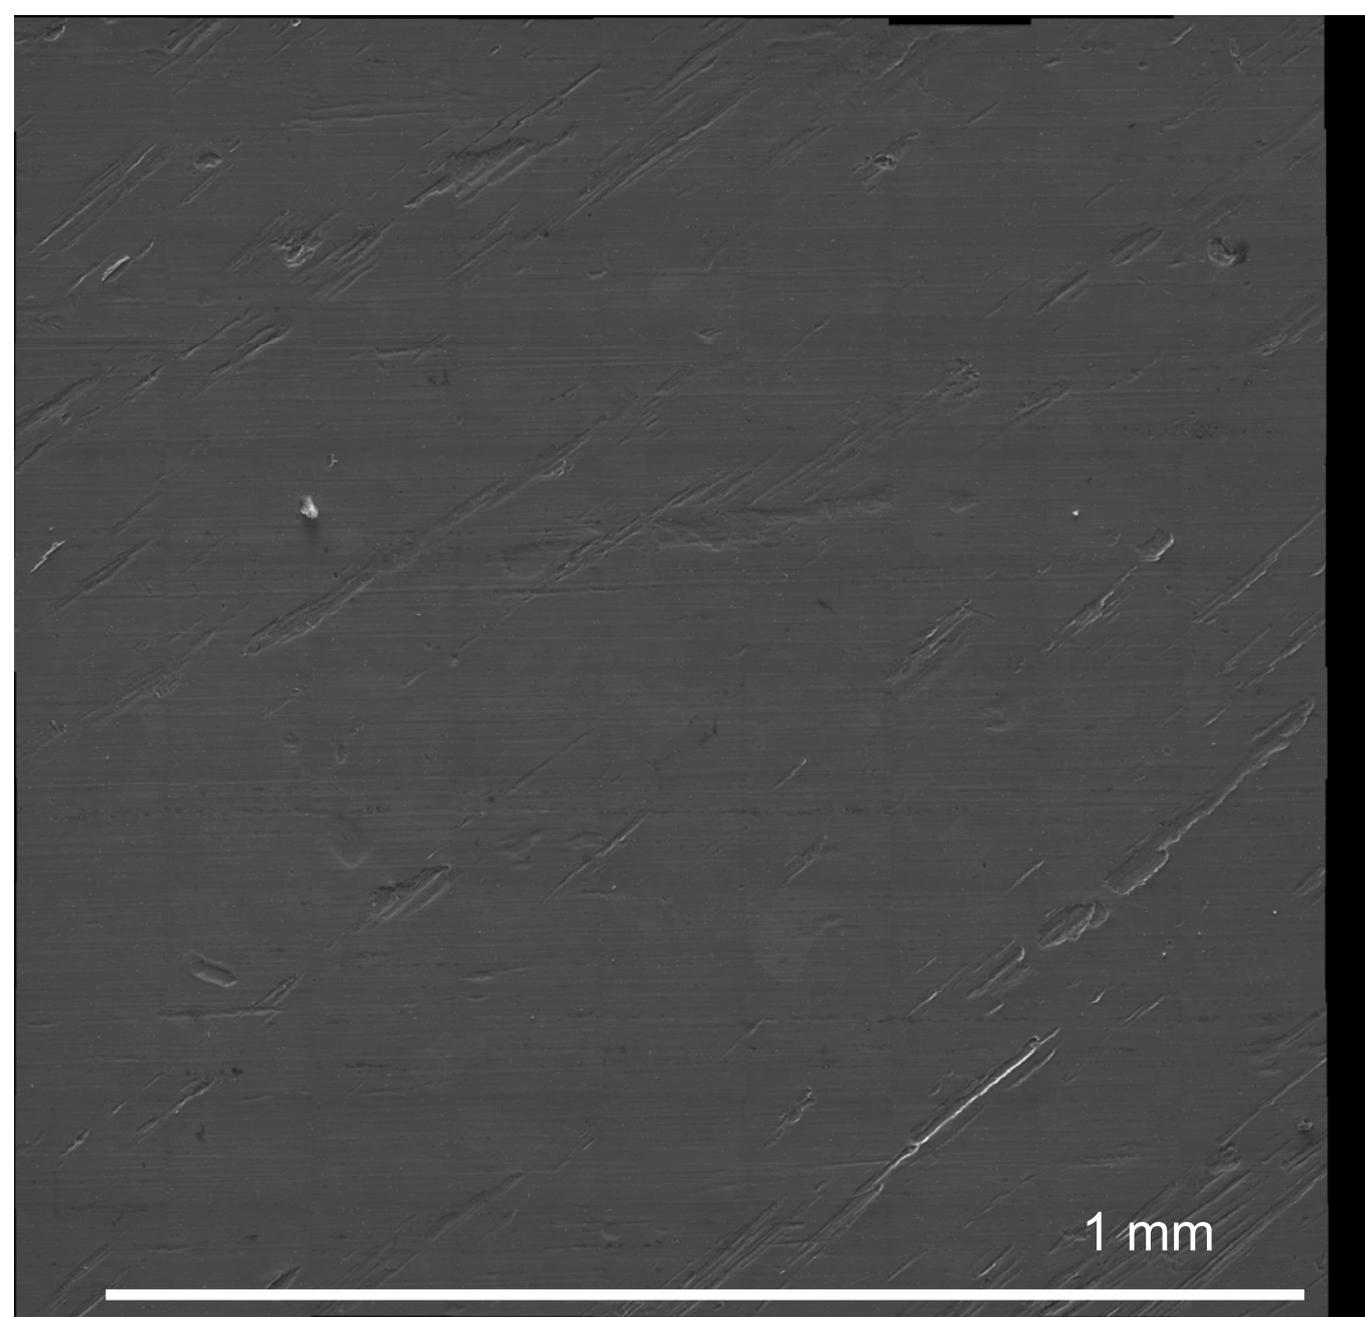
Automatic acquisition and stitching of a montage of 108 secondary electron images, each of 2048 pixels width.

An entire run takes about 2 hours to acquire data, and about 2 minutes to create the montage. Individual frame images are examined for location of impact features

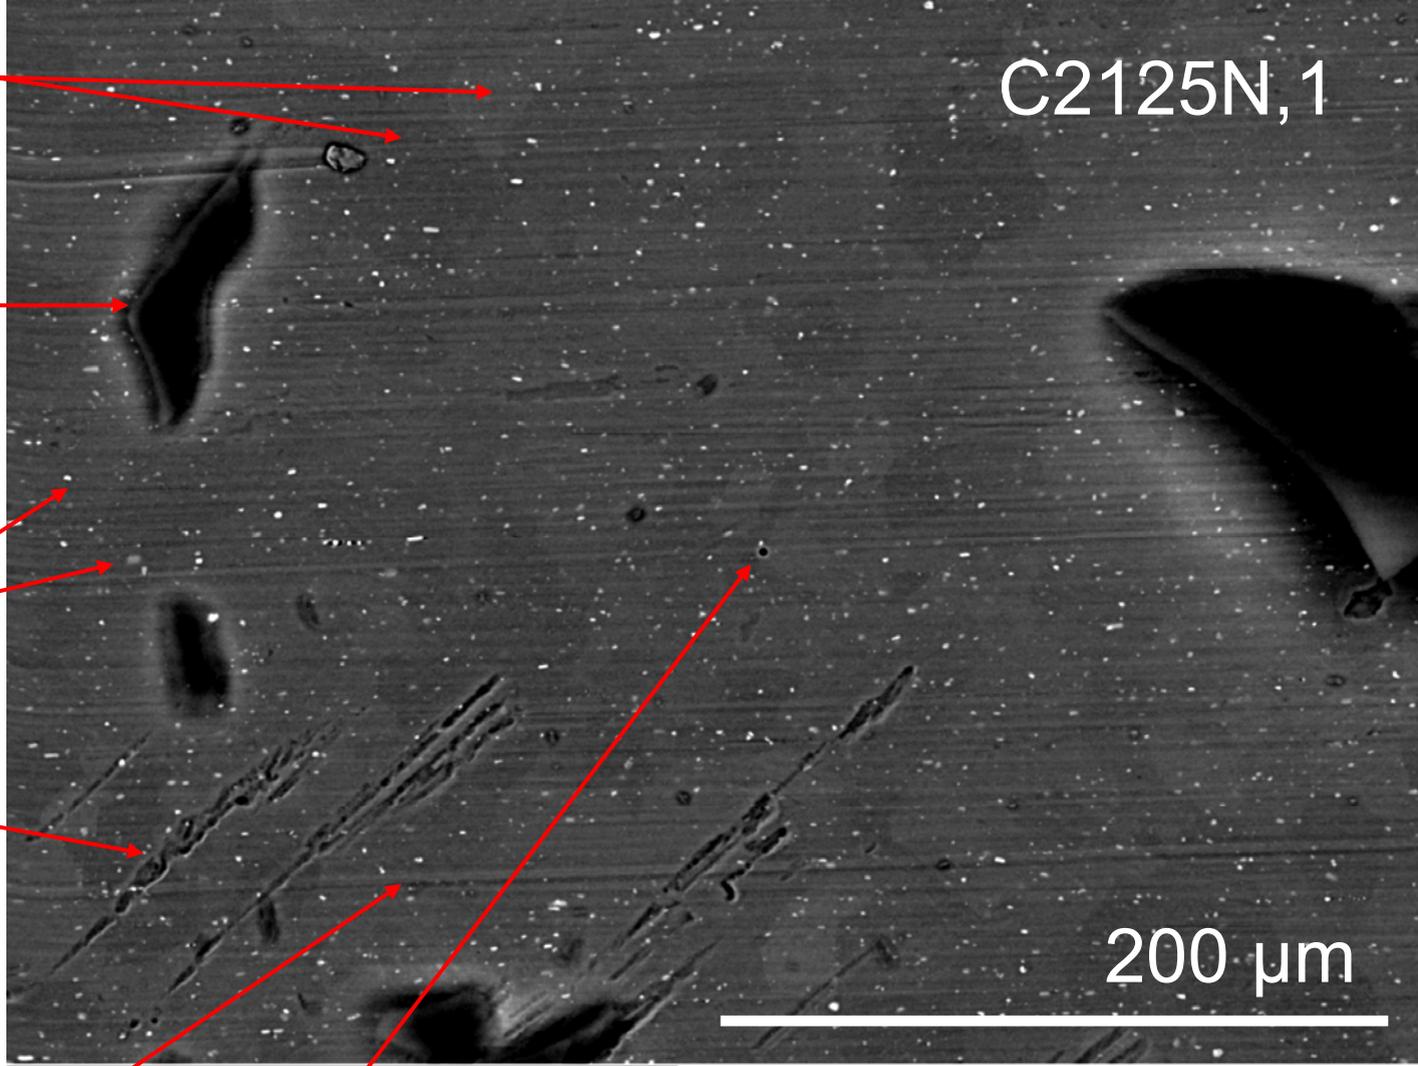
Features seen in backscattered electron images

Crystallographic grain contrast

Aerogel fragment

Fe-rich inclusions

Deep oblique scratch

Shallow longitudinal ridge and furrow

Impact crater (Feature 3, 2.4 microns diameter)

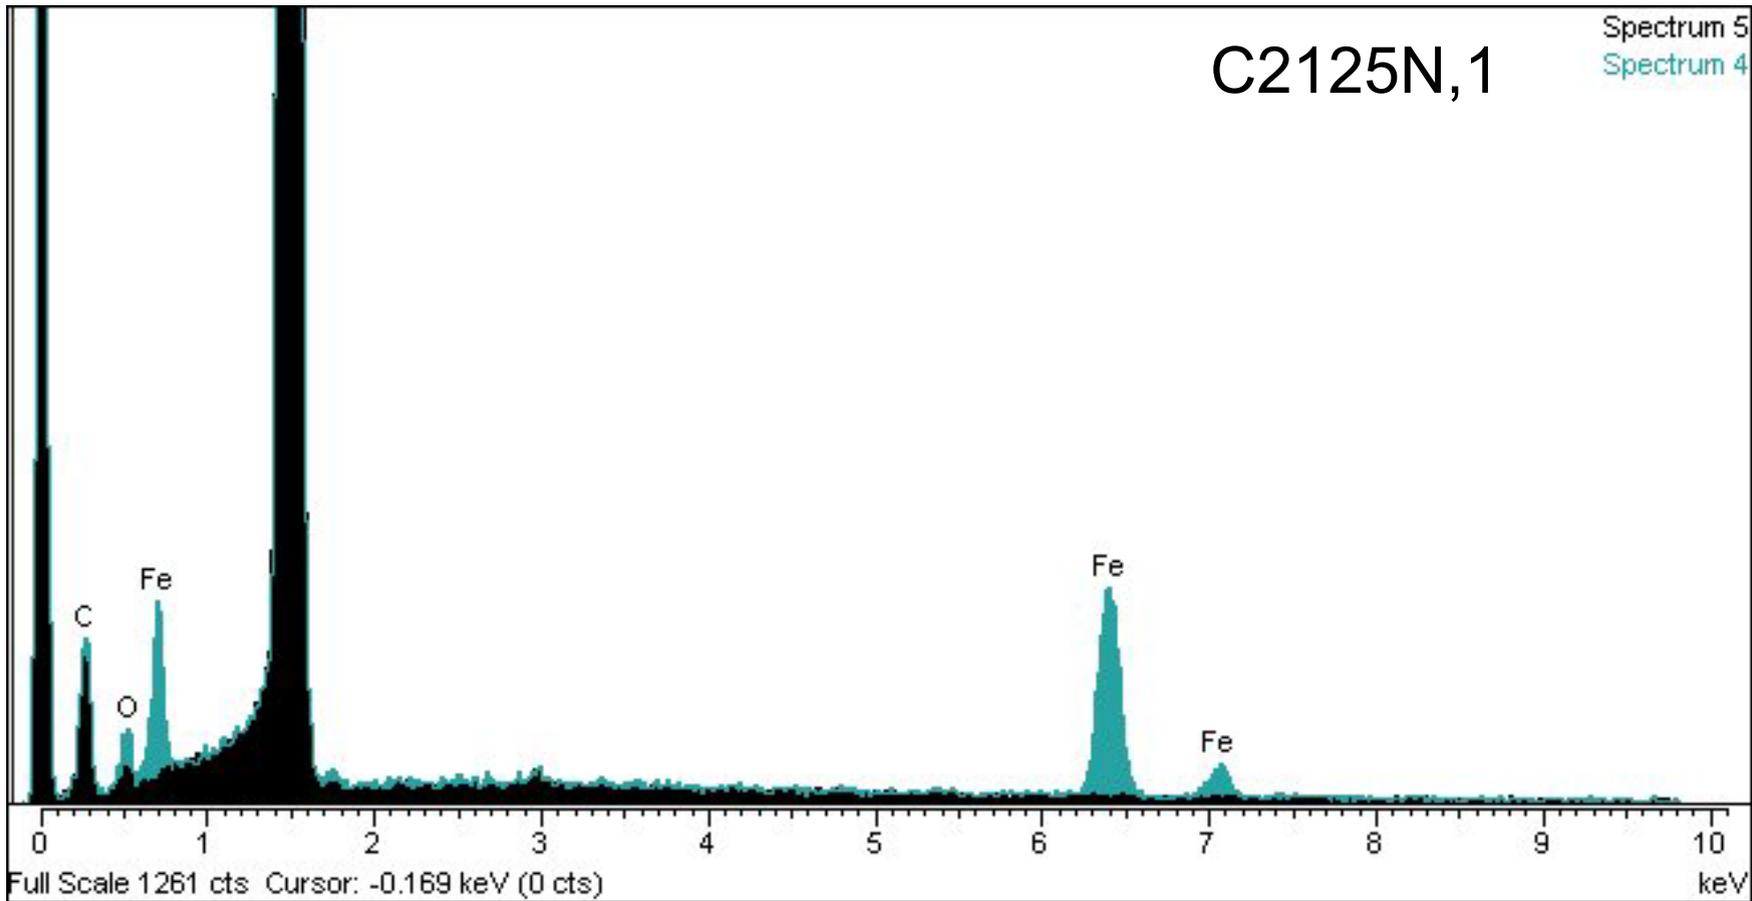
Fe-rich inclusion (shown in **pale blue**) in Aluminium alloy (**black**) shows no enrichment in Sulfur (as found in the impact feature 3), but minor Oxygen is present.

Conclusion: Fe in alloy may be a nuisance, but is unlikely to be confused with Fe sulfide or silicate. Magnetite shows higher Oxygen than in the above spectrum.

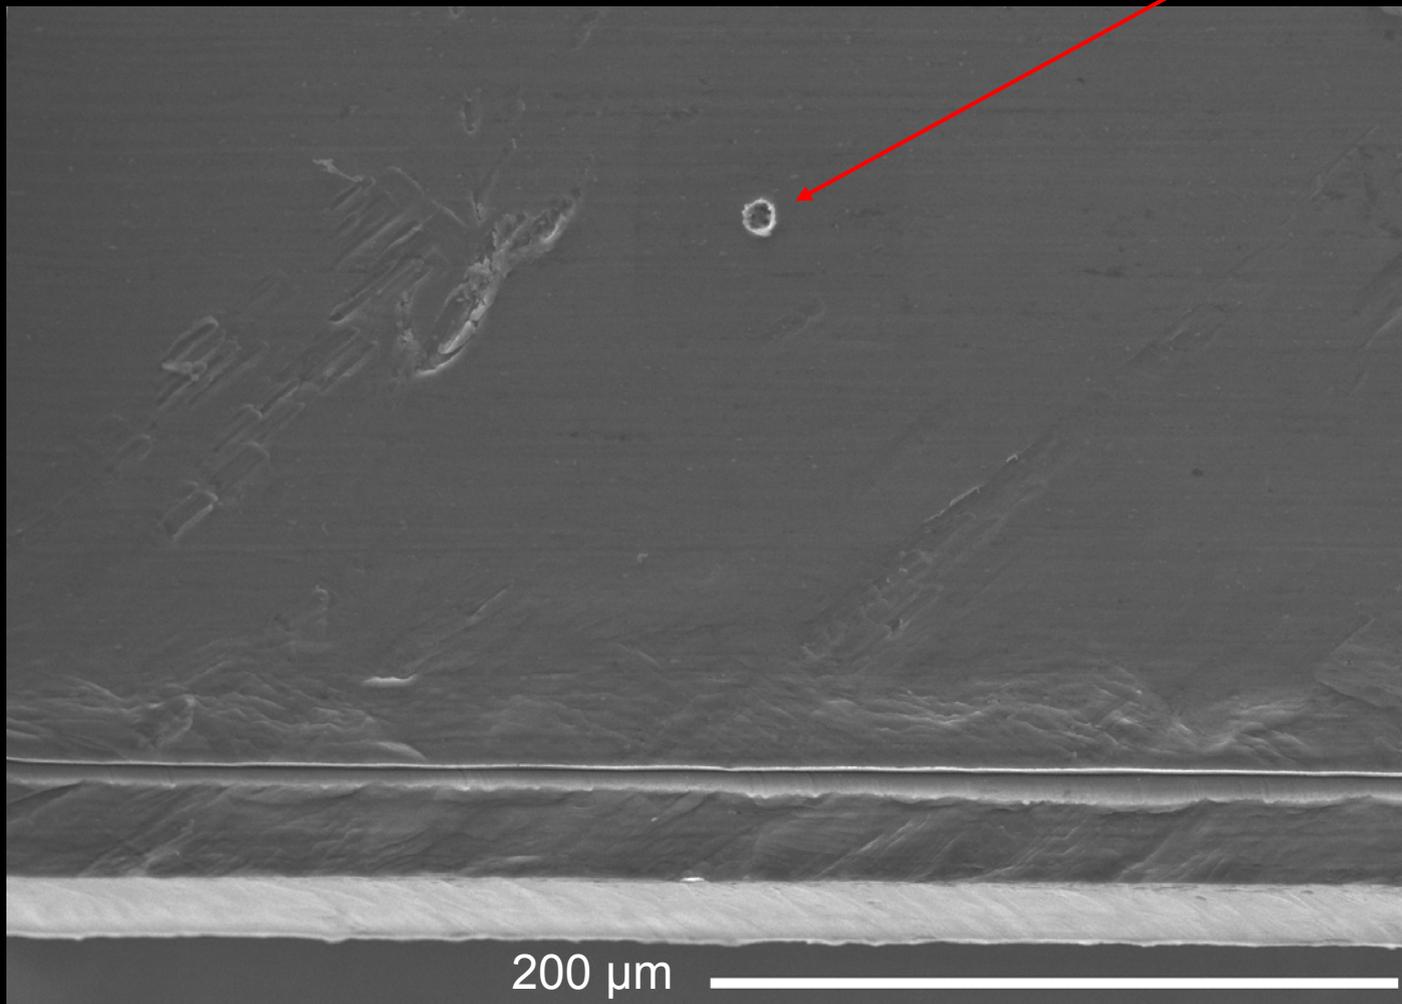
Whole foil with restraining Sn wires.

Impact feature of approximately 9 microns diameter

Cut mark on foil →

Cut edge of foil →

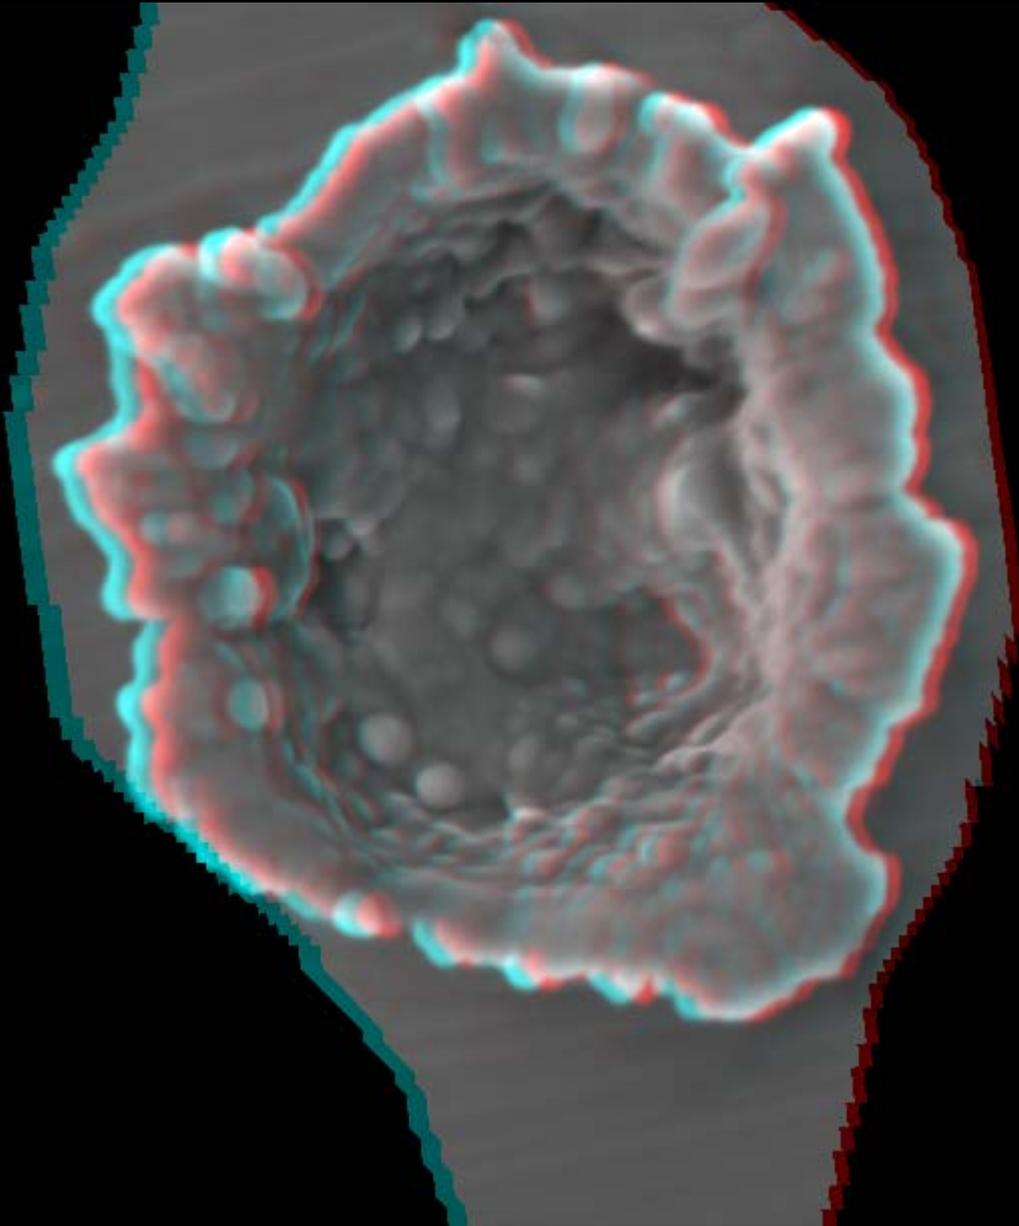
Stereo anaglyph

C2125N,1

feature 2

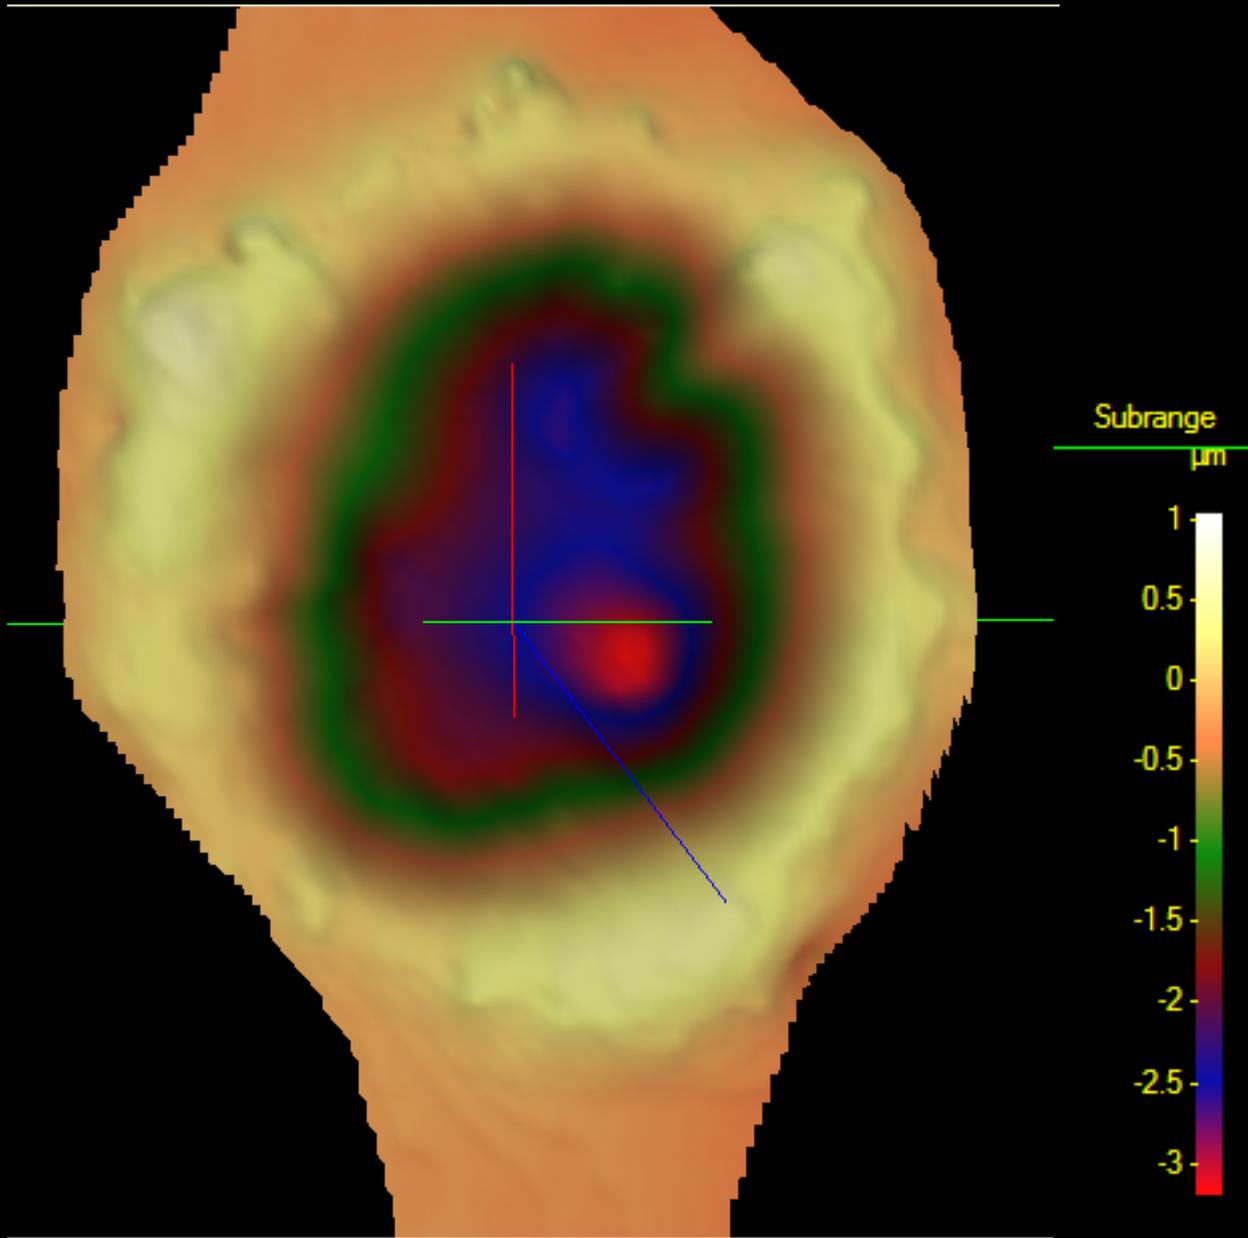
Depth model

C2125N,1

feature 2

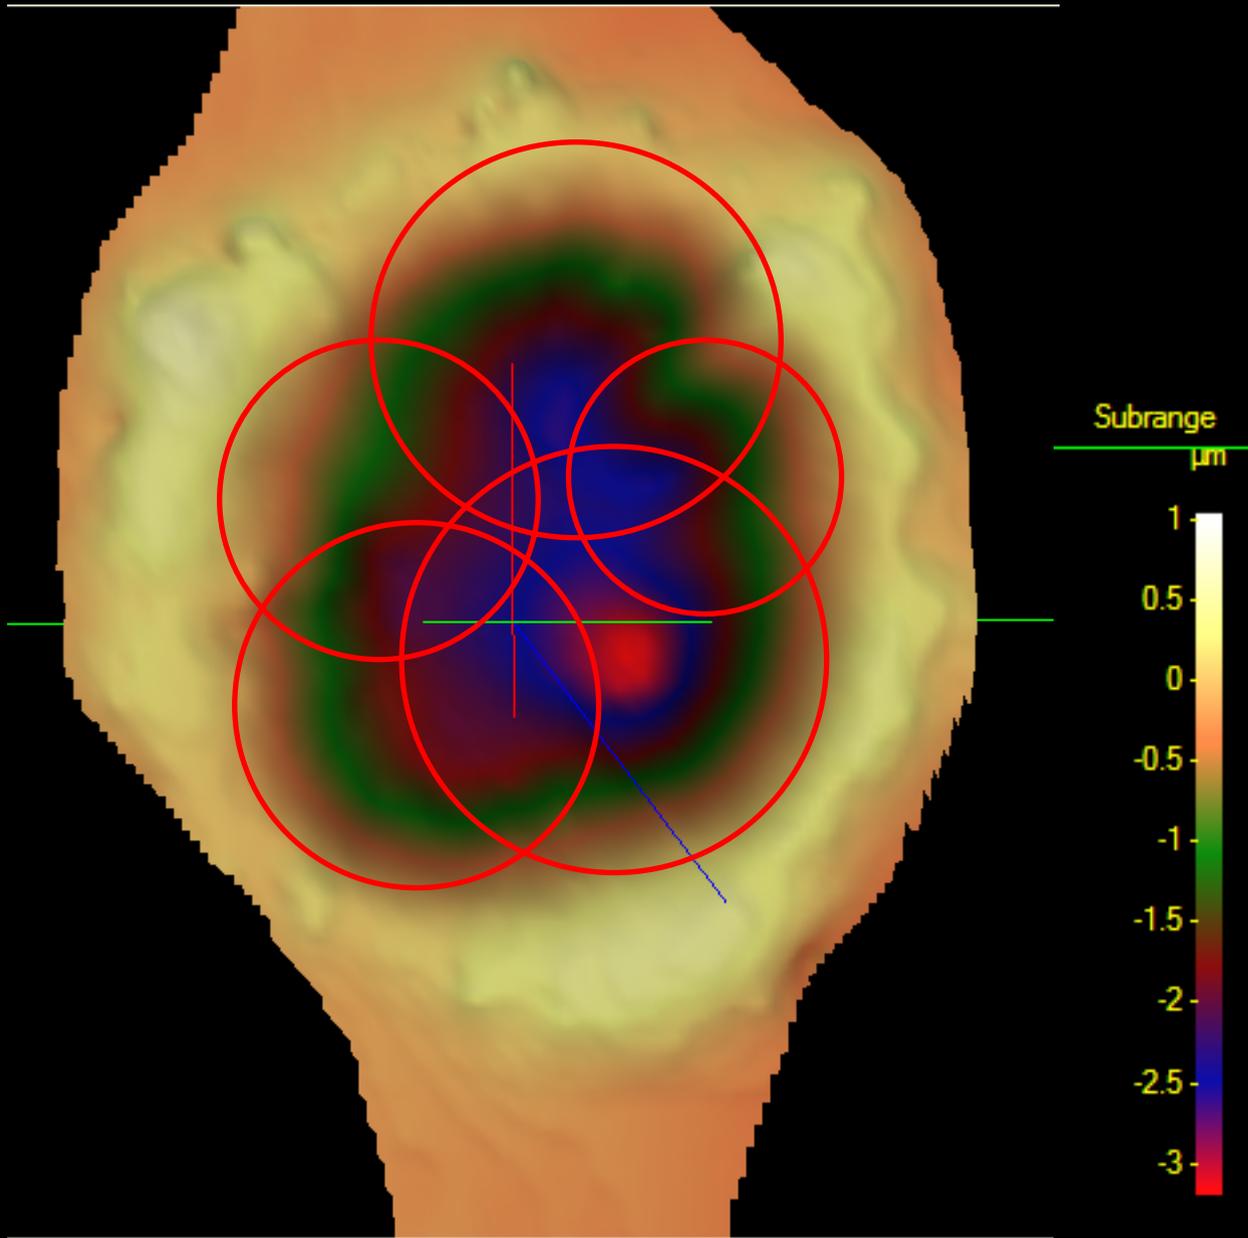
Depth model

with crater
overlap
centres

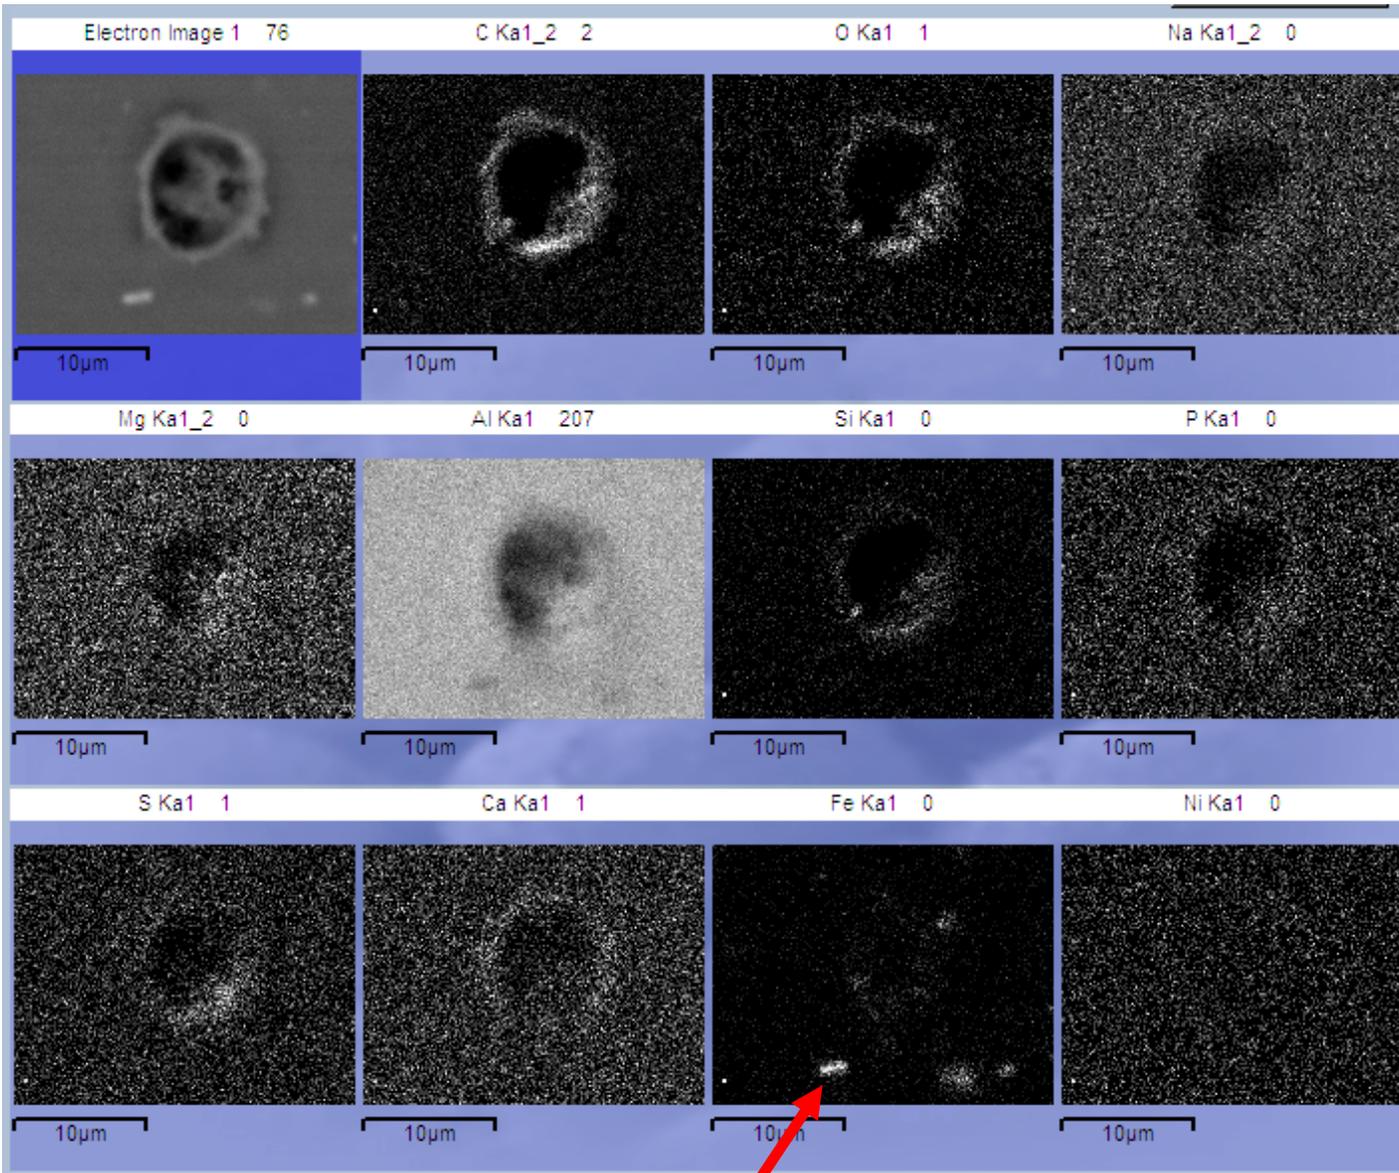
X-ray
maps

Note large Fe-rich inclusion outside crater

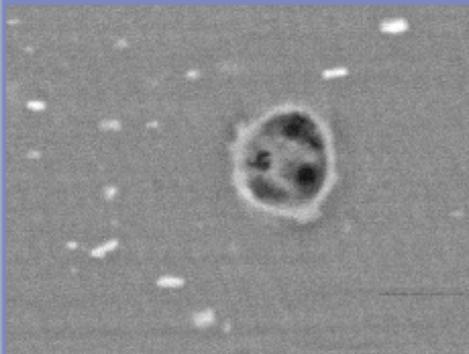
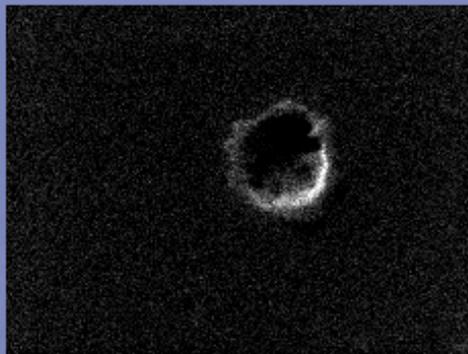
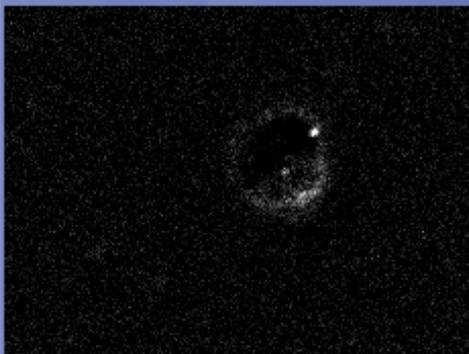
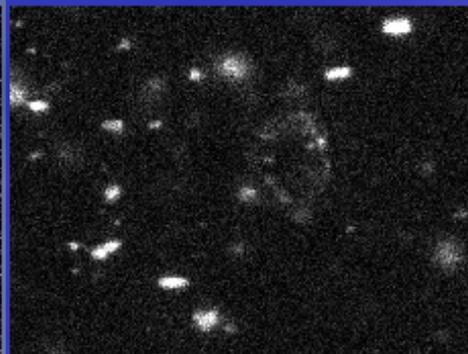
X-ray
maps

C, Mg, Si, S and Fe-rich areas within crater

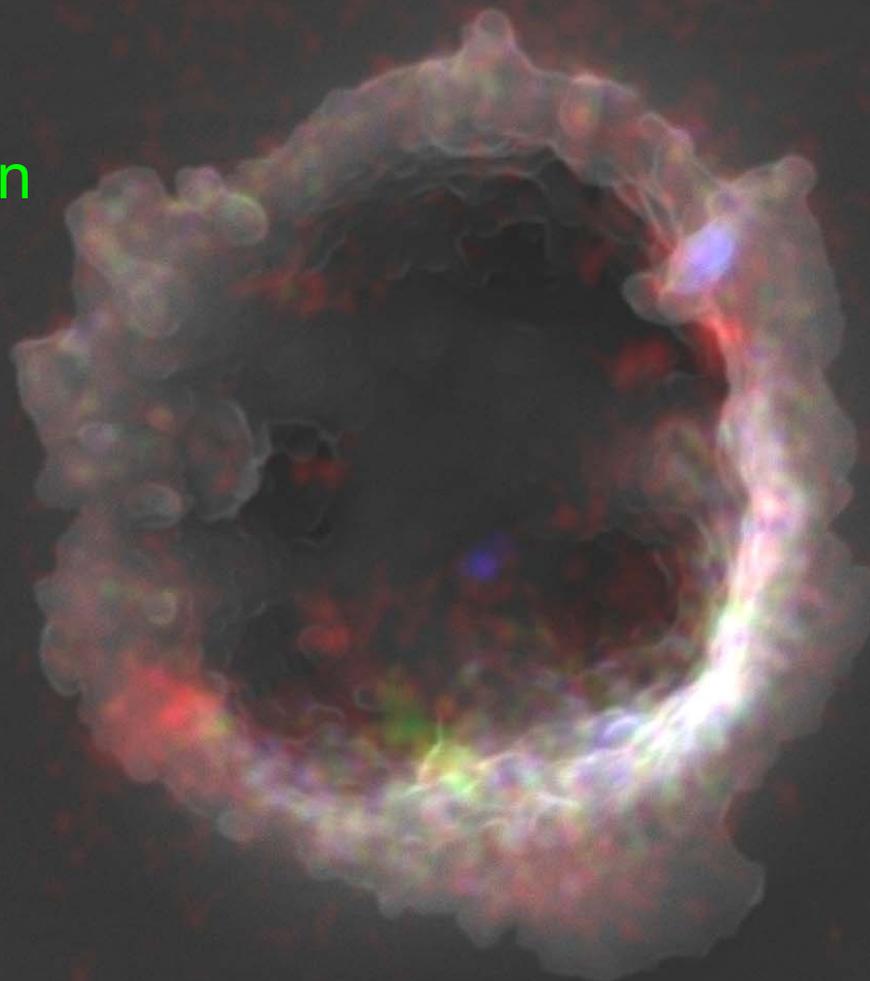
SEI grey

Silicon blue

Sulfur green

Iron red

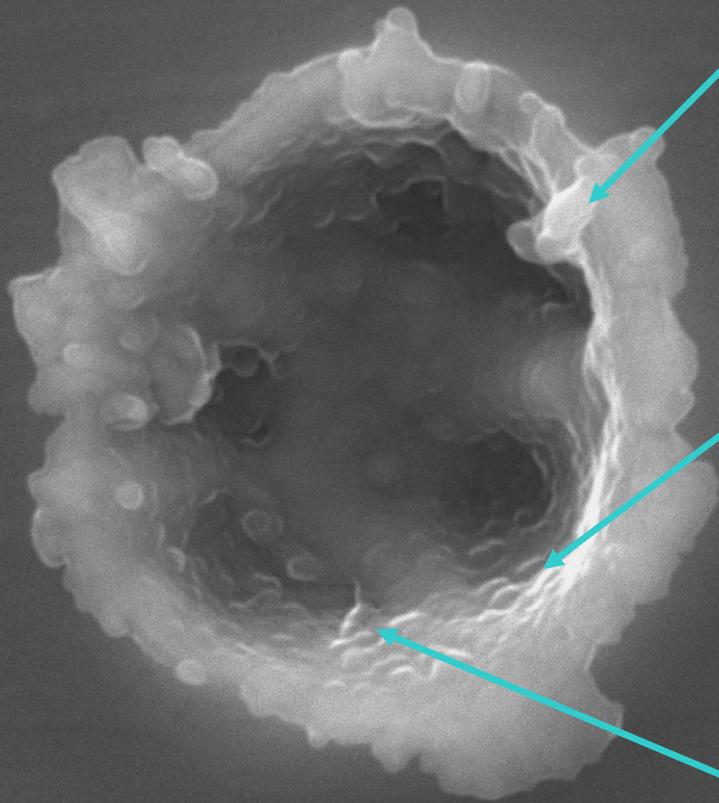
Secondary electron image of
C2125N,1 feature 2
9.3 x 8.8 microns top lip diameter

Walton feature 2: a sub-circular crater of 9.3 x 8.8 microns diameter, containing Mg and Fe silicate, Fe sulfide and ?organic residues

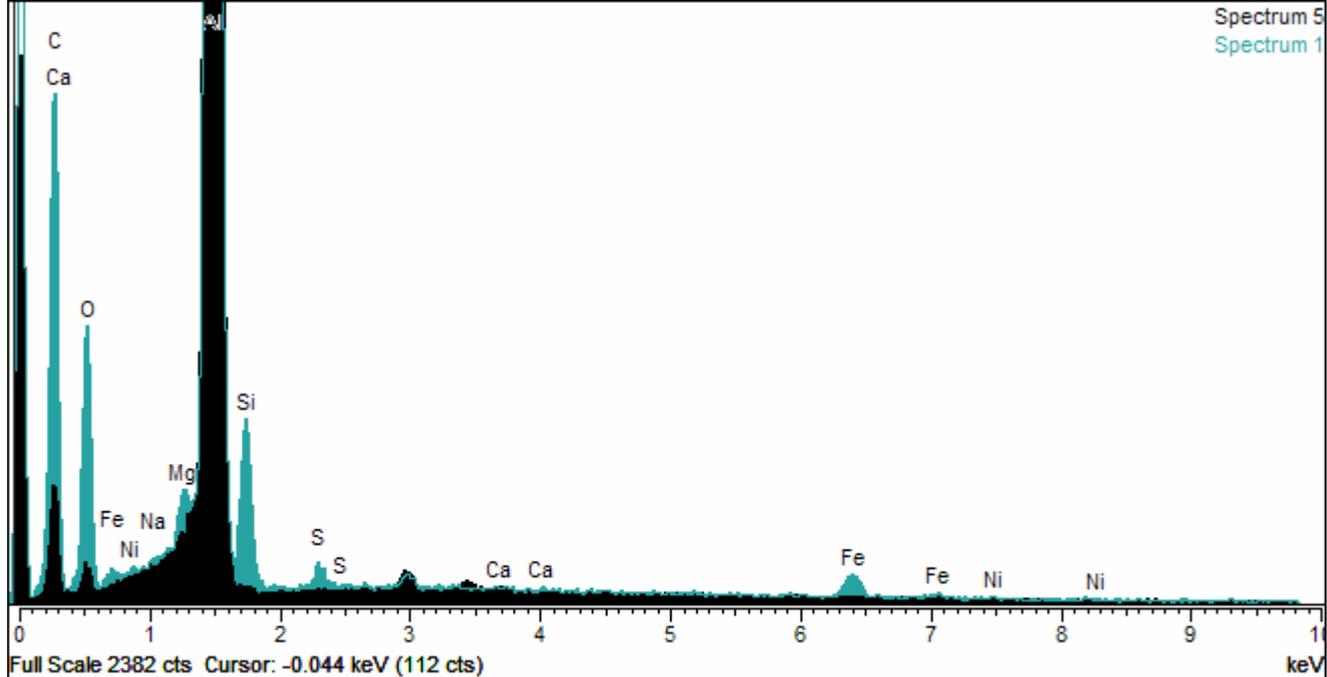
Element	Weight%	Weight% sigma	Atom%	Oxide %	Atoms
Na	trace	0.6	bdl	bdl	bdl
Mg	14.7	0.5	13.0	24.4	5.1
Si	25.0	0.5	19.1	53.4	7.5
S	2.7	0.2	1.8	6.7	0.7
Ca	trace	0.4	bdl	bdl	bdl
Fe	10.8	0.6	4.2	13.9	1.6
Ni	trace	0.5	bdl	bdl	bdl
O	45.6	0.7	61.2		24.0

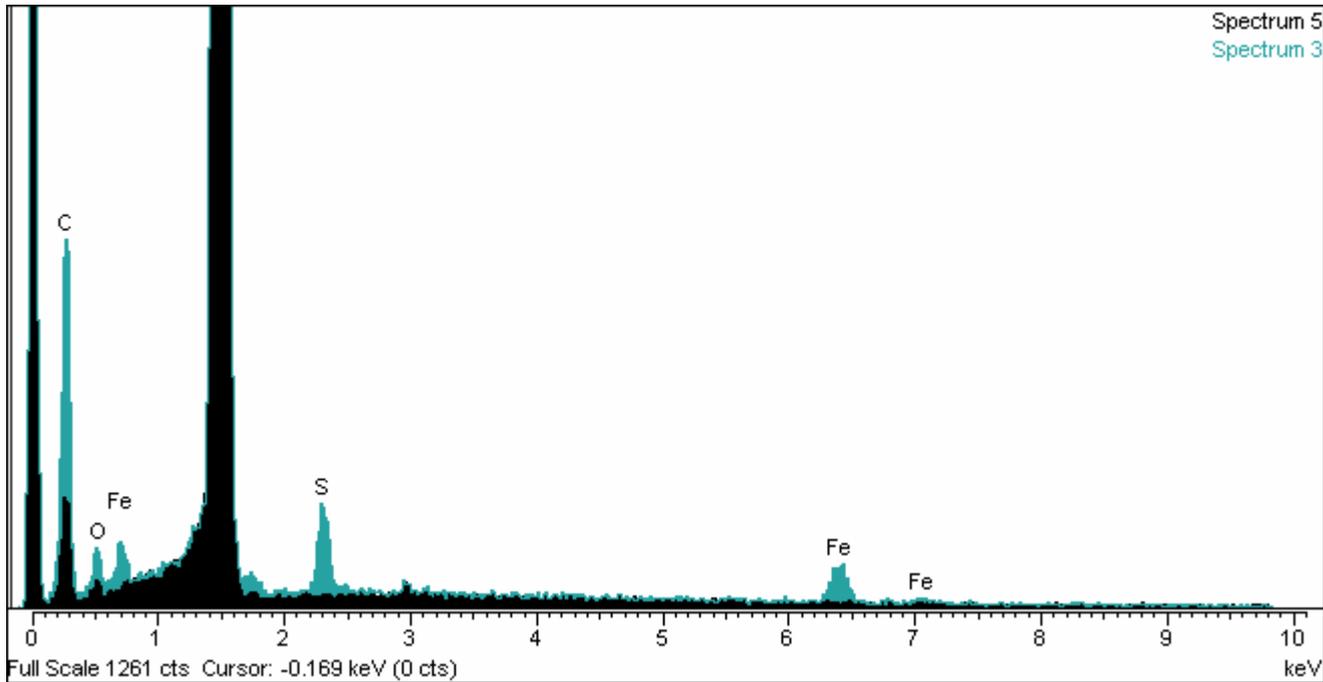
sp5

Element	Weight%	Weight% sigma	Atomic%
S	32.2	4.0	45.3
Fe	67.8	4.0	54.7
Totals	100.0

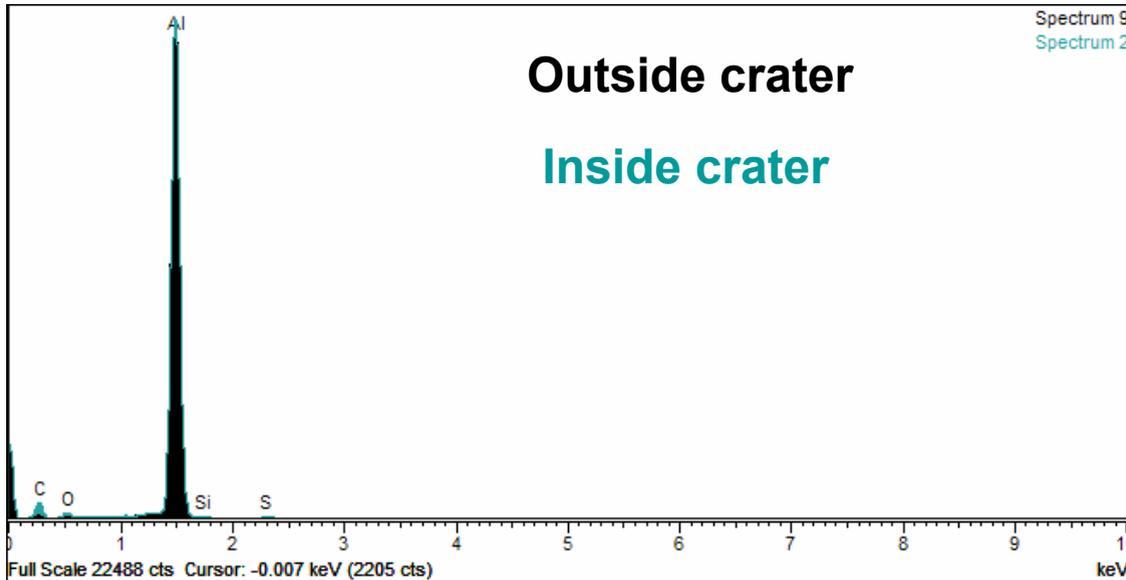
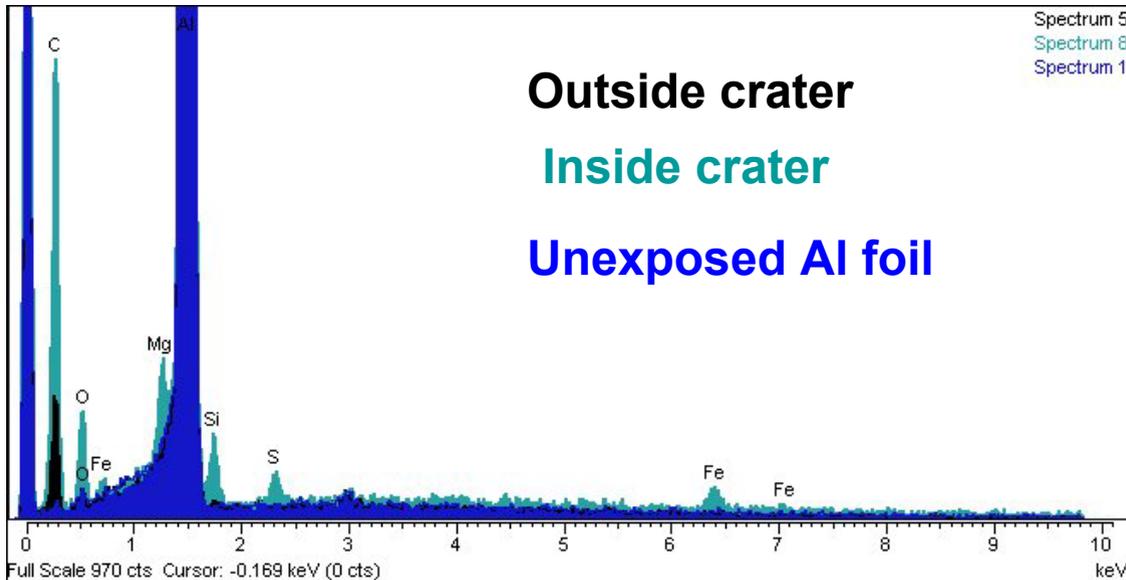
Carbon-rich residue in C2125N,1 feature 2

Comparison of spectra from map data taken inside and outside of the crater show an increase in carbon count rate, even in a full scale spectrum. This apparent excess cannot be explained by sample geometry alone.

A thin Carbon film (shown in **black**) is deposited during prolonged electron beam exposure of clean Al alloy surfaces (unexposed foil shown in **dark blue**). However, carbon levels inside the crater (shown in **pale blue**) are much higher.
