Stardust Foil C2125N,1 “Walton”

Survey of entire top surface of the foil to identify, locate, measure and count all hypervelocity impact features of 5 microns and larger.

Three impact features found: 1) 9.3 x 8.8 microns; 2) 2.4 microns and 3) 5.7 x 3.9 microns.

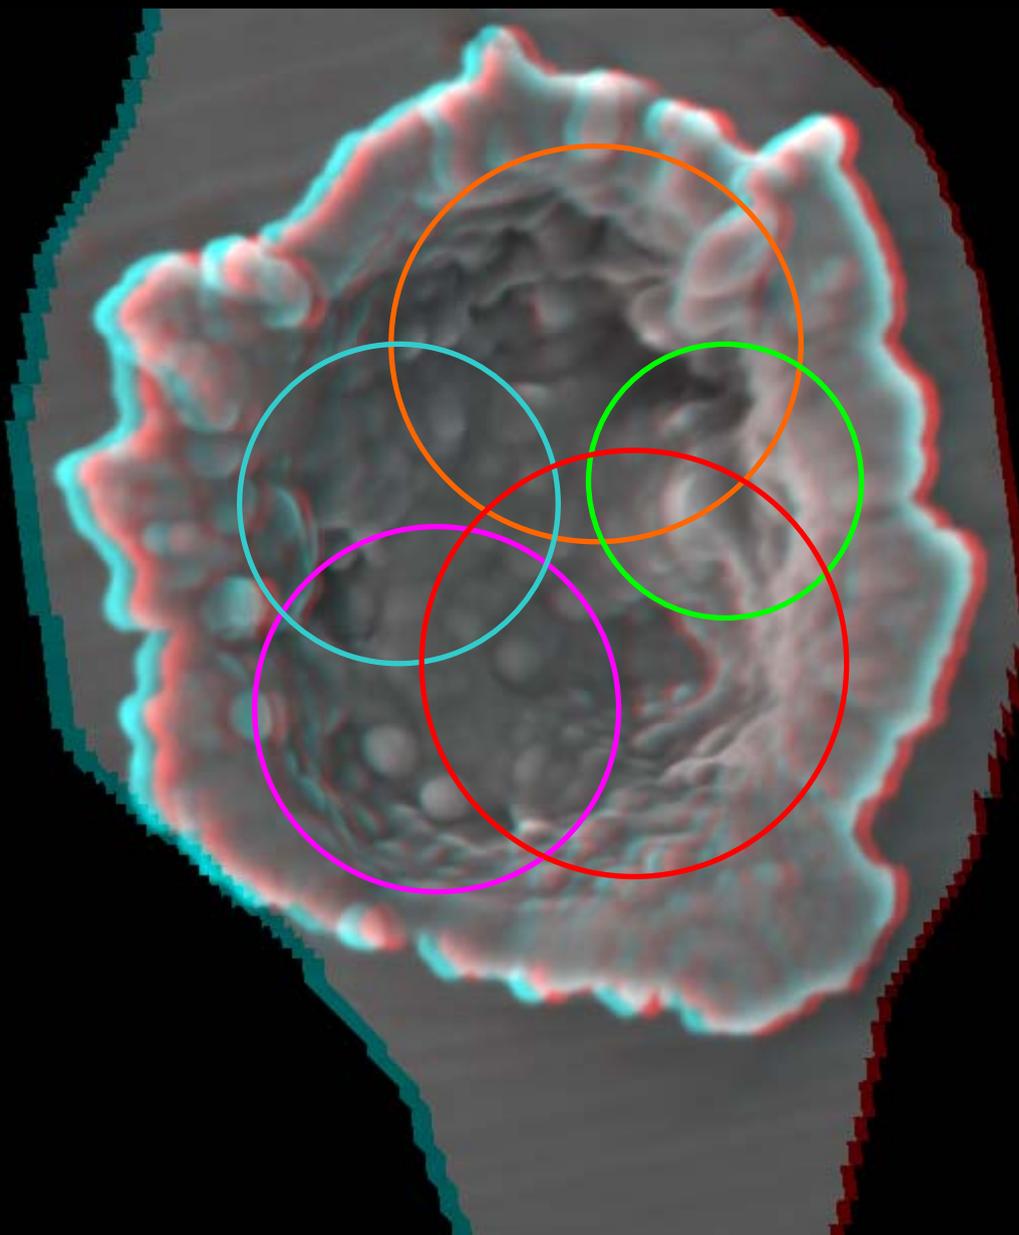
Stereo anaglyph
with crater overlap

Assume all silicates = 3.2 gcm^{-3}

Crater diameter	particle diameter	mass
4.37 microns	790nm	0.8 pg
3.03 microns	540nm	0.27 pg
4.73 microns	850nm	1 pg
4.06 microns	730nm	0.65 pg
3.52 microns	630nm	0.42 pg
+ one more?	850nm	1 pg

Total mass 4.14 pg in an aggregate of c.4 microns diameter gives a whole particle density of 0.12 gcm^{-3}

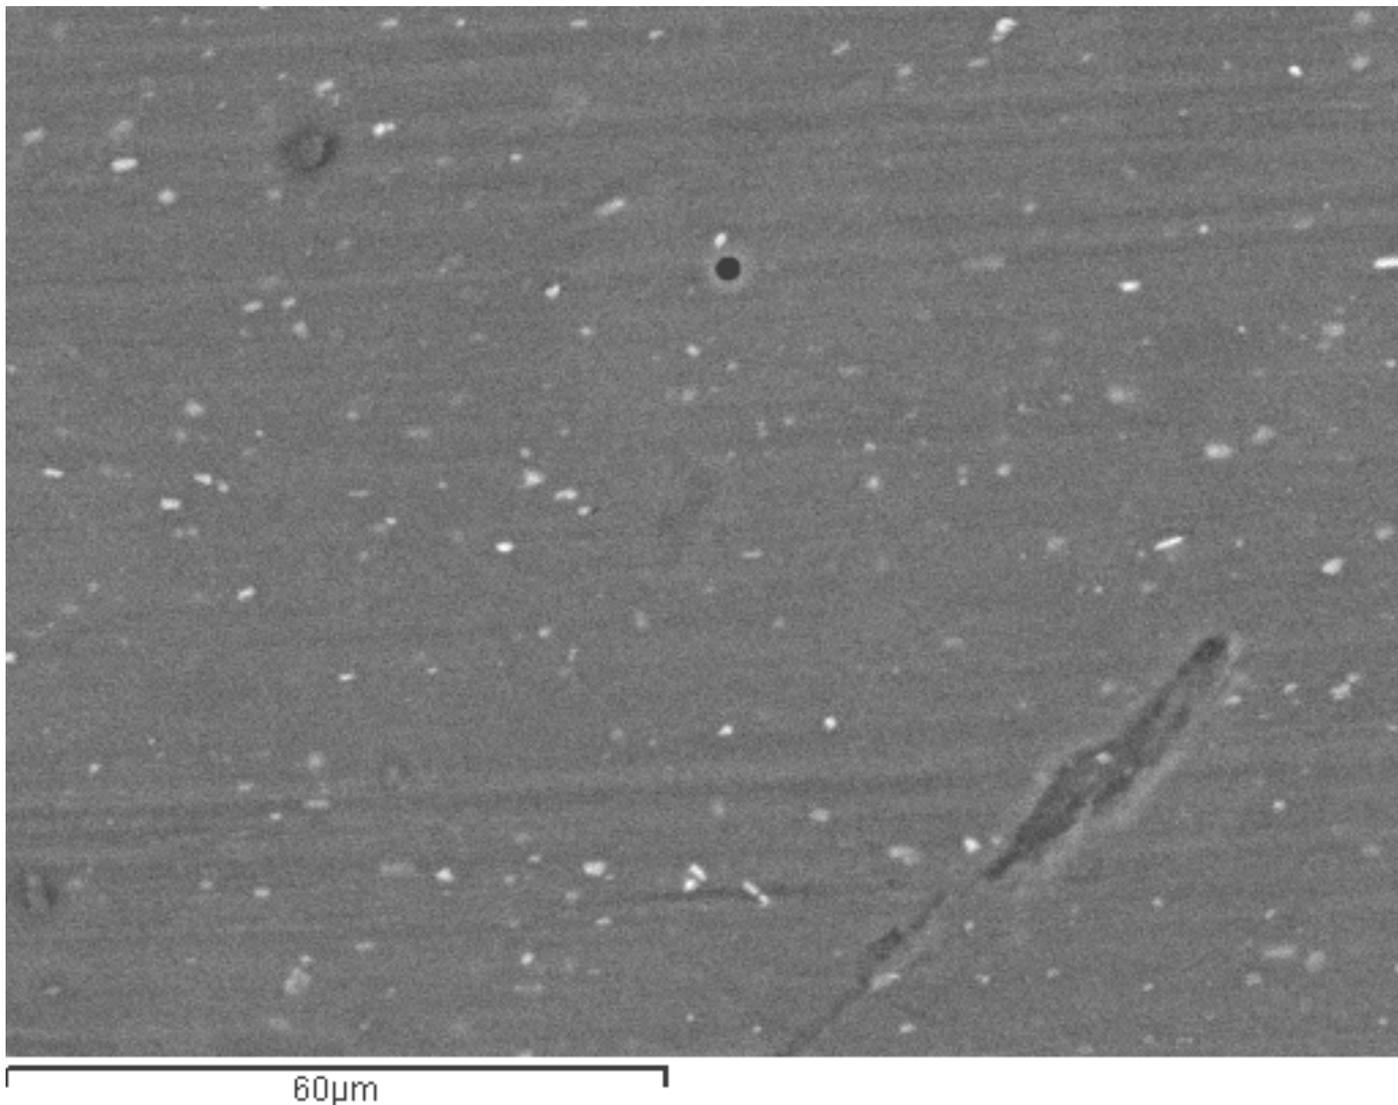
BEI frame 281 from automated montage run 4 (ak060214b.ipj), showing a dark circular feature, subsequently identified as a 2.4 micron diameter impact crater (C2125N,1 feature 3), during secondary electron imagery campaign 1 (ak060302).

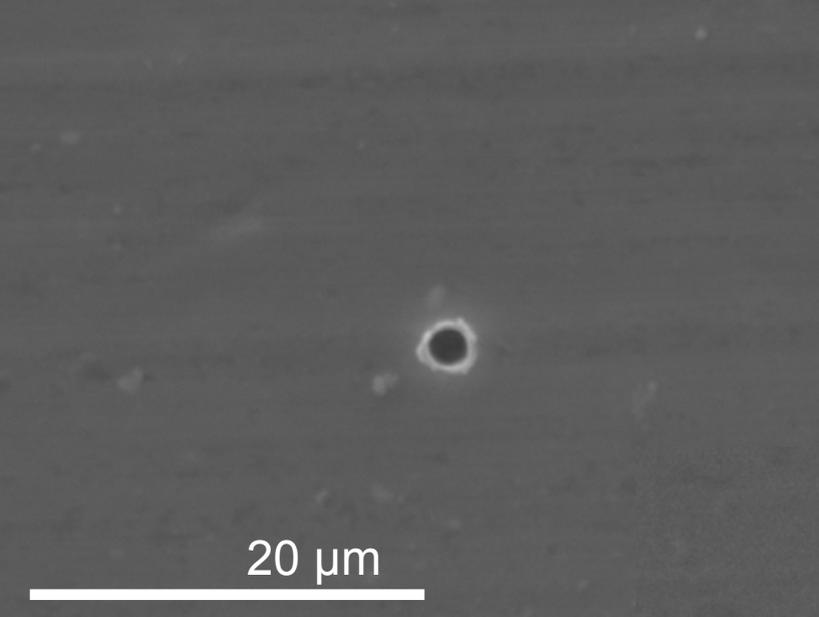
C2125N,1 feature 3

2.41 microns top lip diameter

Secondary electron images

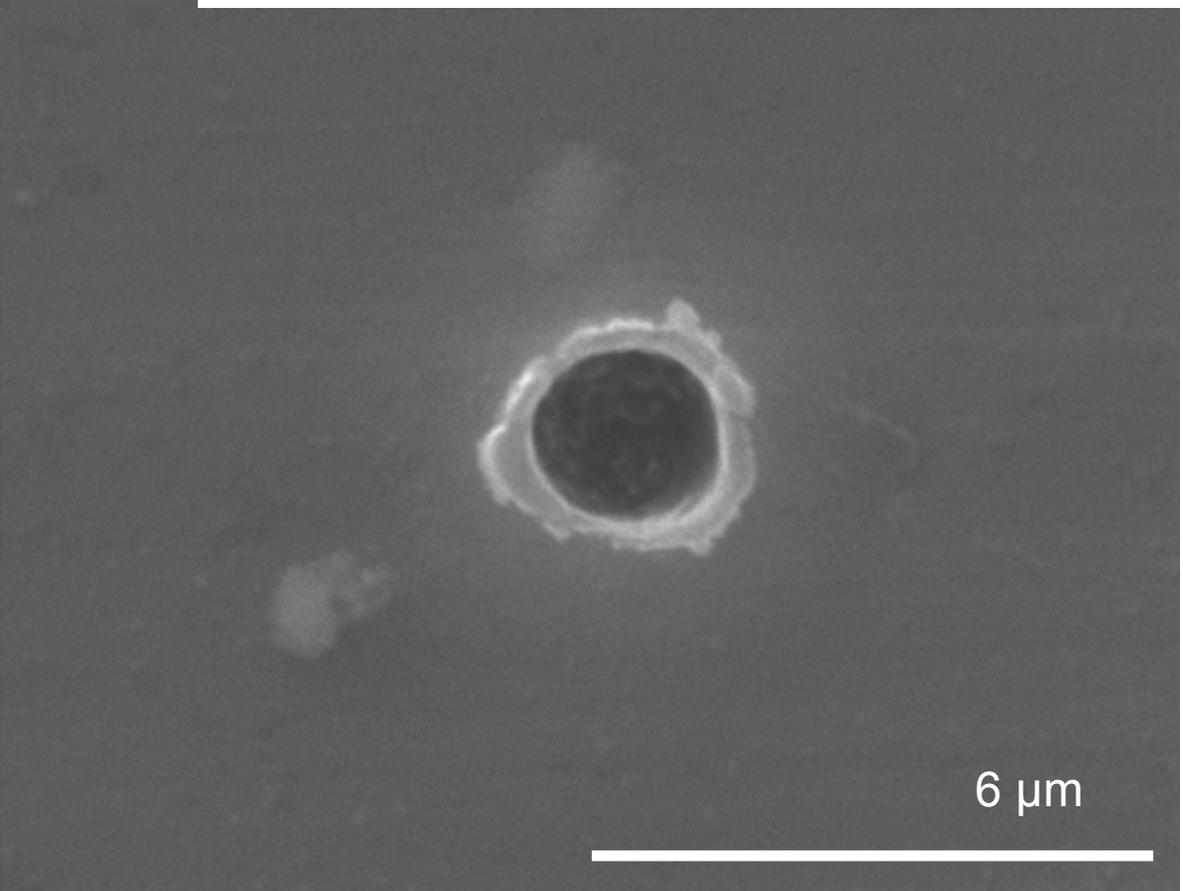
C2125N,1 feature 3

2.41 microns top lip diameter

Secondary electron image and energy dispersive X-ray spectrum

Oxygen,
Magnesium,
Silicon, Sulfur,
Calcium (and
probably also Iron)
are seen above
background levels

Walton feature 3: a circular crater of 2.4 microns, containing Mg, S, Ca and Fe silicate residue

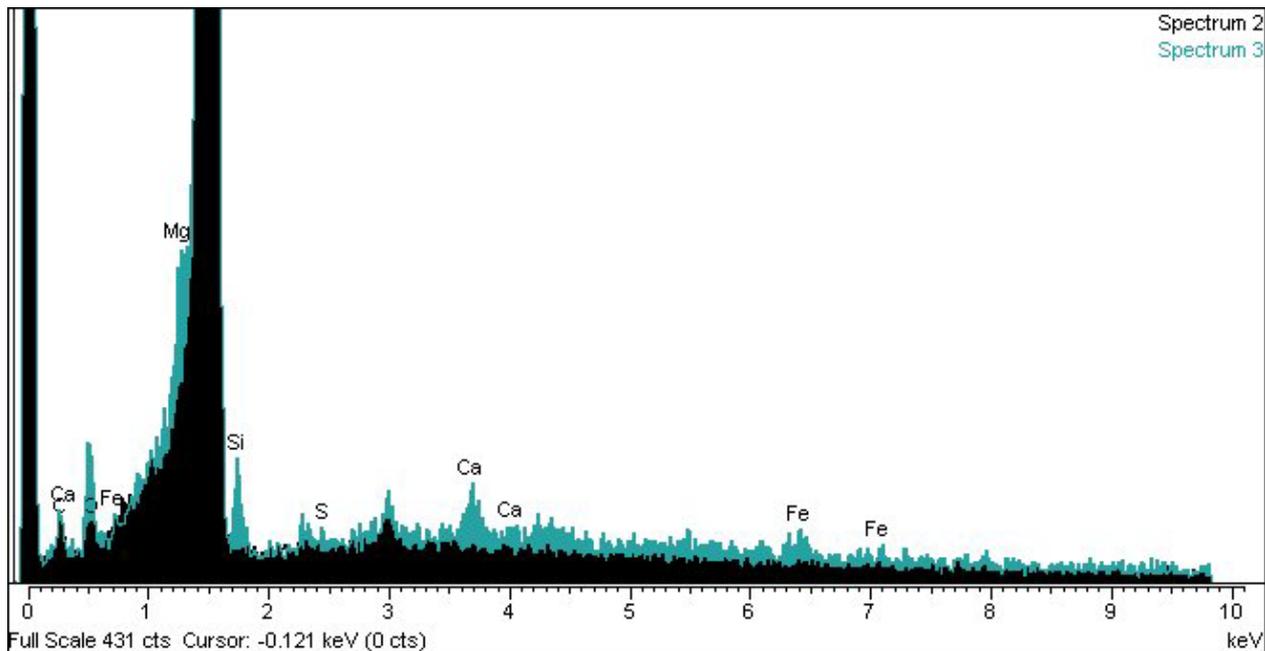
C2125N,1 feature 3

Element	Weight%	Weight% sigma	Atomic%	Compound%	Number of ions
Mg	21.37	0.68	19.05	35.43	7.83
Si	19.66	0.5	15.17	42.07	6.24
S	0.97	0.26	0.65	2.41	0.27
Ca	5.9	0.4	3.19	8.25	1.31
Cr	1.51	0.48	0.63	2.21	0.26
Fe	7.49	0.75	2.91	9.63	1.19
O	43.11	0.84	58.4		24

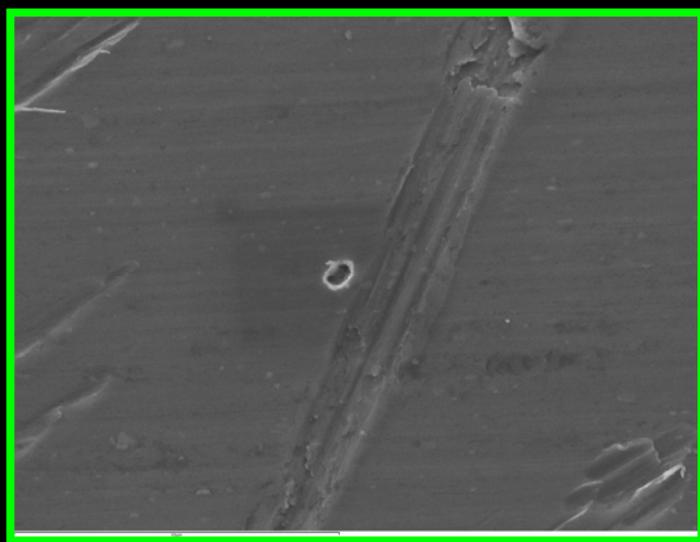
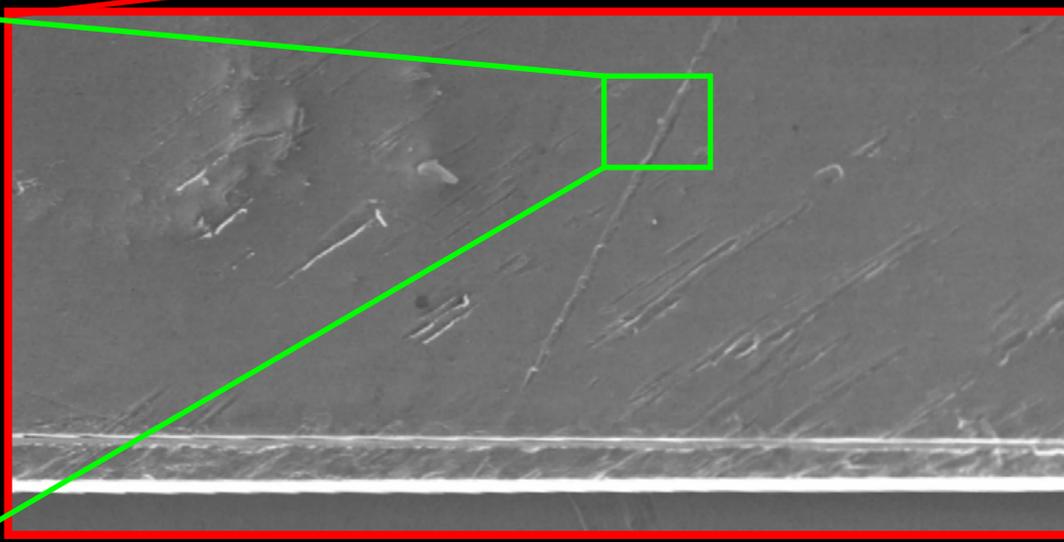
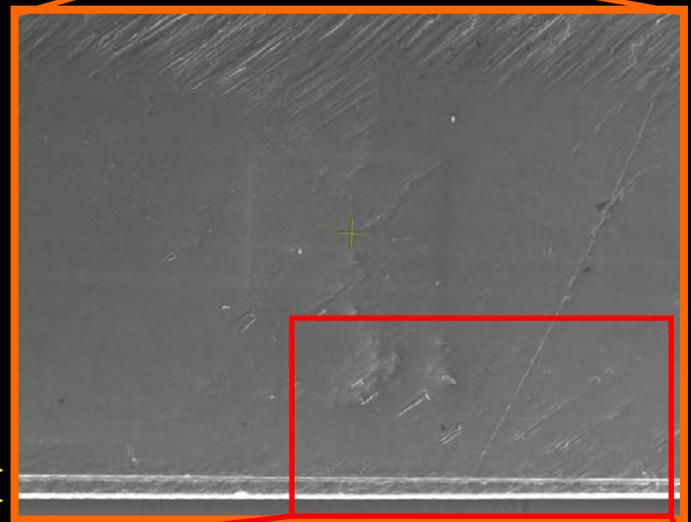
C2125N, 1 feature 4 secondary electron images

Cut line on foil →
Cut edge of foil →

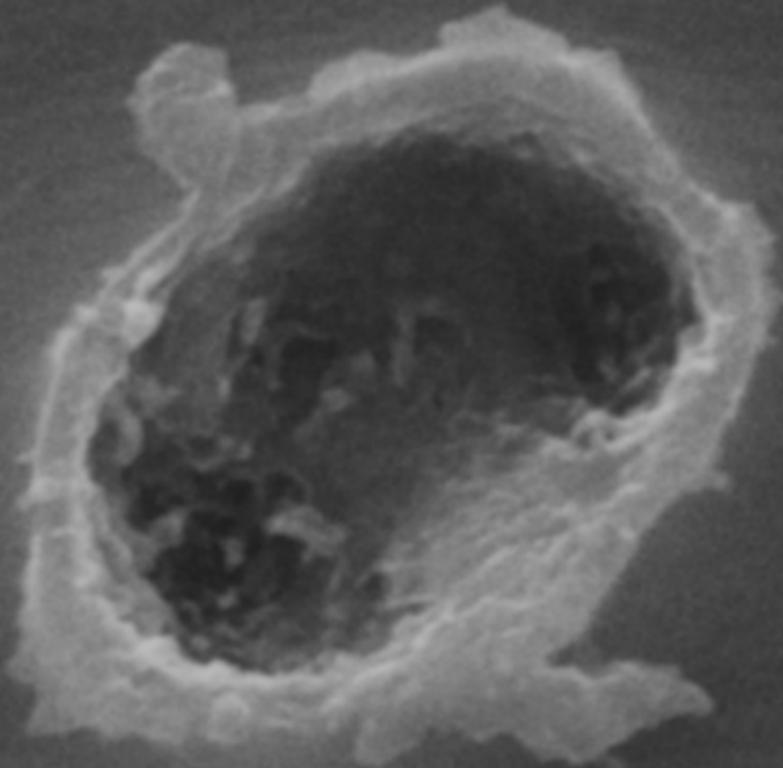
C2125N,1 feature 4 secondary electron image

Oval feature of
3.9 x 5.7 microns
Top lip diameter

Walton feature 4: an oval crater of 5.7 x 3.9 microns diameter with Mg and S bearing silicate residue.

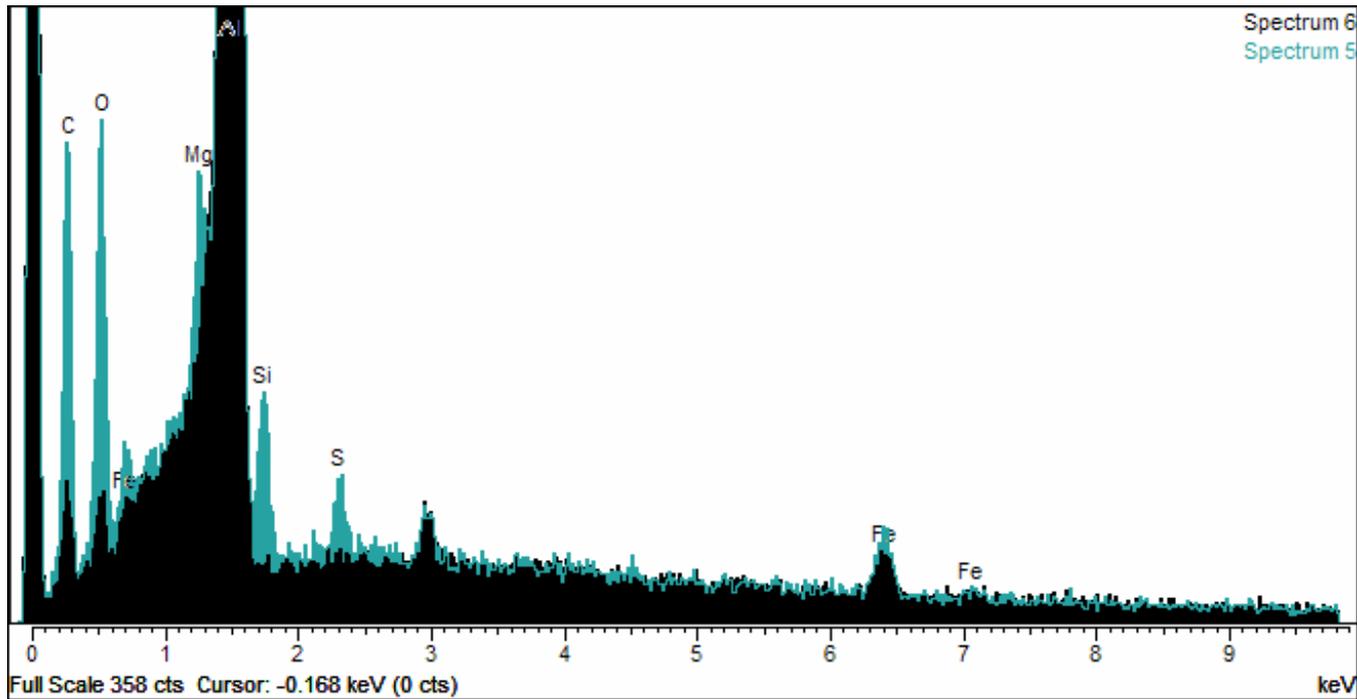
Element	Weight%	Weight% sigma	Atomic%	Compound%	Formula	Number of ions
Mg	24.52	1.02	21.92	40.65	MgO	8.99
Si	15.25	0.62	11.8	32.63	SiO ₂	4.84
S	3.74	0.45	2.54	9.35	SO ₃	1.04
Ti	trace	0.6	bdl	Bdl	TiO ₂	trace
Fe	13.18	1.08	5.13	16.95	FeO	2.1
O	43.06	1.19	58.5			24
