METEOROID AND DEBRIS IMPACT FEATURES DOCUMENTED ON THE LONG DURATION EXPOSURE FACILITY

A Preliminary Report

Compiled by Members
of the LDEF Meteoroid
and Debris Special
Investigation Group

August 1990

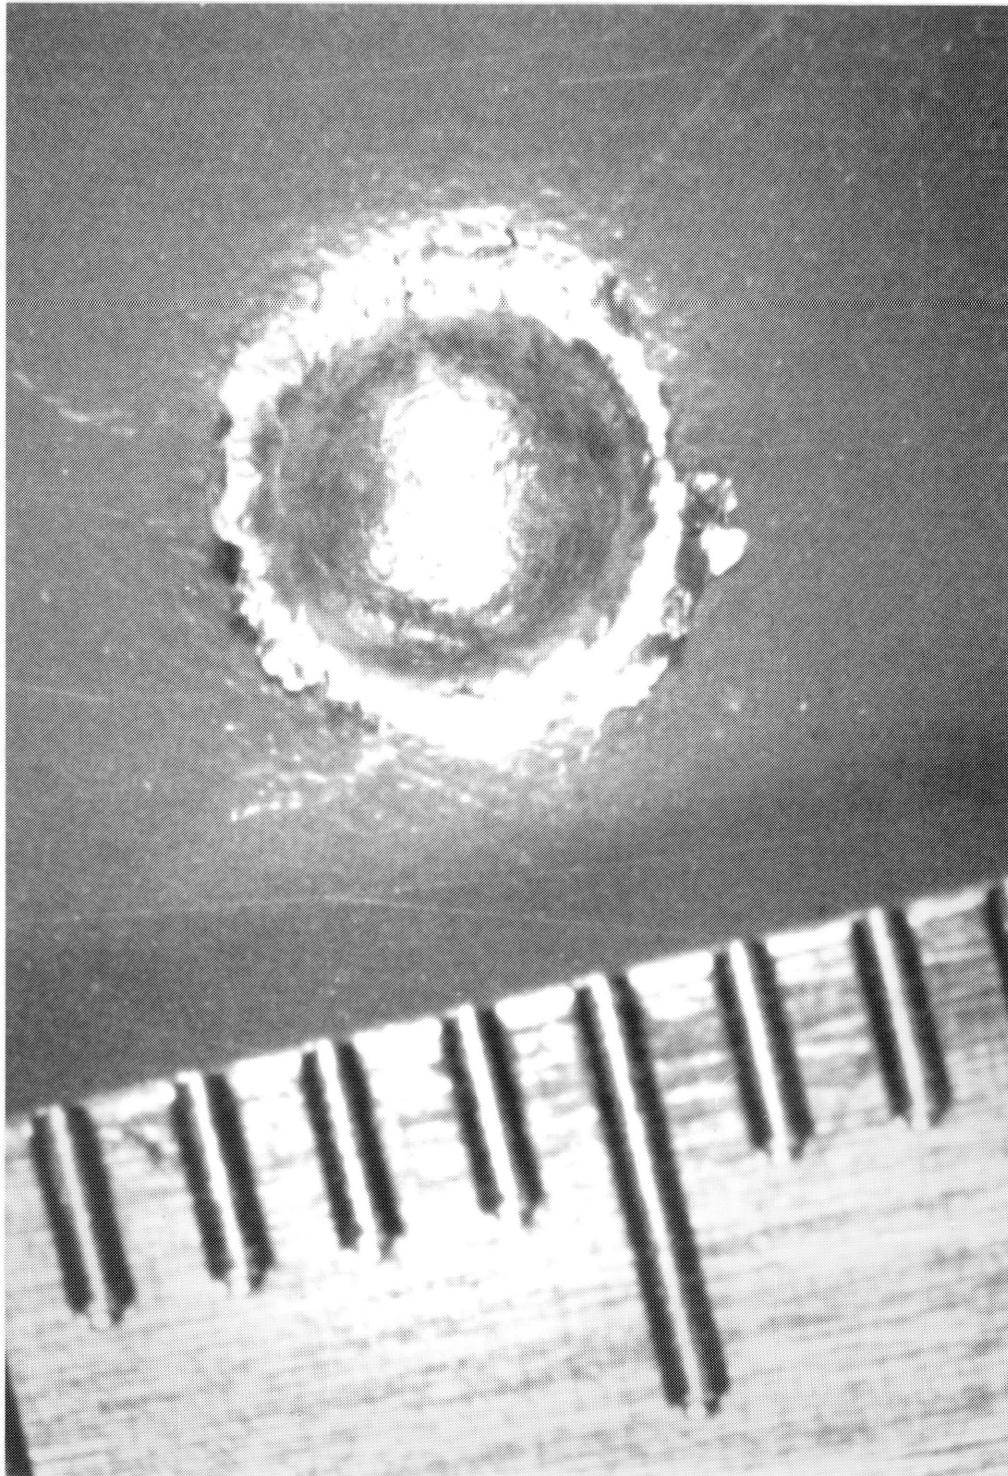
Figure 2. Photograph of a symmetrically-shaped crater in an aluminum surface. Most features on LDEF were of this type. Small divisions on scale are in millimeters.

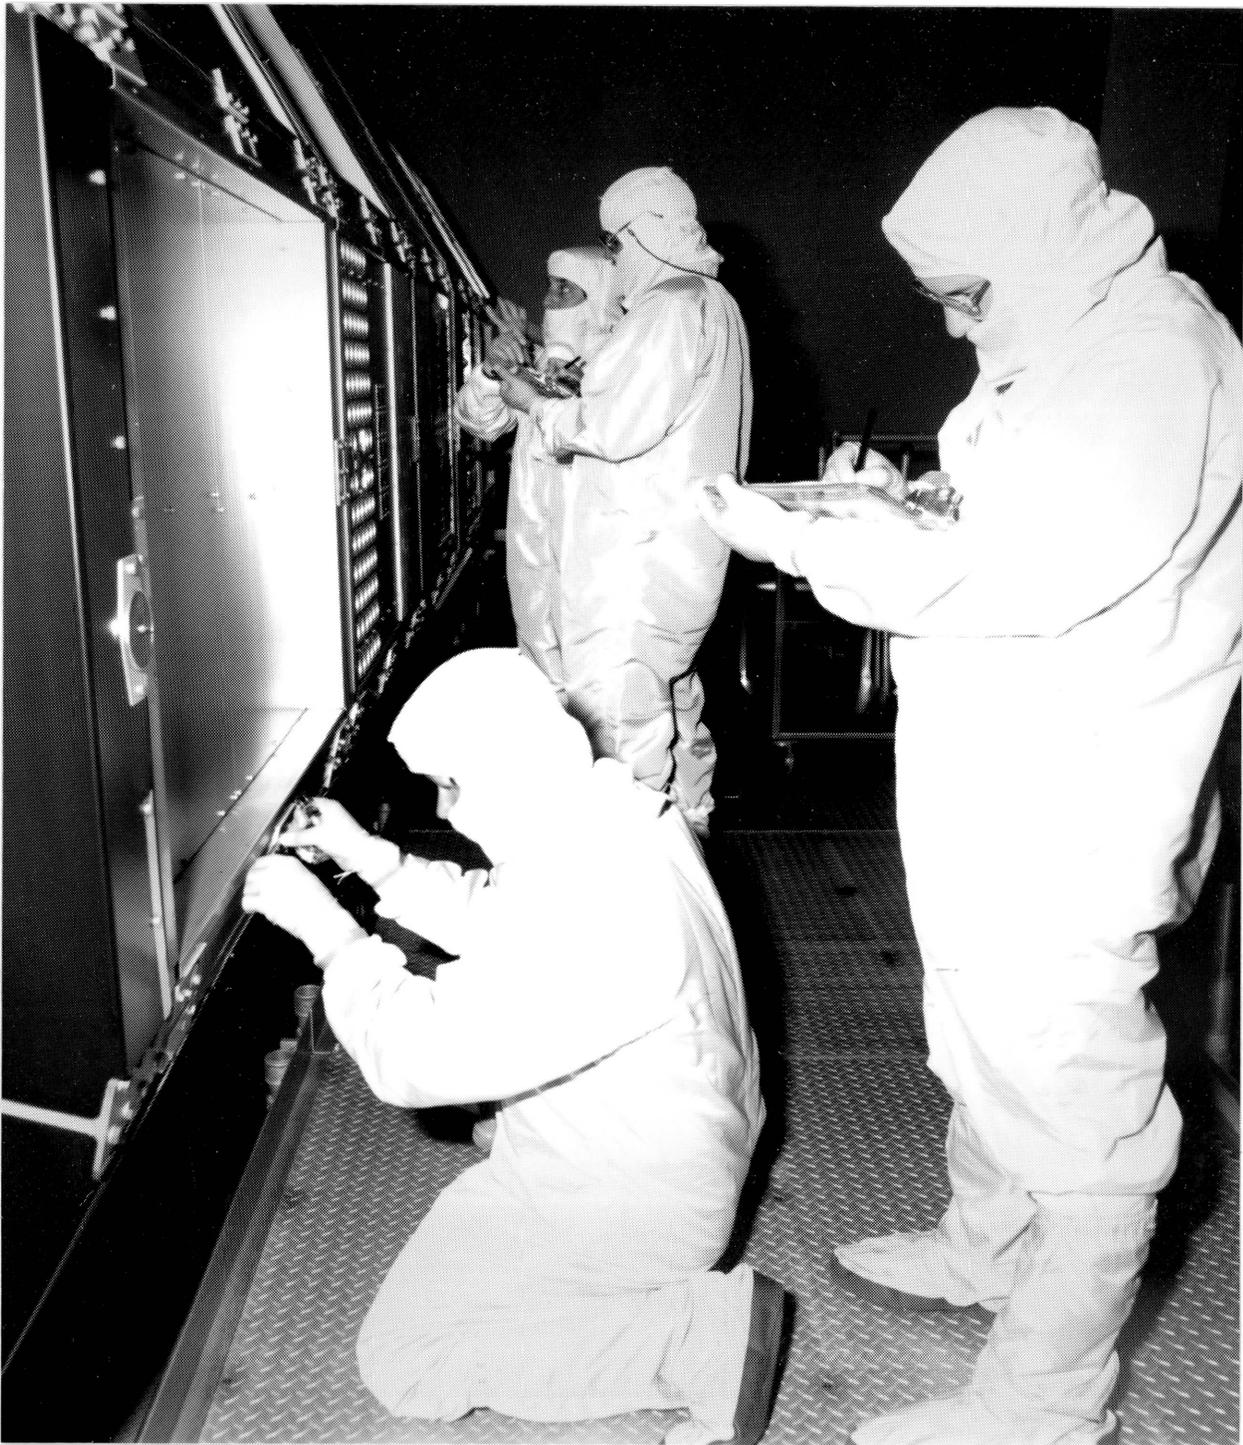
Figure 21. Members of the M&D SIG performing the BOLTS, CLAMPS, SHIMS, AND EXPERIMENT TRAY FLANGES/LIPS INSPECTION AND BOLT ORIENTATION SURVEY prior to the commencement of the deintegration operations.

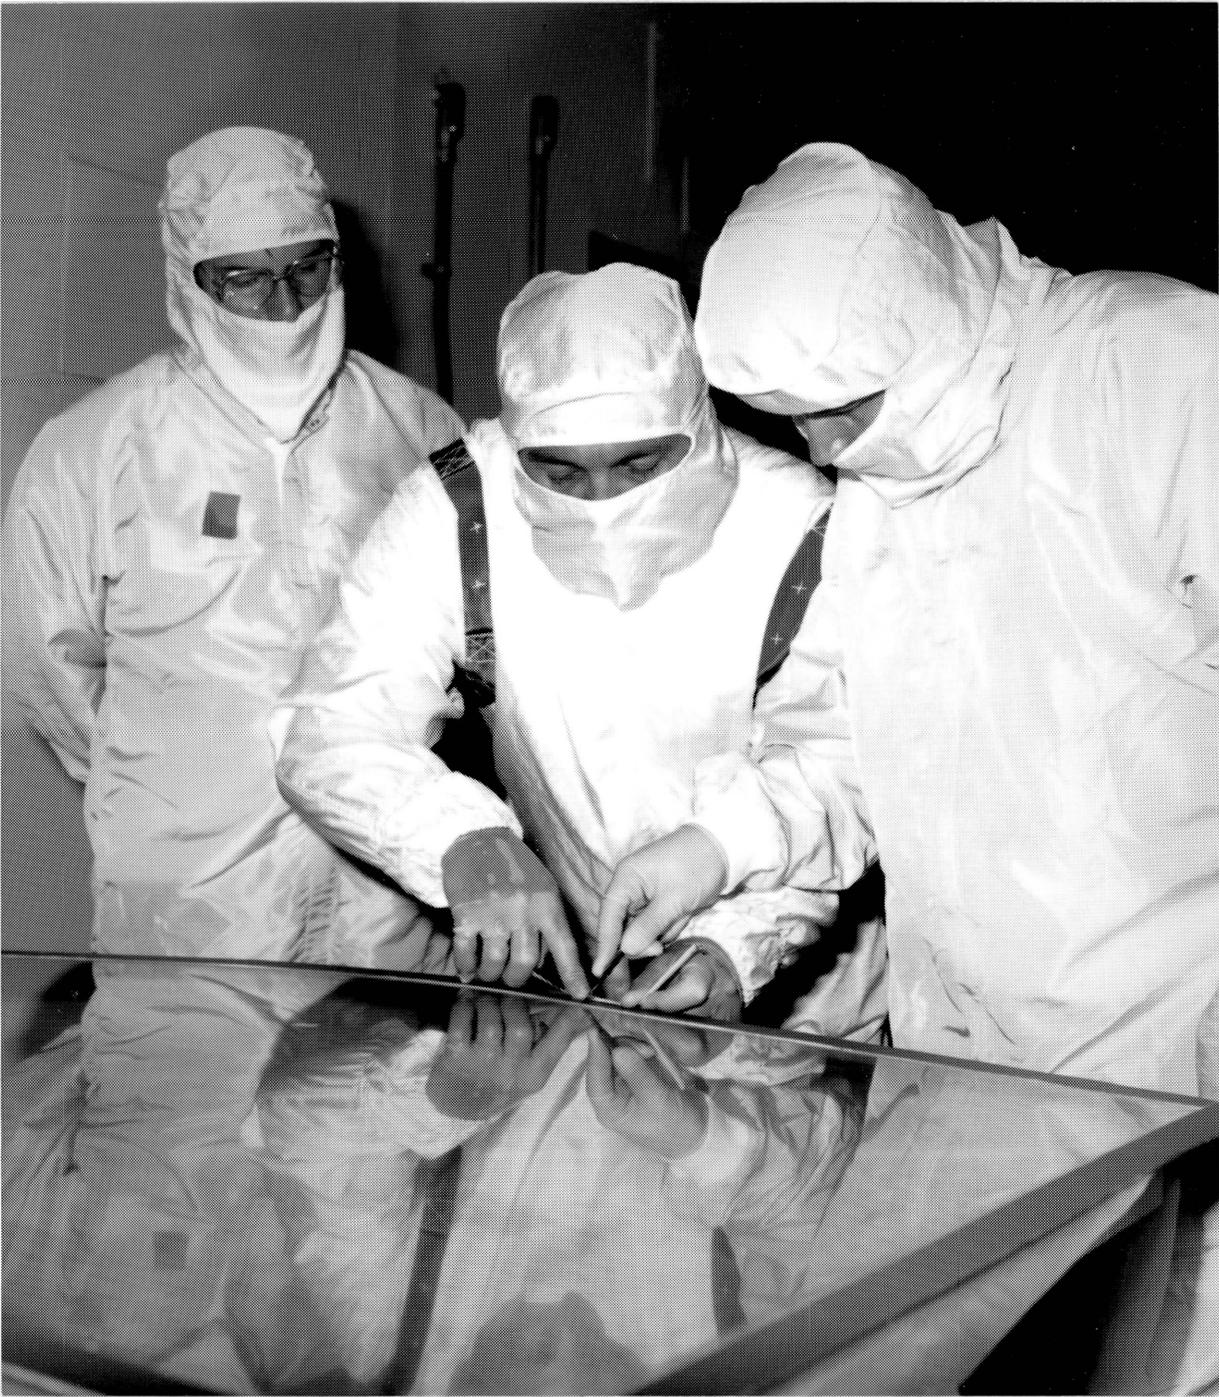
Figure 23. M&D SIG and Ground Operations personnel removing small sections of the experiment-tray cover gasket to prevent damage and contamination to features residing on the experiment-tray flanges.

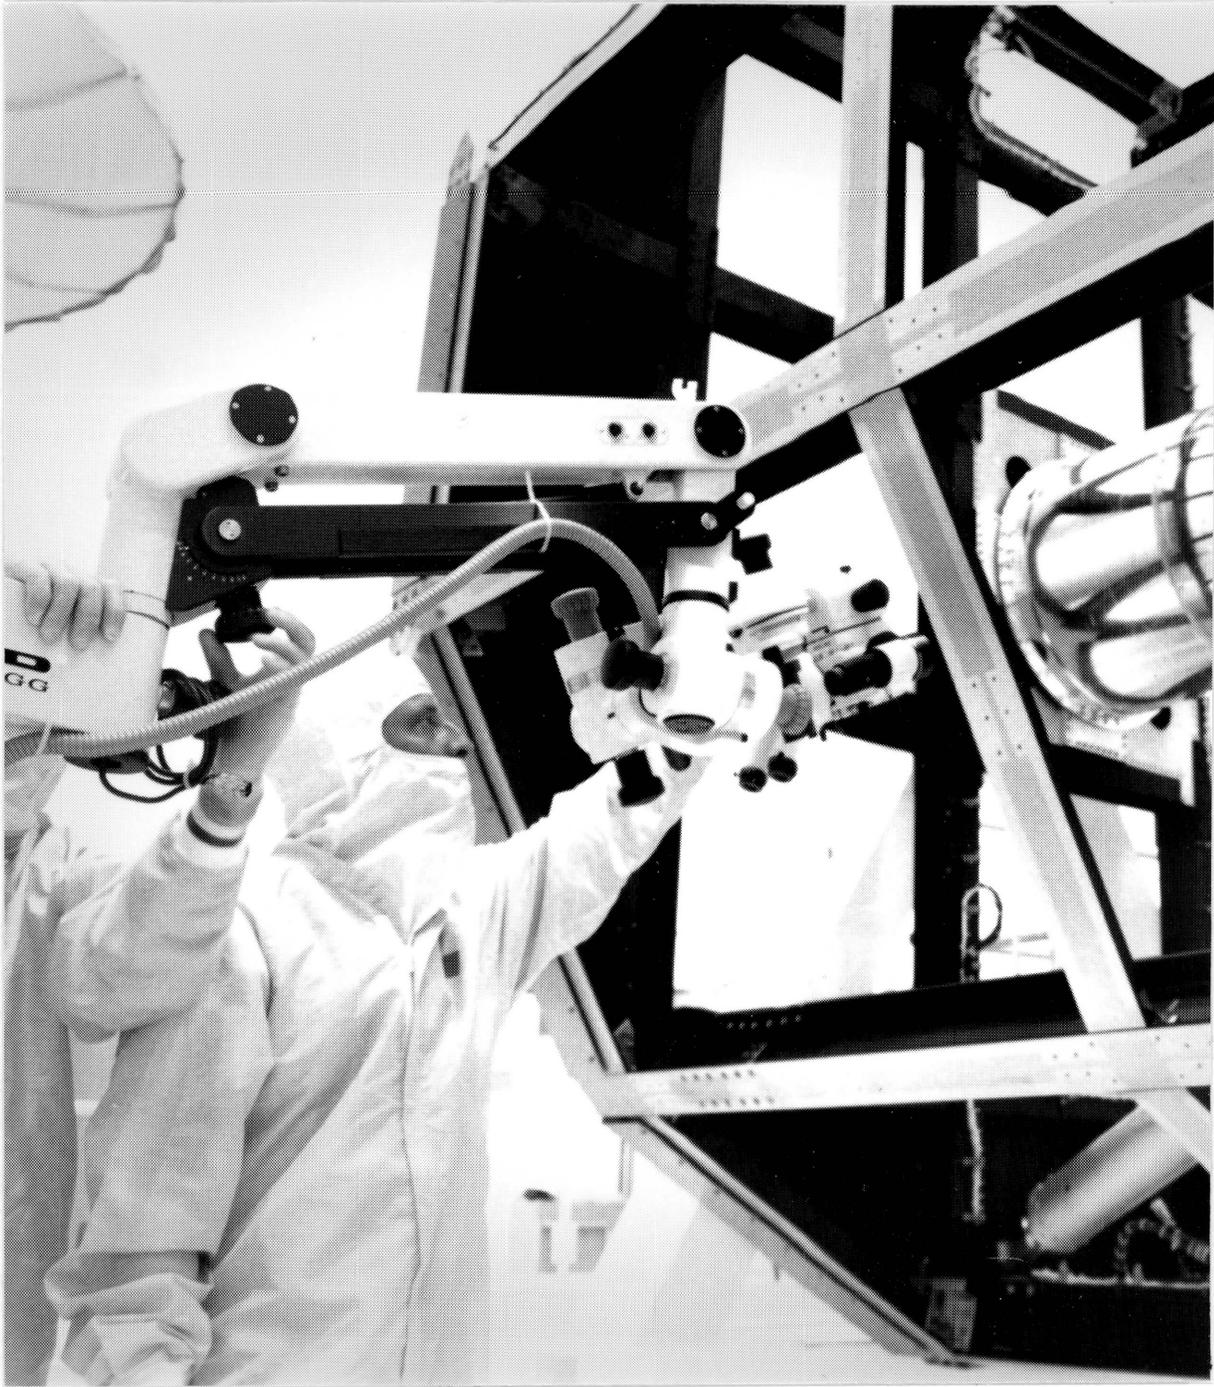
Figure 33. Members of the M&D SIG A-Team shown configuring one of the Stereo-Microscope Imaging Systems for photodocumentation of the LDEF structural frame. Note the dark discoloration of the space-exposed areas on the structural-frame members.

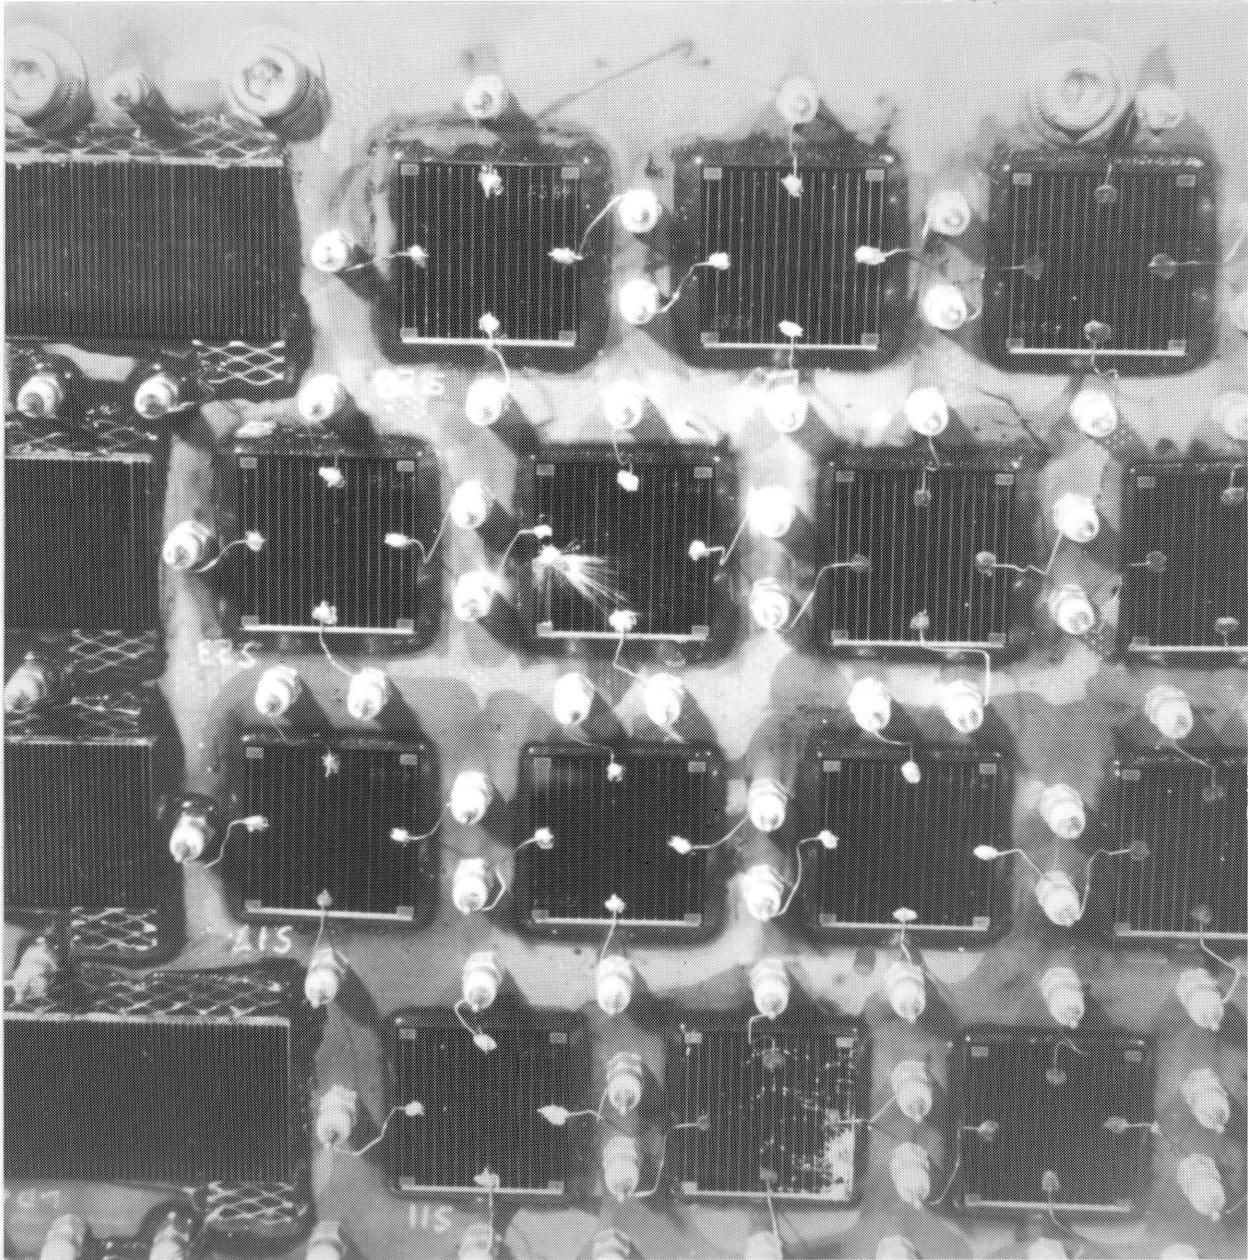
Figure A08-2 - This is a close-up of the sub-tray in the lower left of tray A08, showing an impact feature on a solar cell. This view measures approximately 13 cm across.

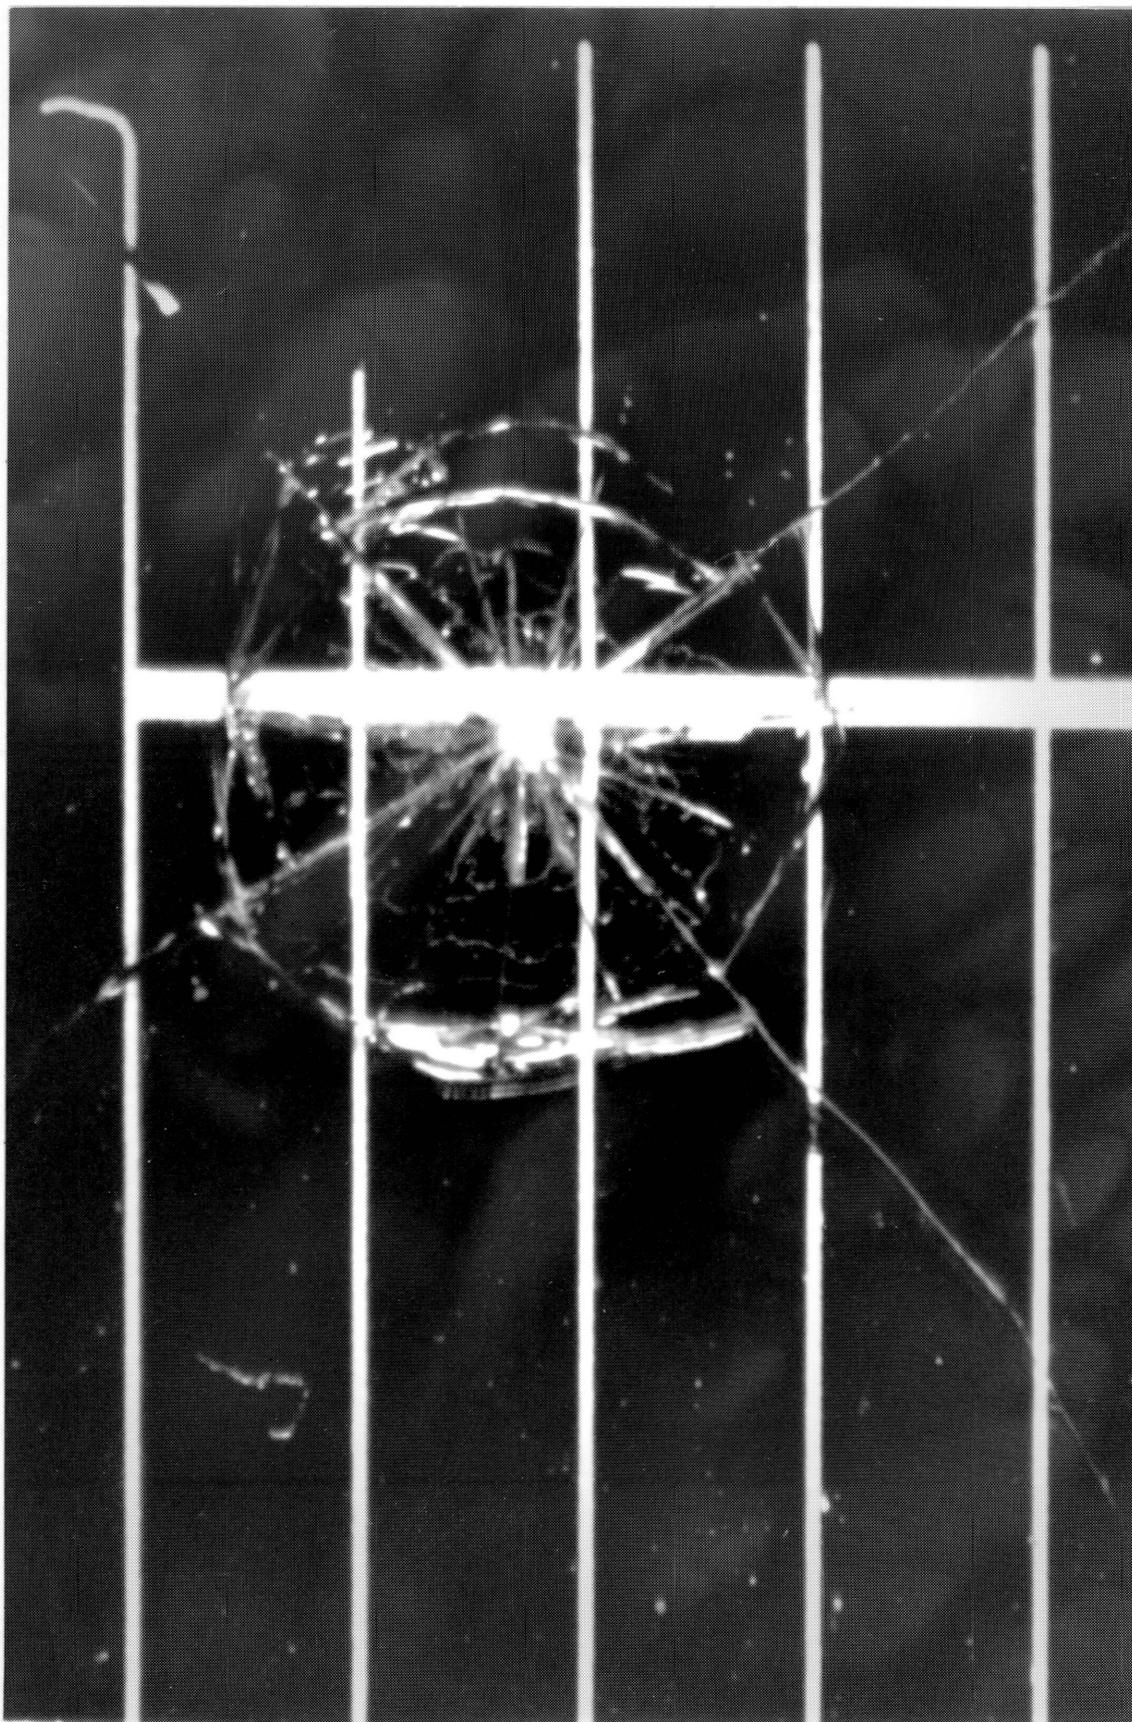
Figure A08-3. This is a close-up on an impact into a solar cell, showing accompanying shattering, and measures approximately 3 cm across.

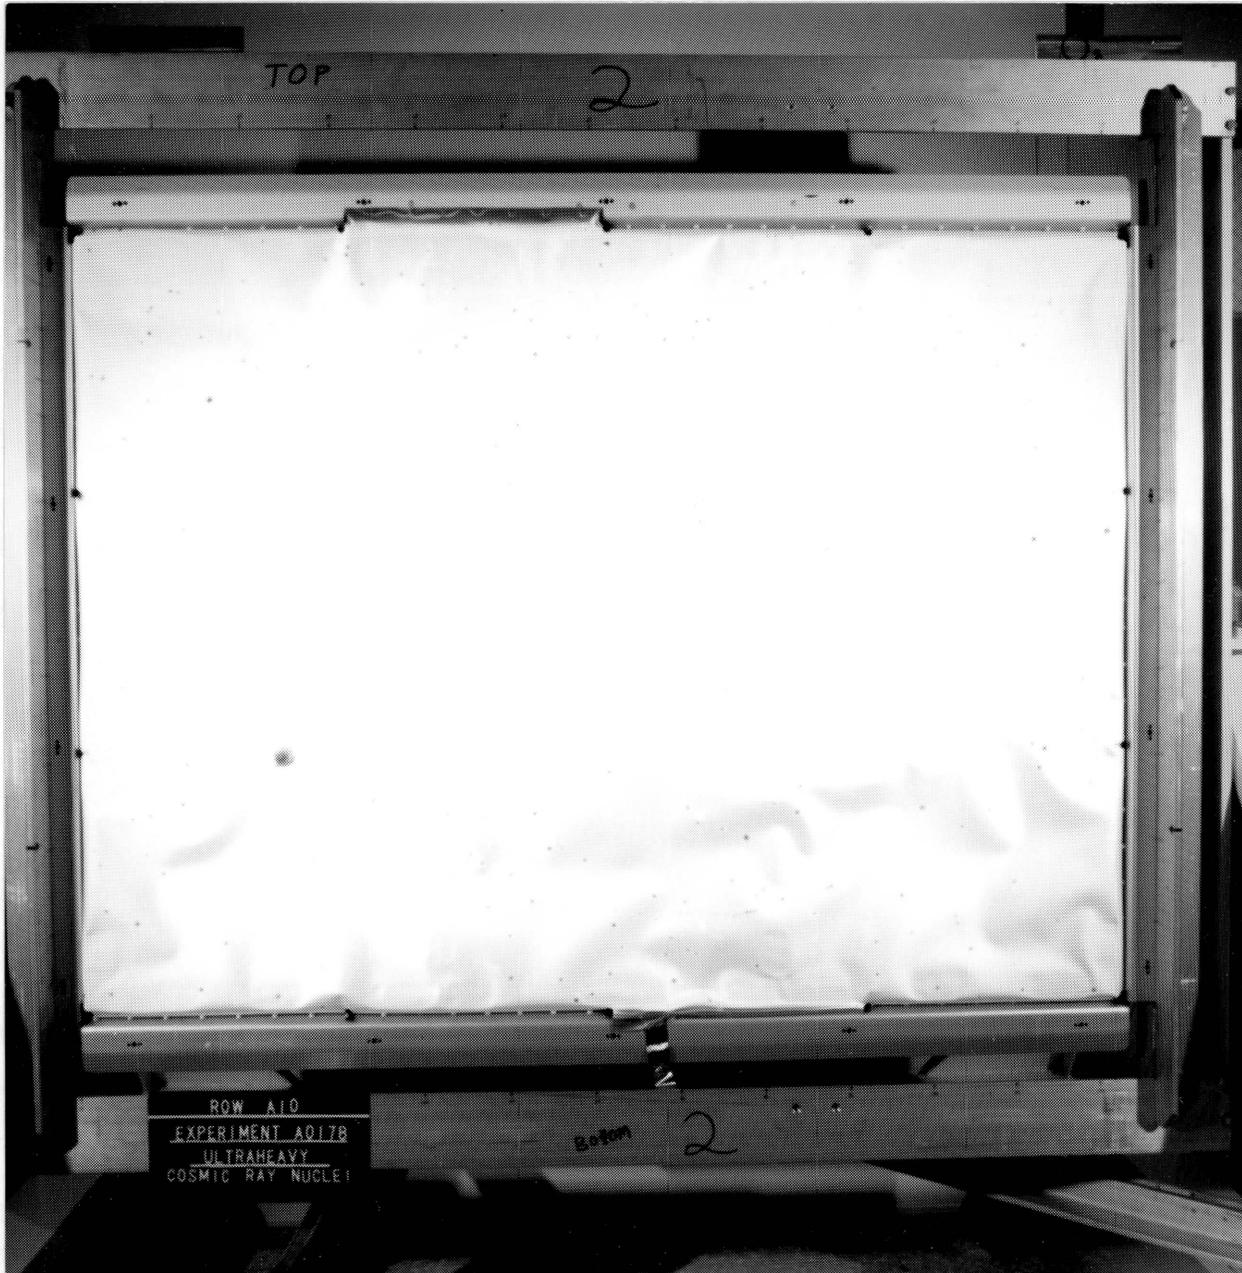
Figure A10-1 - This post-deintegration view shows the front of the entire A10 experiment thermal blanket. *Fleur-de-lis* patterns across the blanket are surface expressions of the velcro attachment points to the underlying aluminum frame. Many impact features are apparent across the blanket surface. The large impact feature in the lower left is also shown in Figure A10-2.

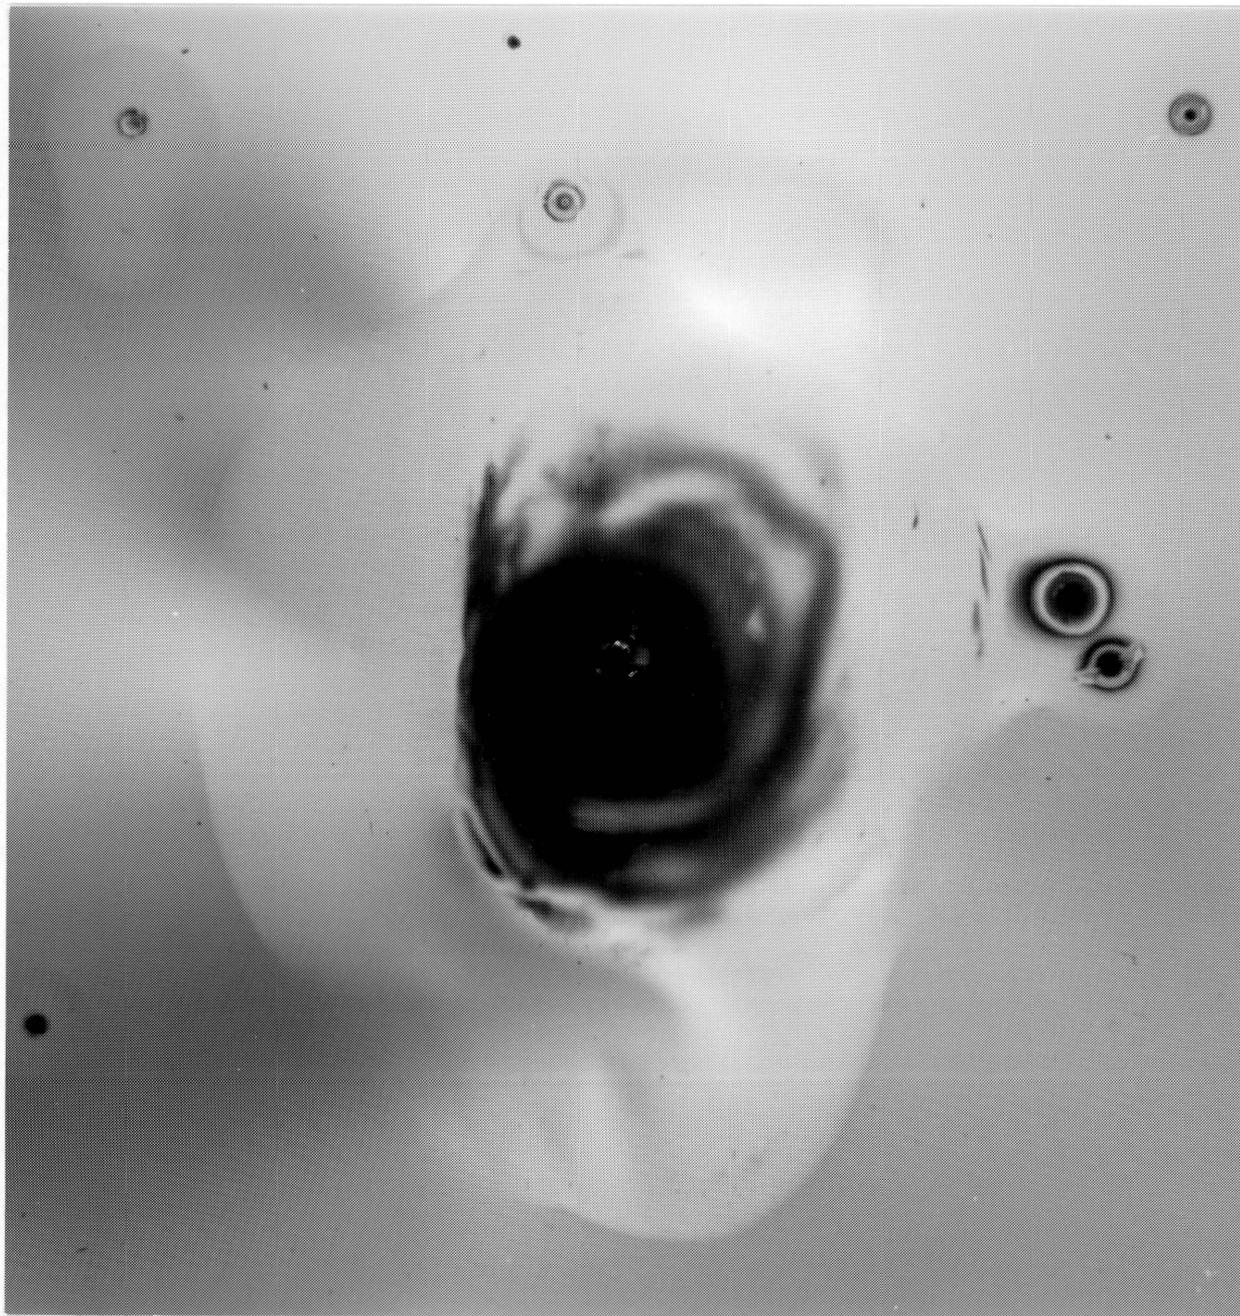
Figure A10-2. This is a view of large impact features on the A10 thermal blanket. Dark rings encircle many of the features. Some rings are incomplete. Rounded delamination areas surround most impact features shown here. View measures approximately 10 cm across.

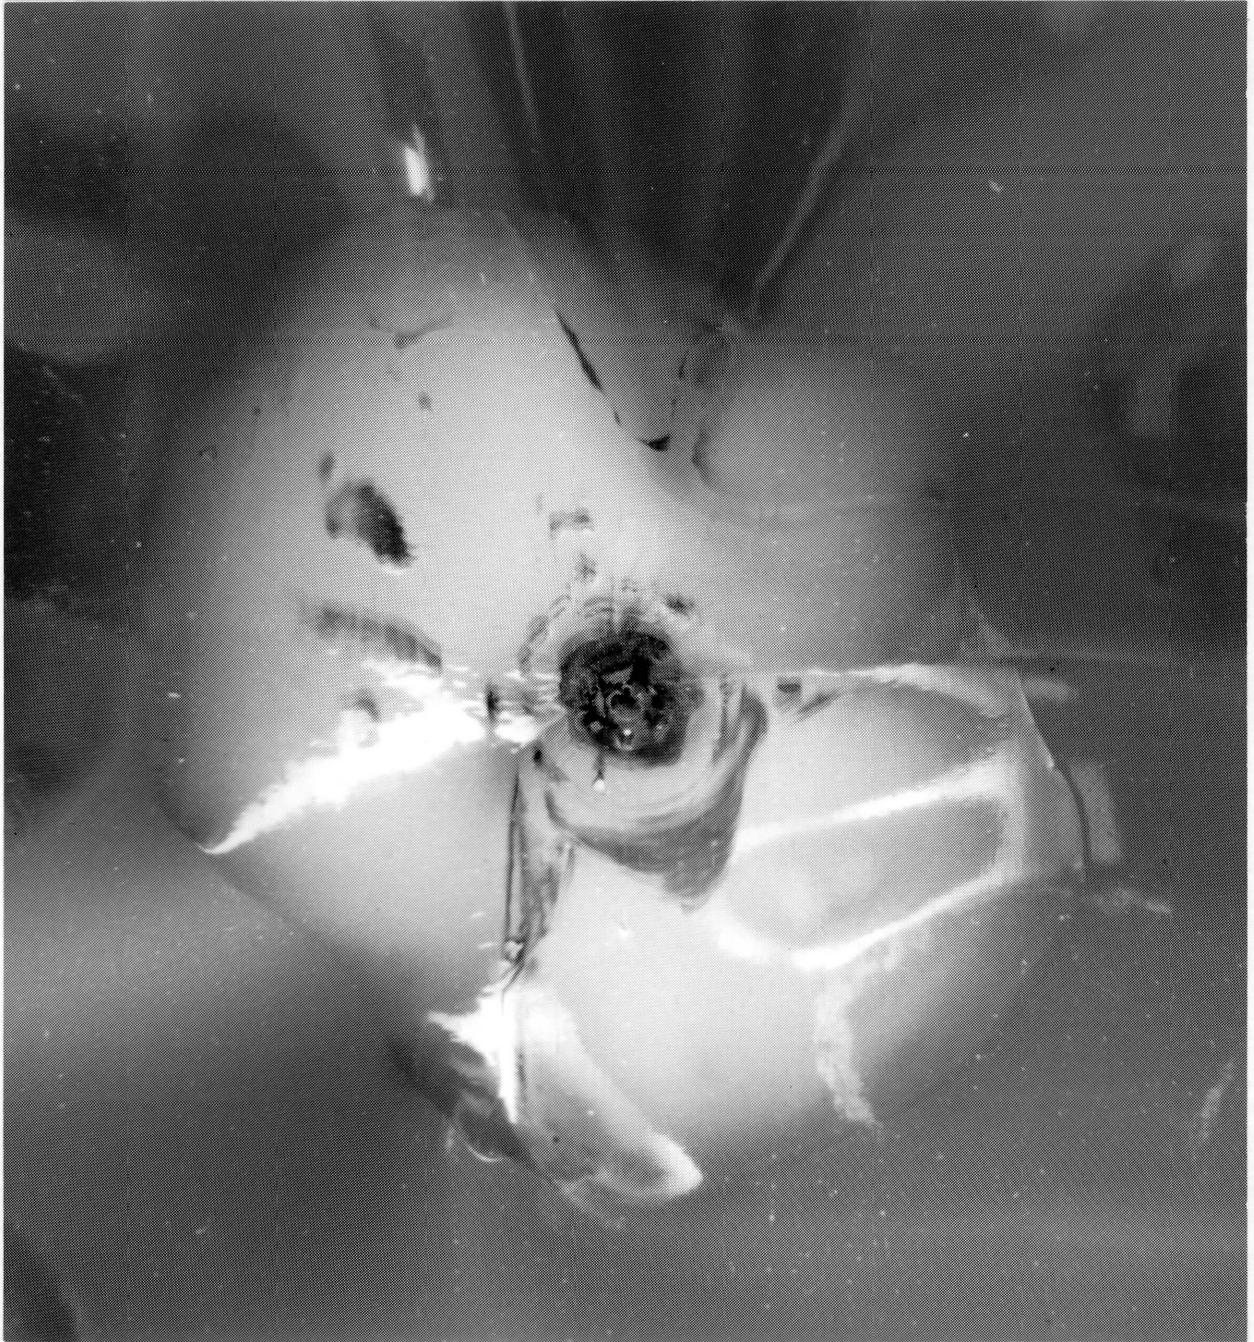
Figure B07-1. This is a view of one large impact feature on the B07 thermal blanket. A rounded delamination area surrounds the impact feature shown here, and the penetration hole is not spherical, possibly reflecting deformation of the Teflon surface. View measures approximately 10 cm across.

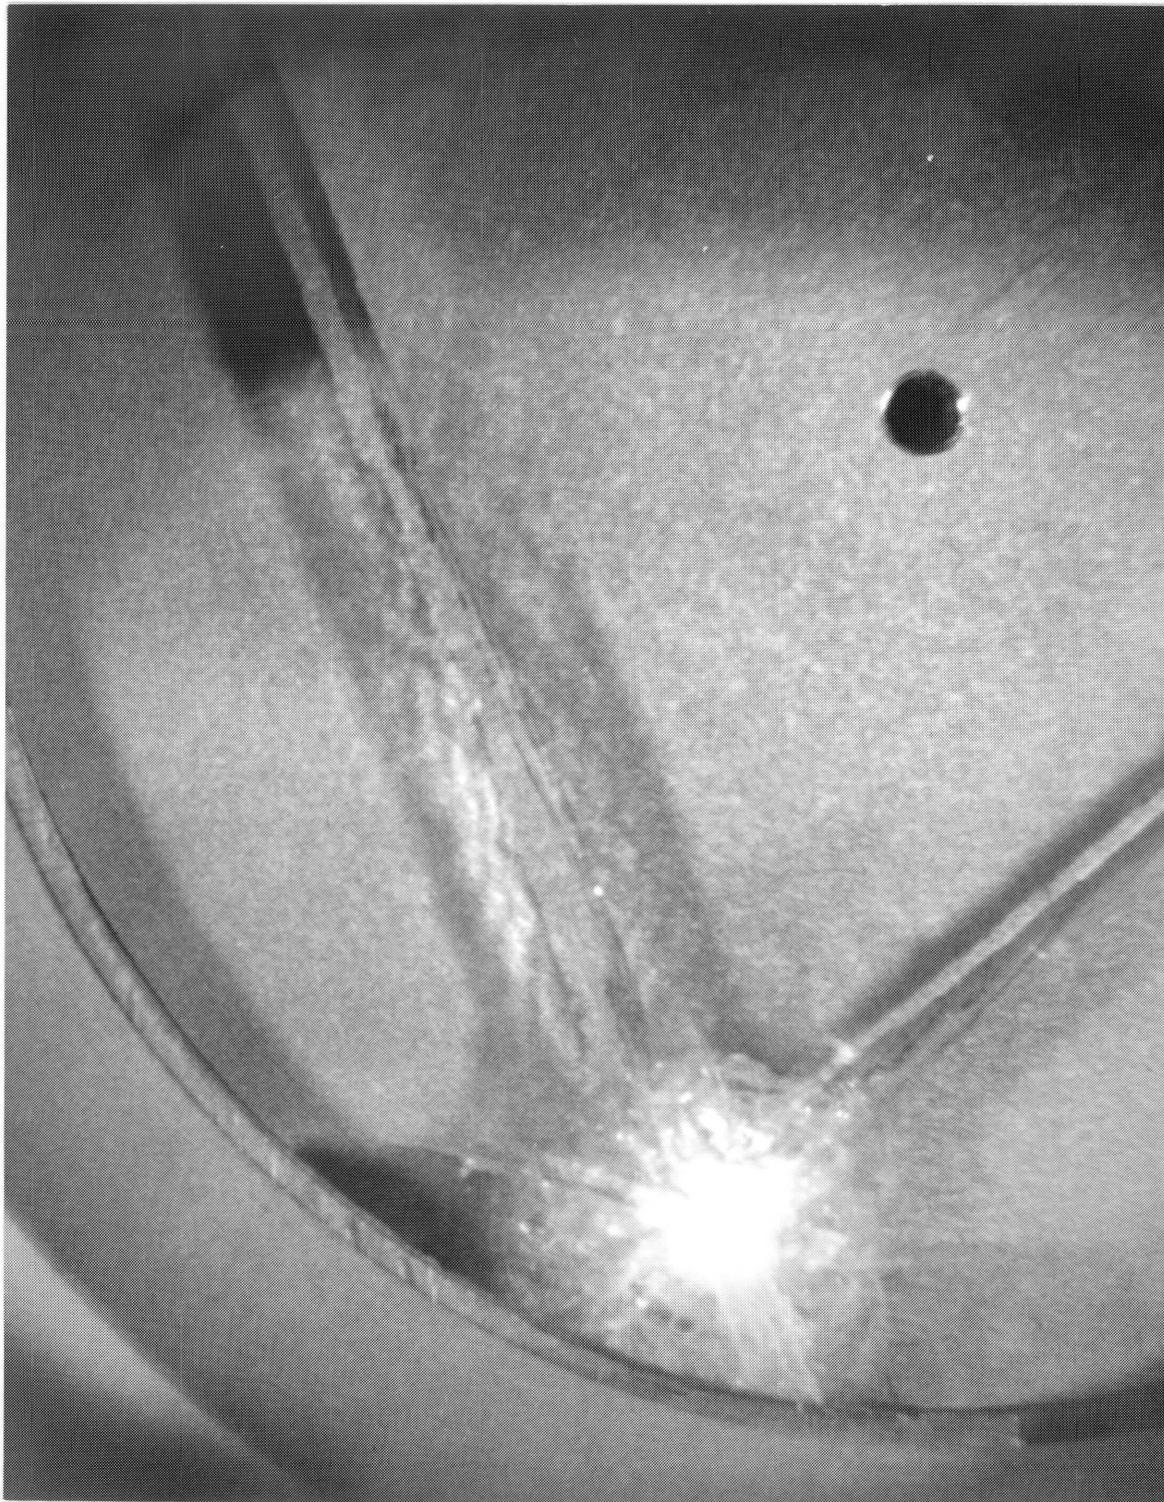
Figure B08-1. This is a view of one large impact feature on an optical surface from tray B08. Large radial cracks extend across the entire surface of the sample, and the "crater" consists of finely-shattered material. View measures approximately 2 cm across.

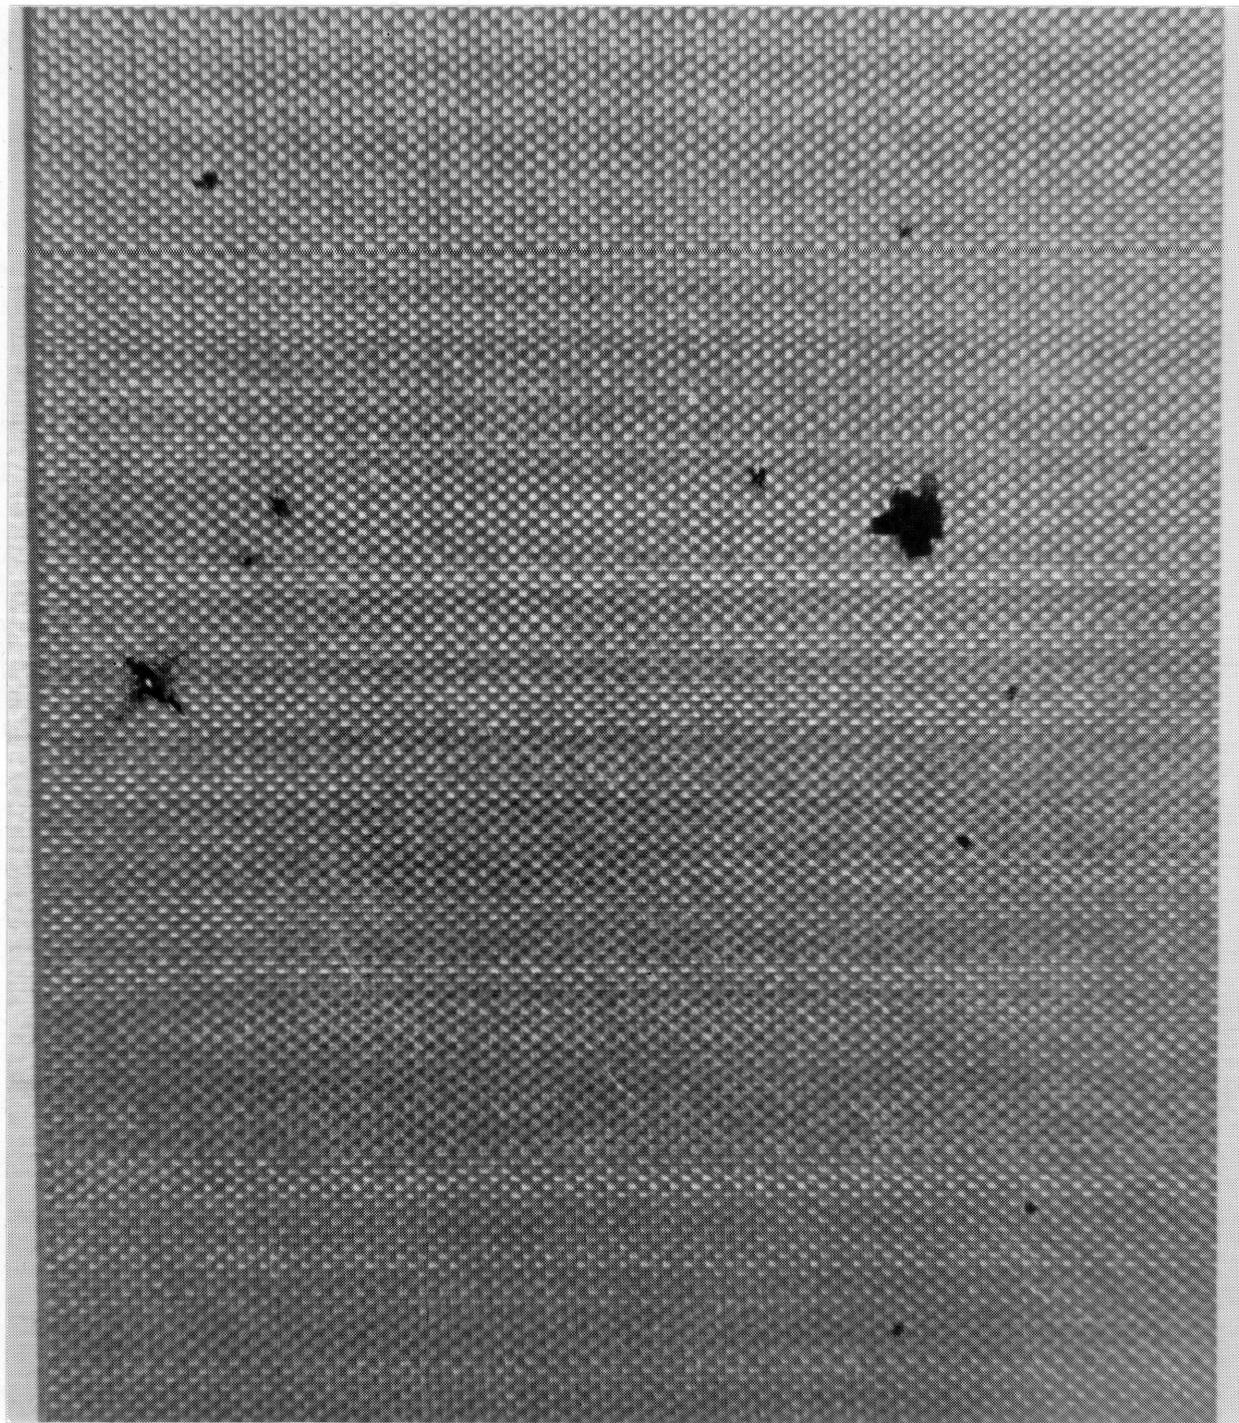
Figure B09-2. This view shows impact features in the fabric material of Tray B09. View measures approximately 4 cm across.

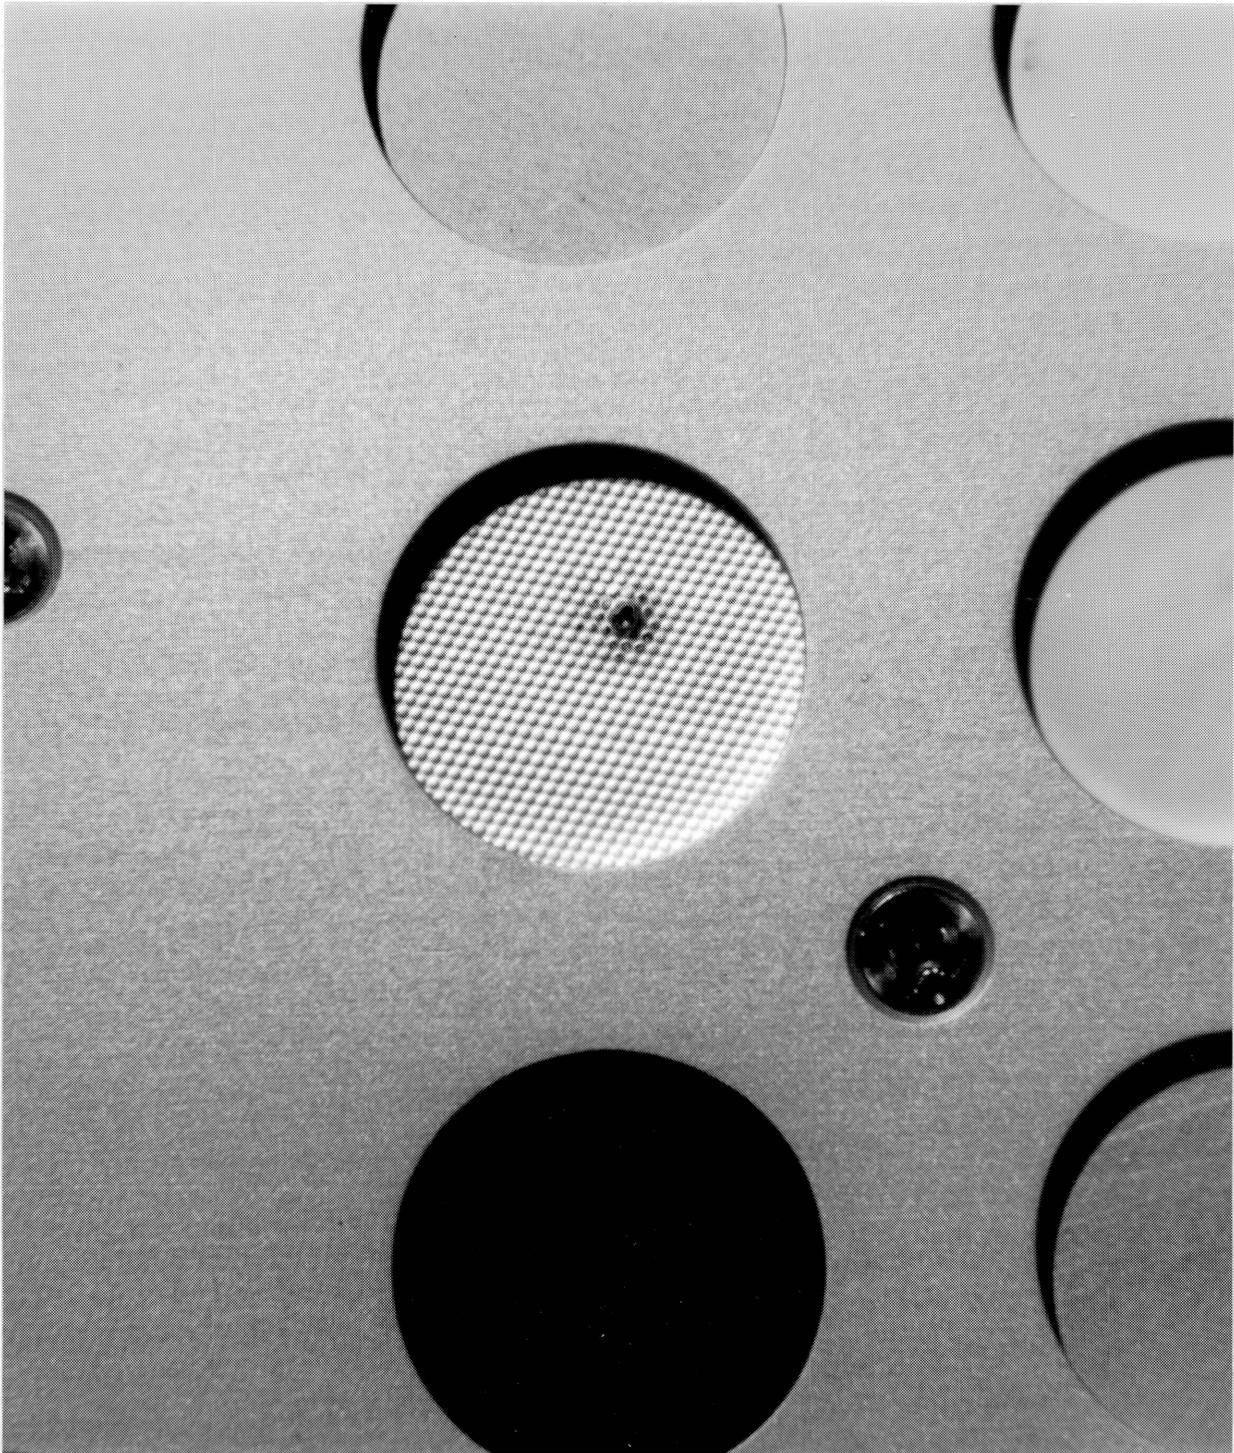
Figure B09-3. This view illustrates impact features in two materials from the bottom of Tray B09. View measures approximately 4 cm across.

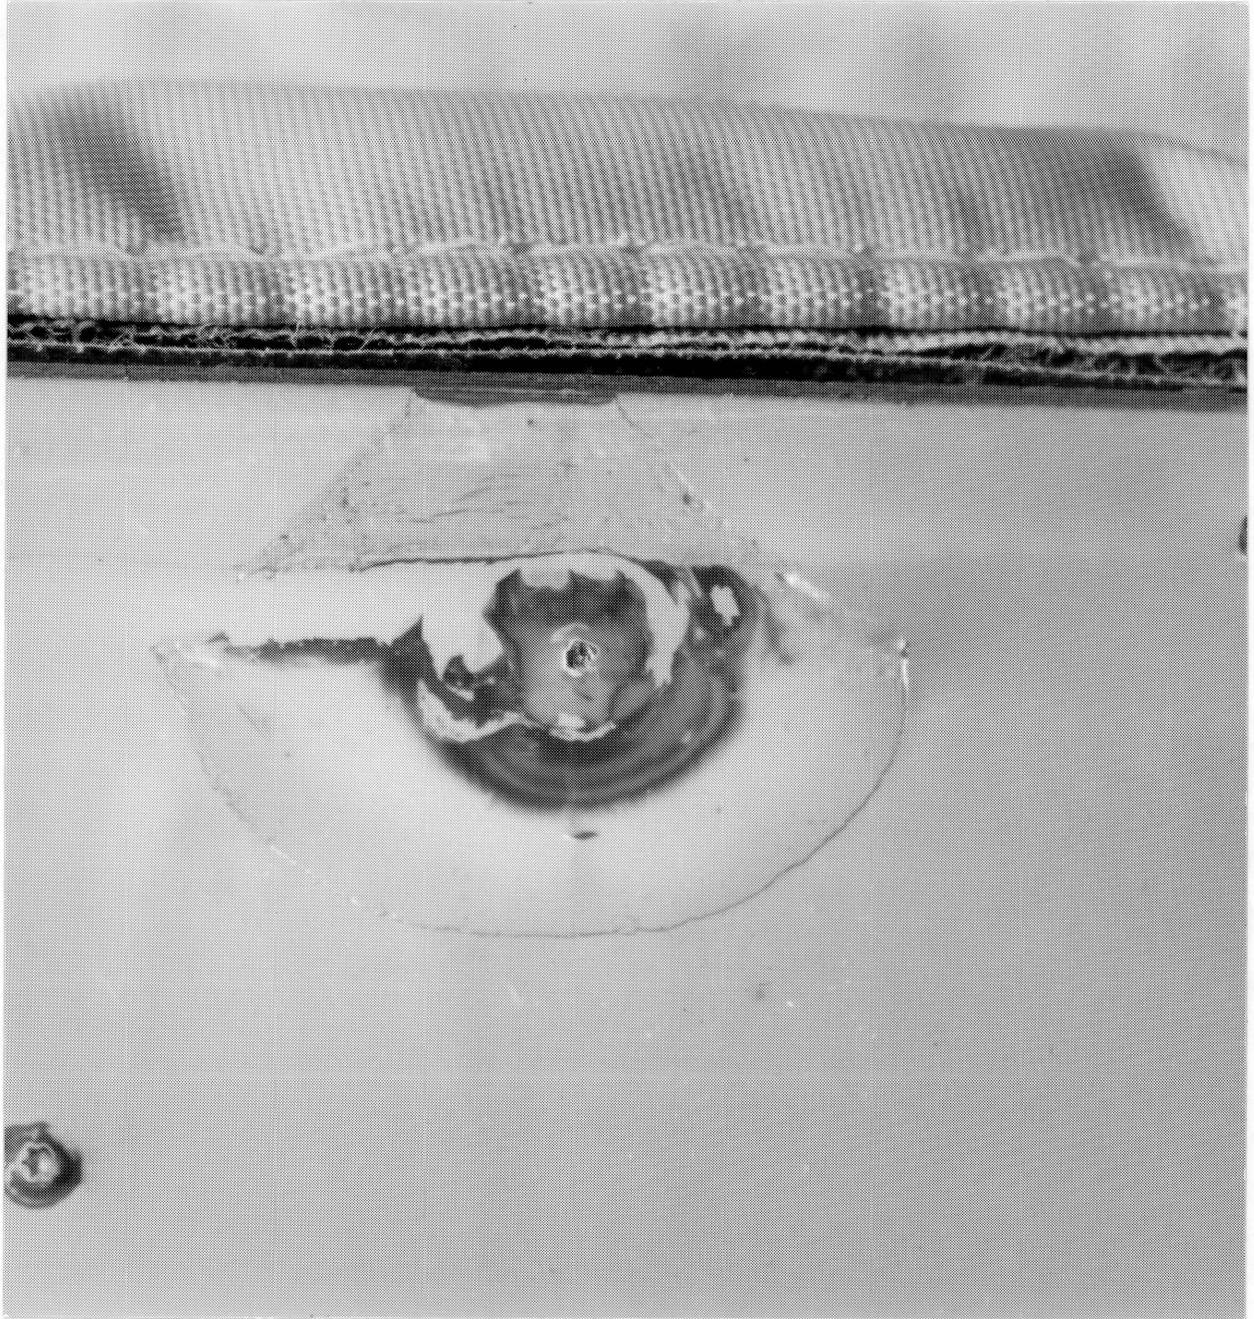
Figure B10-2. This is a view of a large impact with spall across one of the heat-pipe covers. View measures approximately 4 cm across.
