METEOROID AND DEBRIS IMPACT FEATURES DOCUMENTED ON THE LONG DURATION EXPOSURE FACILITY

A Preliminary Report

Compiled by Members
of the LDEF Meteoroid
and Debris Special
Investigation Group

August 1990

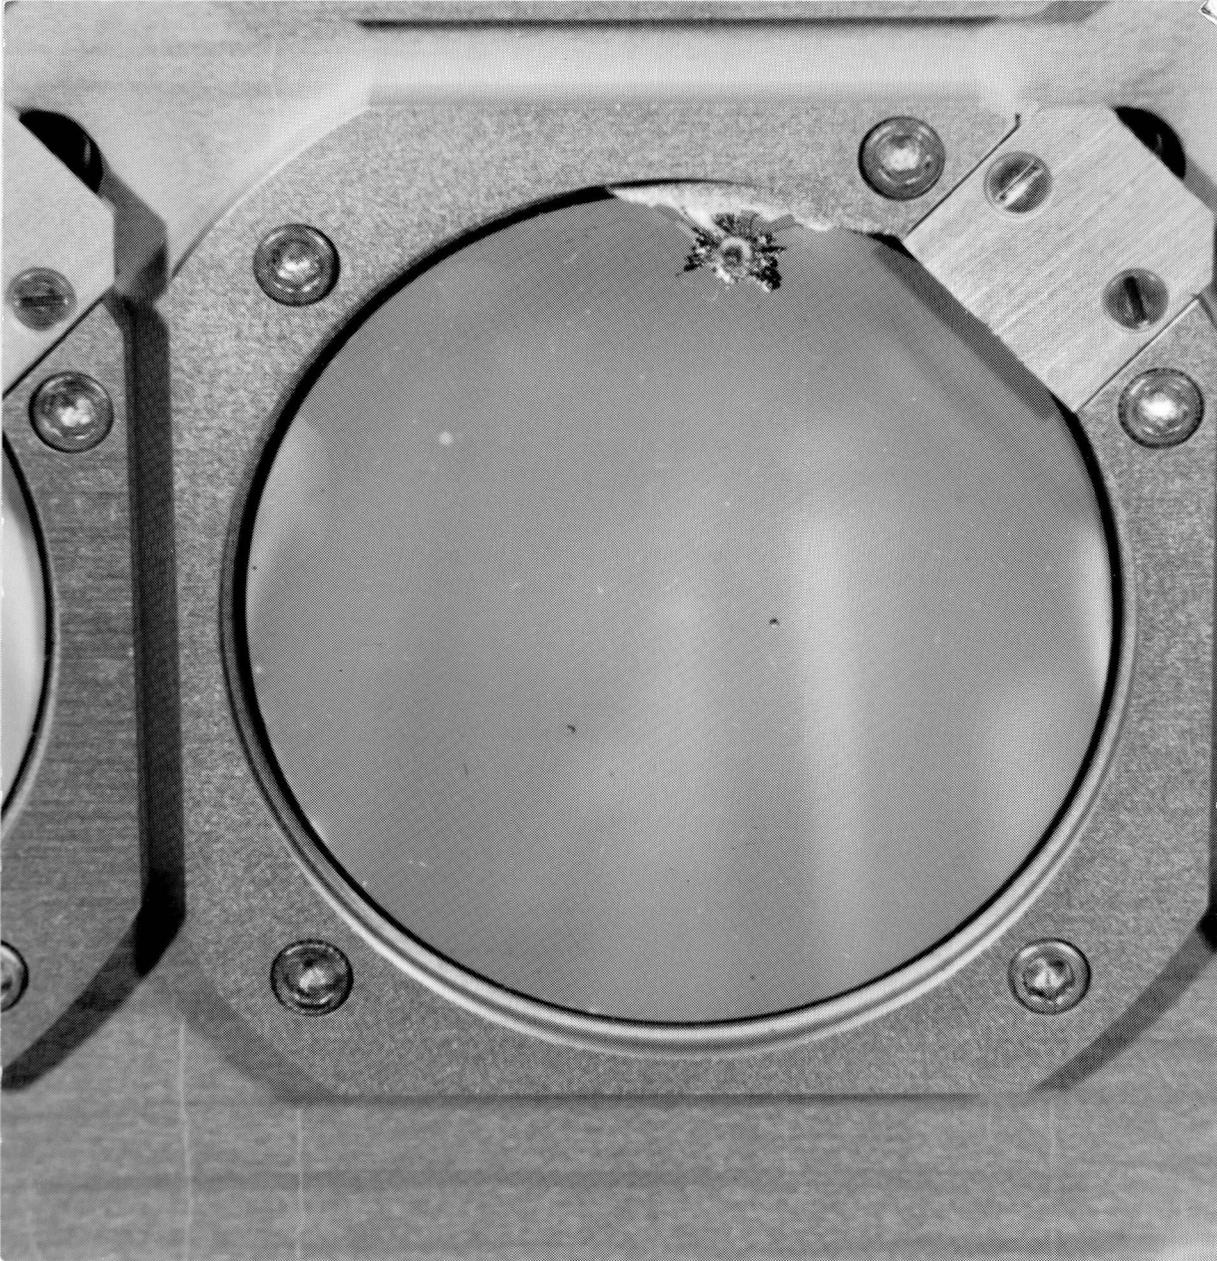
Figure B12-2. This is a view of impact feature #17, with associated shattering, onto a MOS detector. View measures approximately 9 cm across.

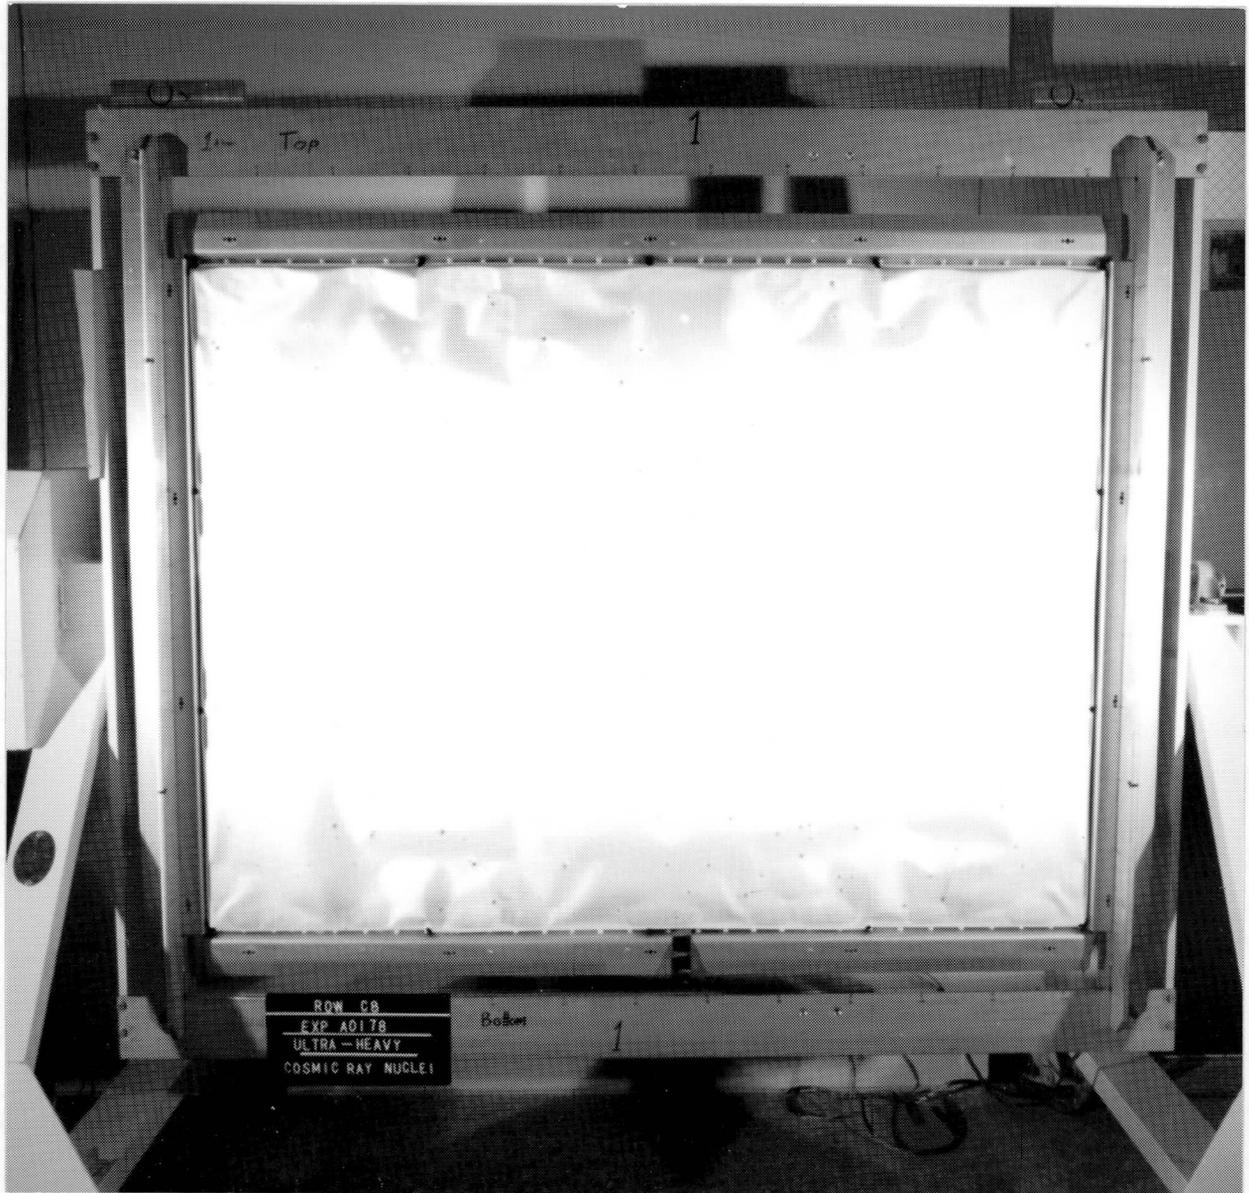
Figure C08-1. This post-deintegration view shows the front of the entire C08 experiment thermal blanket. Oxygen erosion has given this blanket a frosted appearance. The large impact (#94, with a streak) on the lower right is shown in Figure C08.

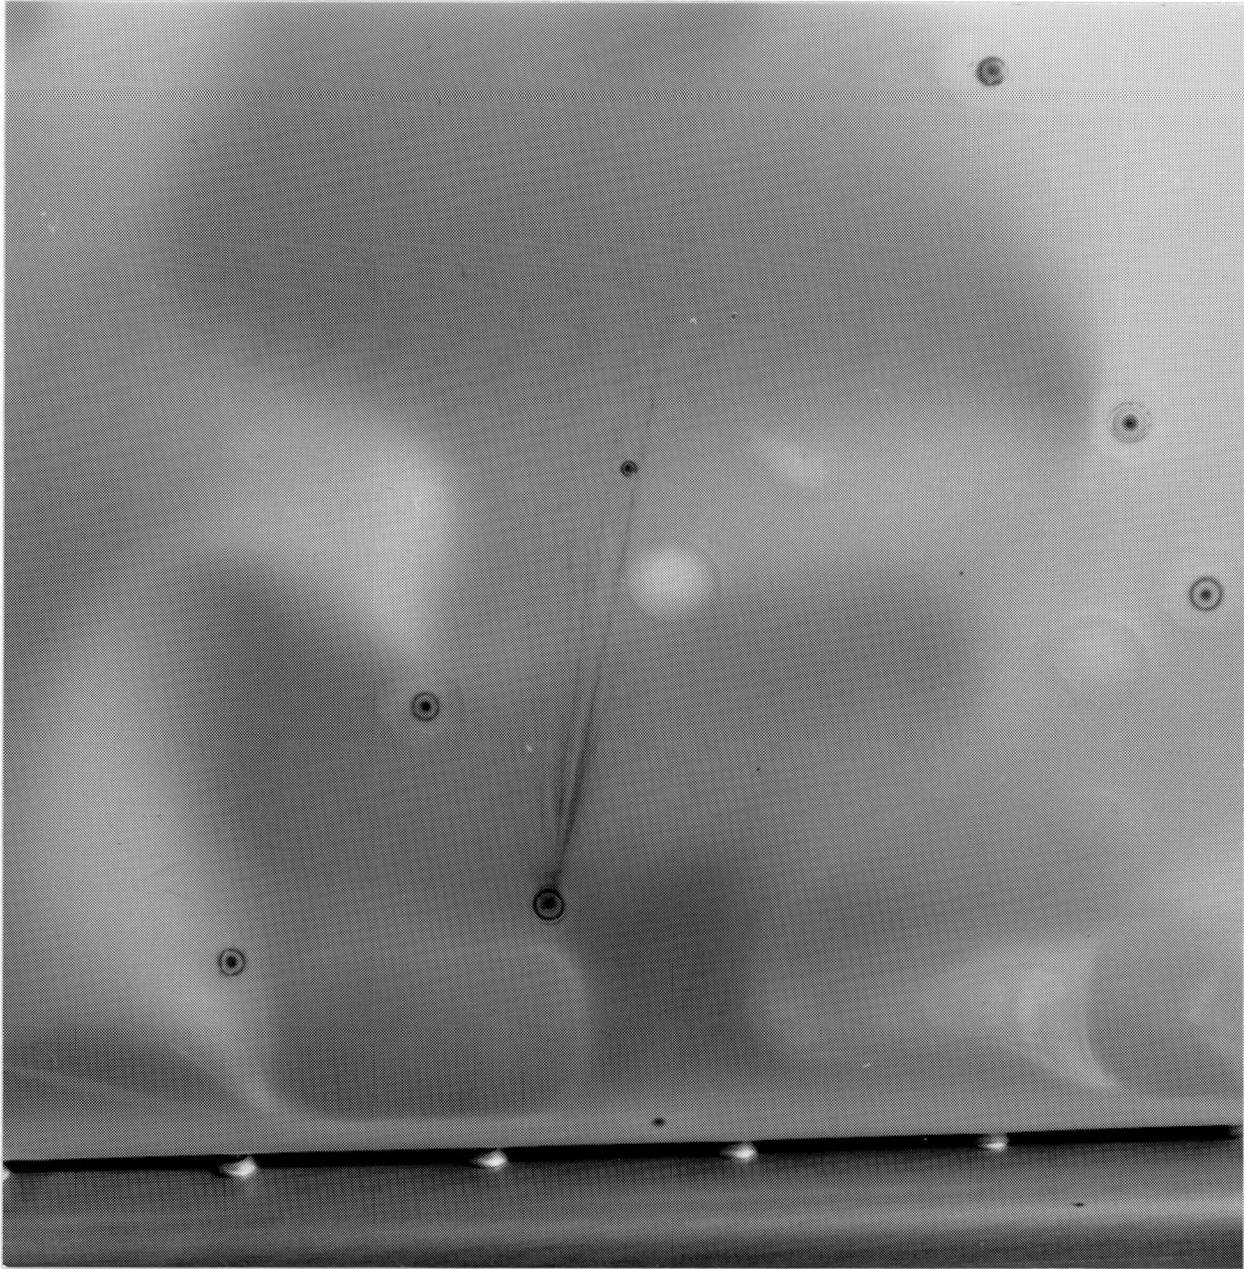
Figure C08-2. This view shows several impact penetrations on C08, most with rings and delamination areas. A large streak of impact-related origin accompanies feature #94. View measures approximately 21 cm across.

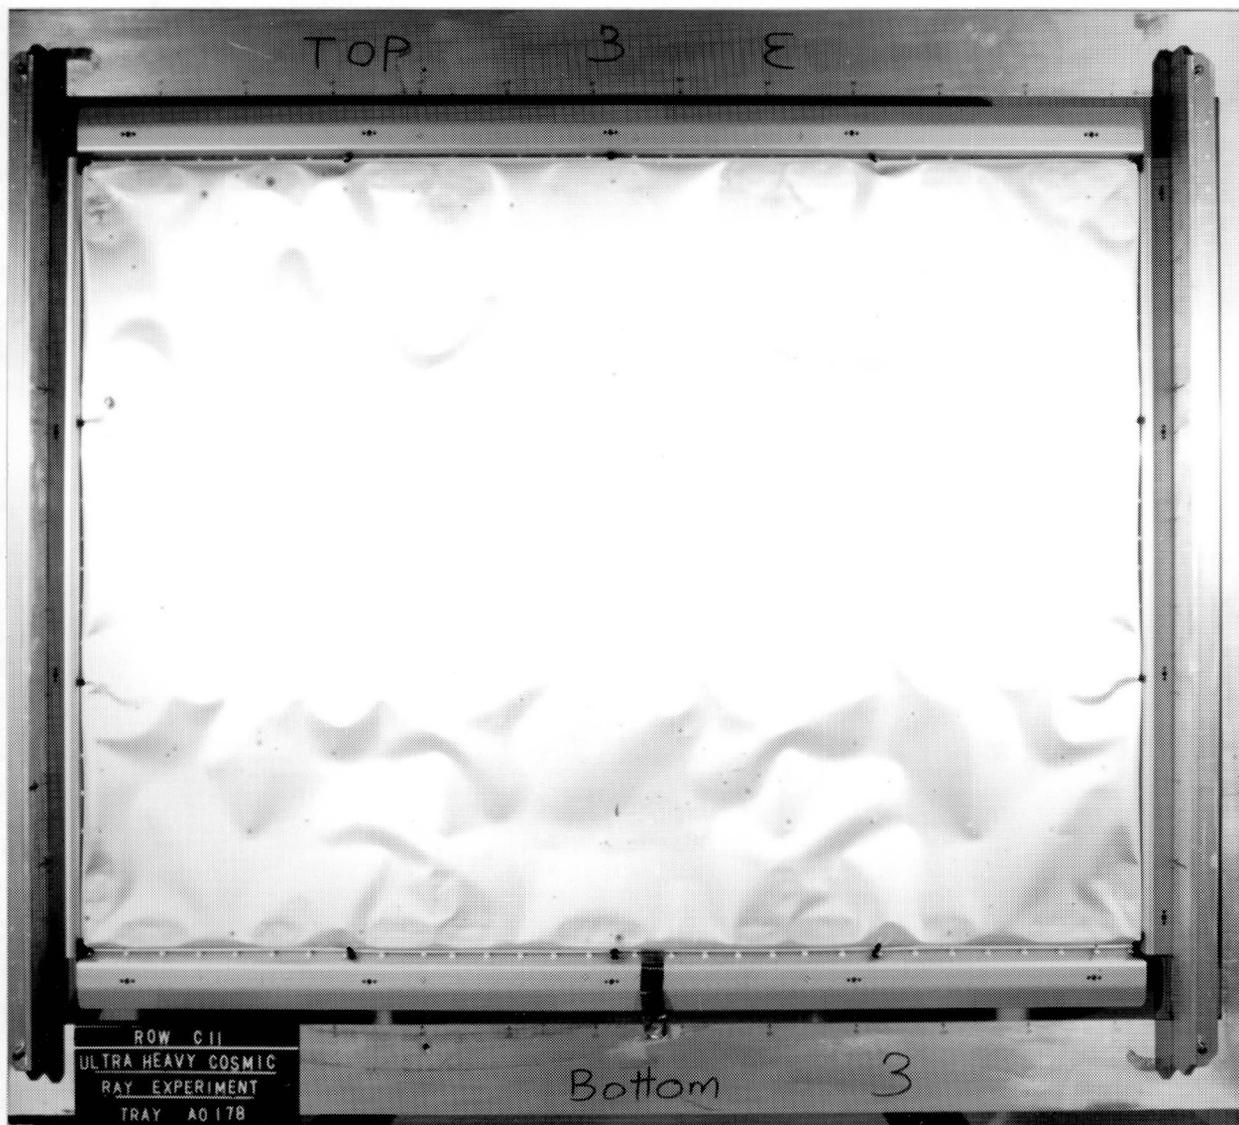
Figure C11-1. This post-deintegration view shows the front of the entire C11 experiment thermal blanket. Oxygen erosion has given the blanket a frosted appearance. The double impact feature in the center of the blanket is shown in Figure C11.

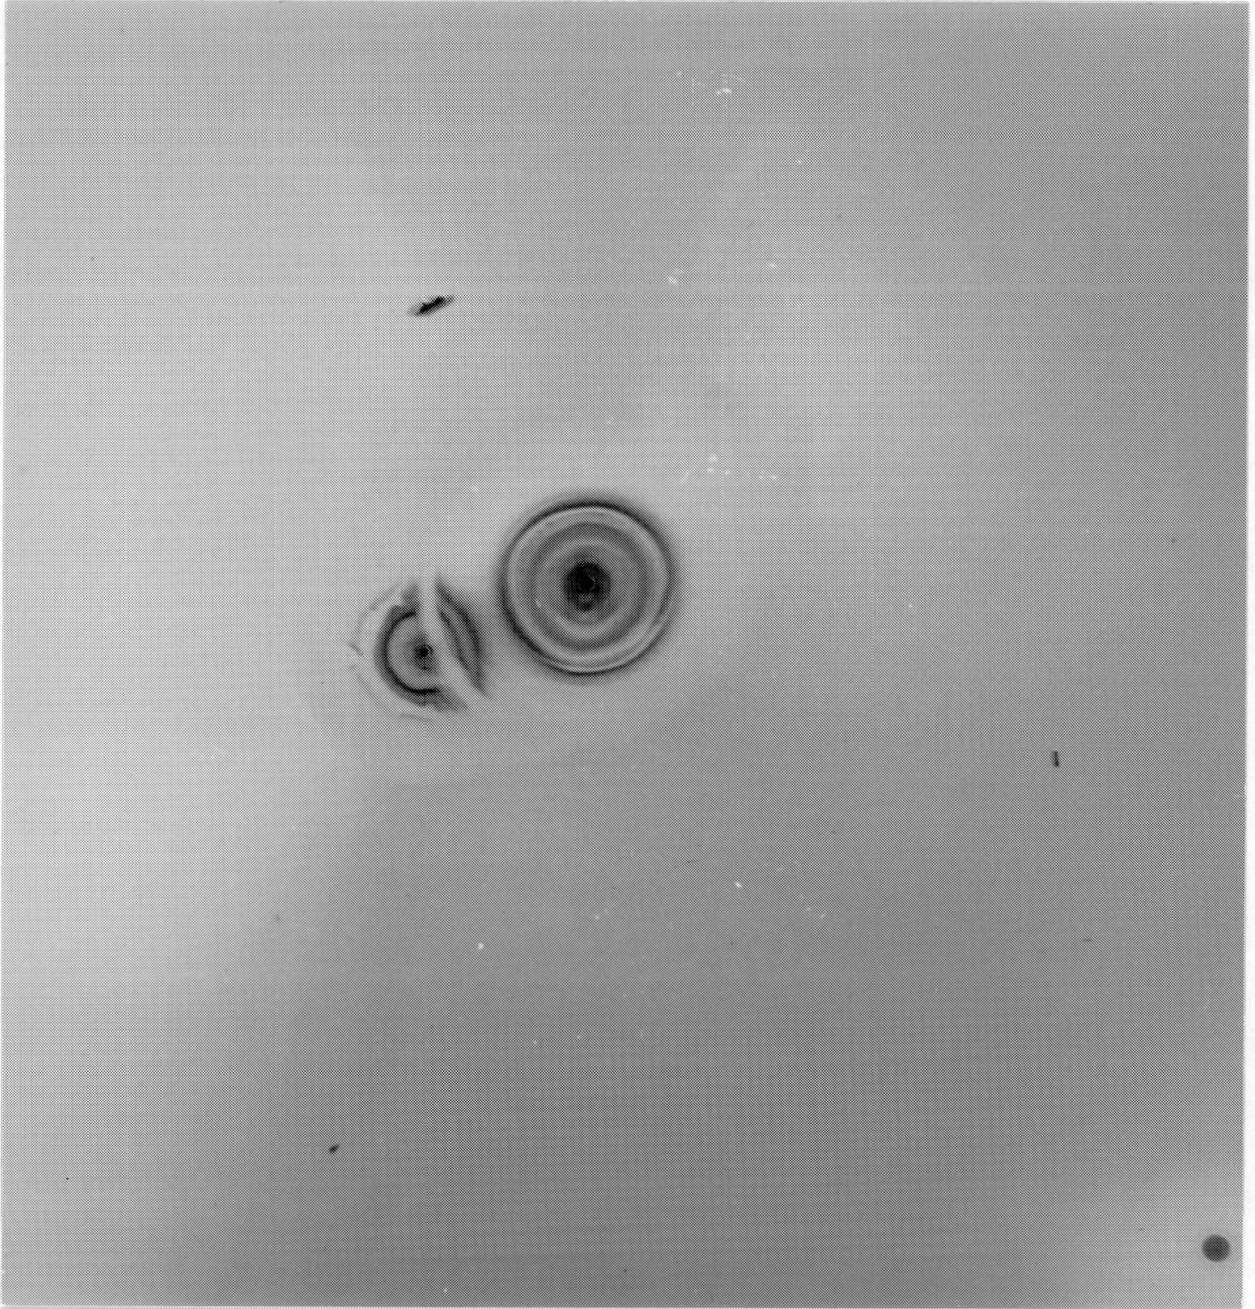
Figure C11-2. This is a pair of impact penetration features on the C11 thermal blanket, both with concentric rings. The rings of the smaller feature are incomplete, possibly related to the formation of the larger impact feature. View measures approximately 9 cm across.

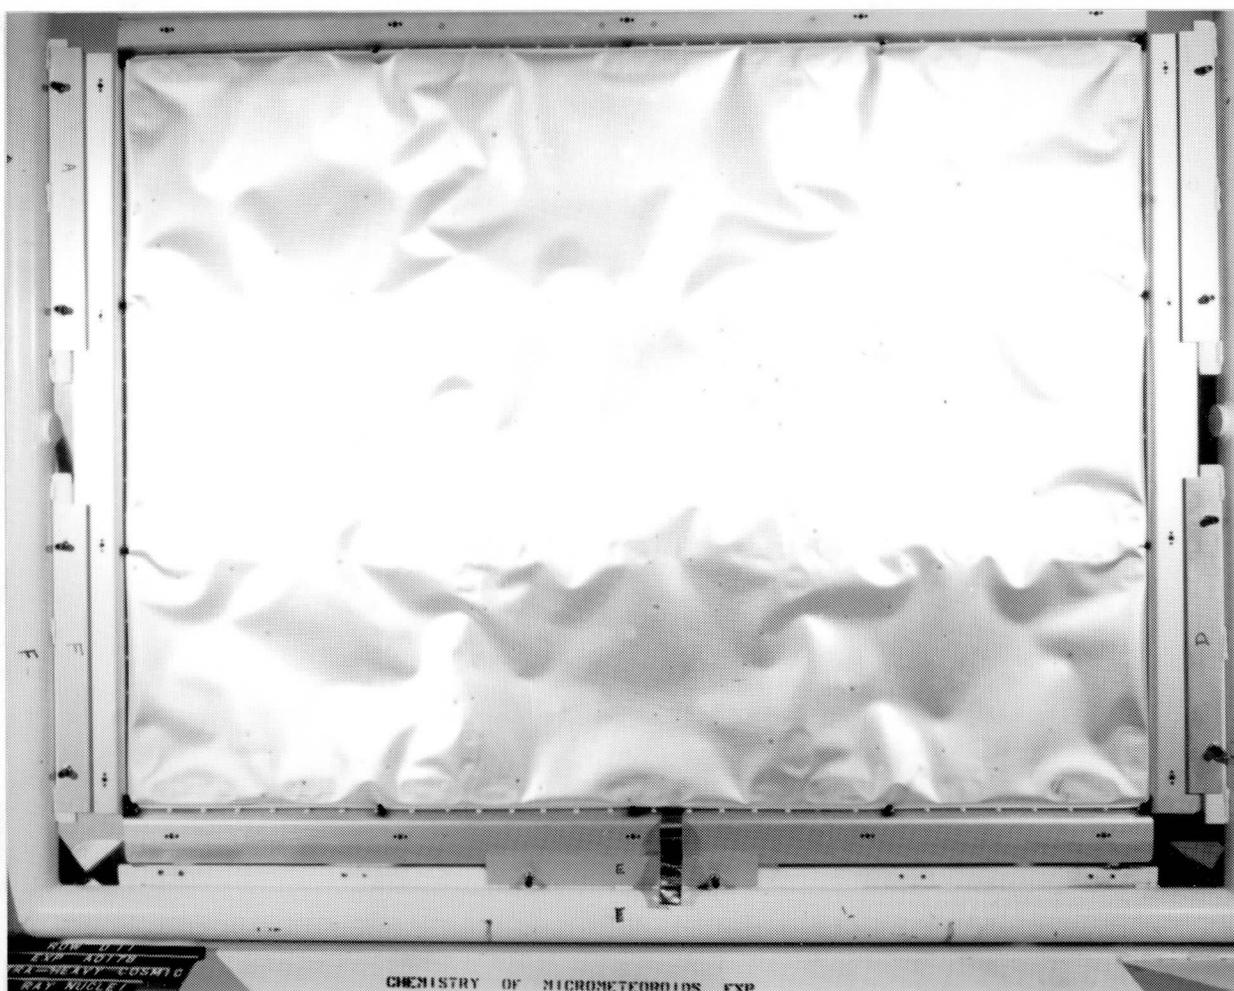
Figure D11-1. This post-deintegration view shows the front of the entire D11 experiment thermal blanket. Some impact features are apparent.

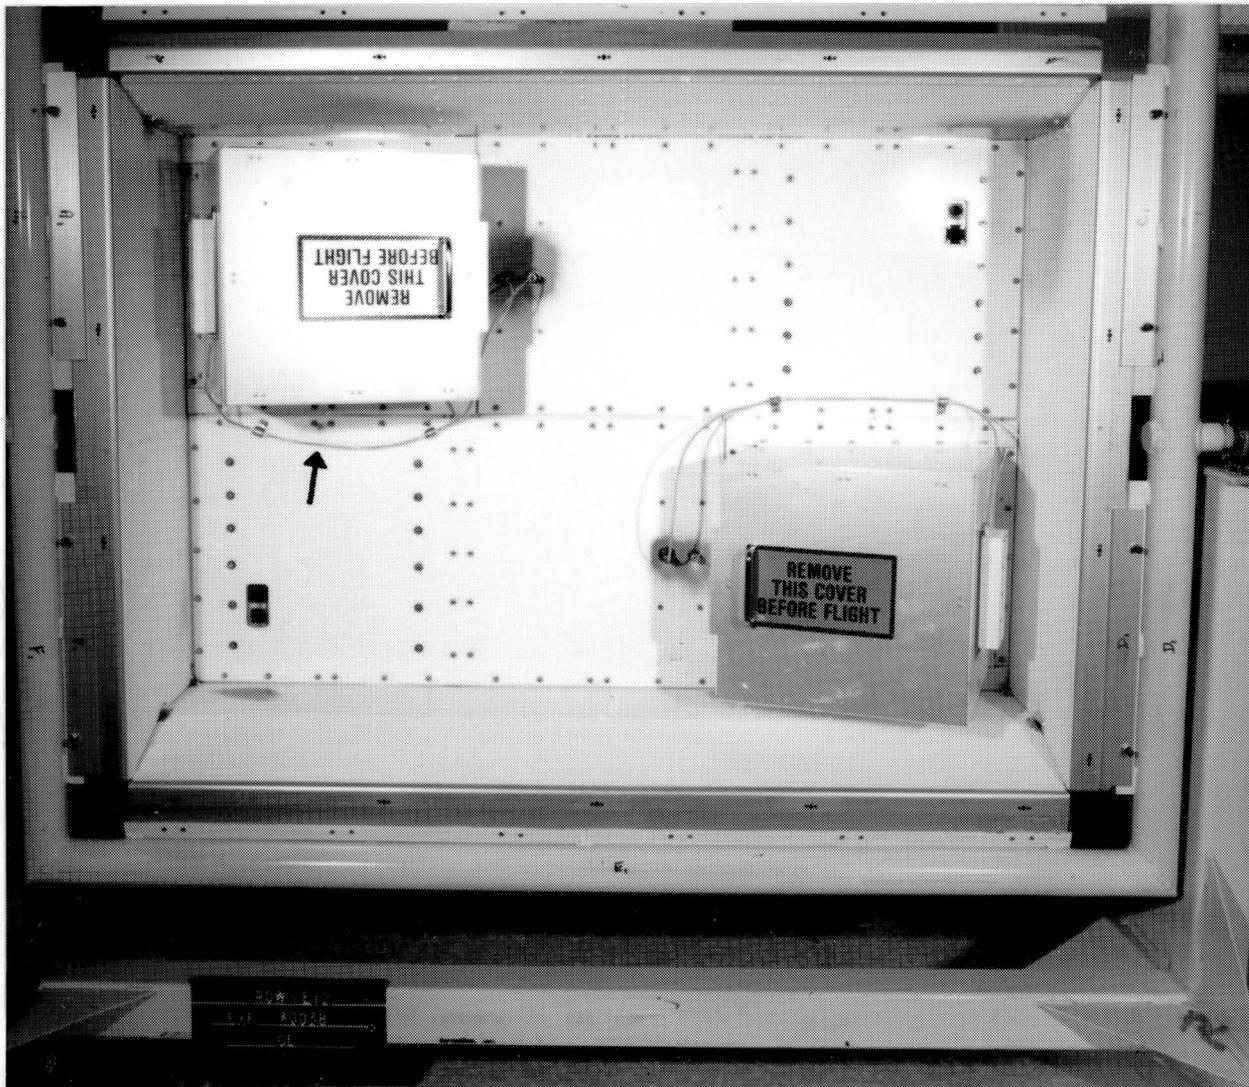
Figure E12-1. This post-deintegration view shows the front of the entire E12 experiment tray. The space-exposed interstellar gas collector foils have been covered in this view. An arrow points to the impact feature (#8) shown in Figure E12-2.

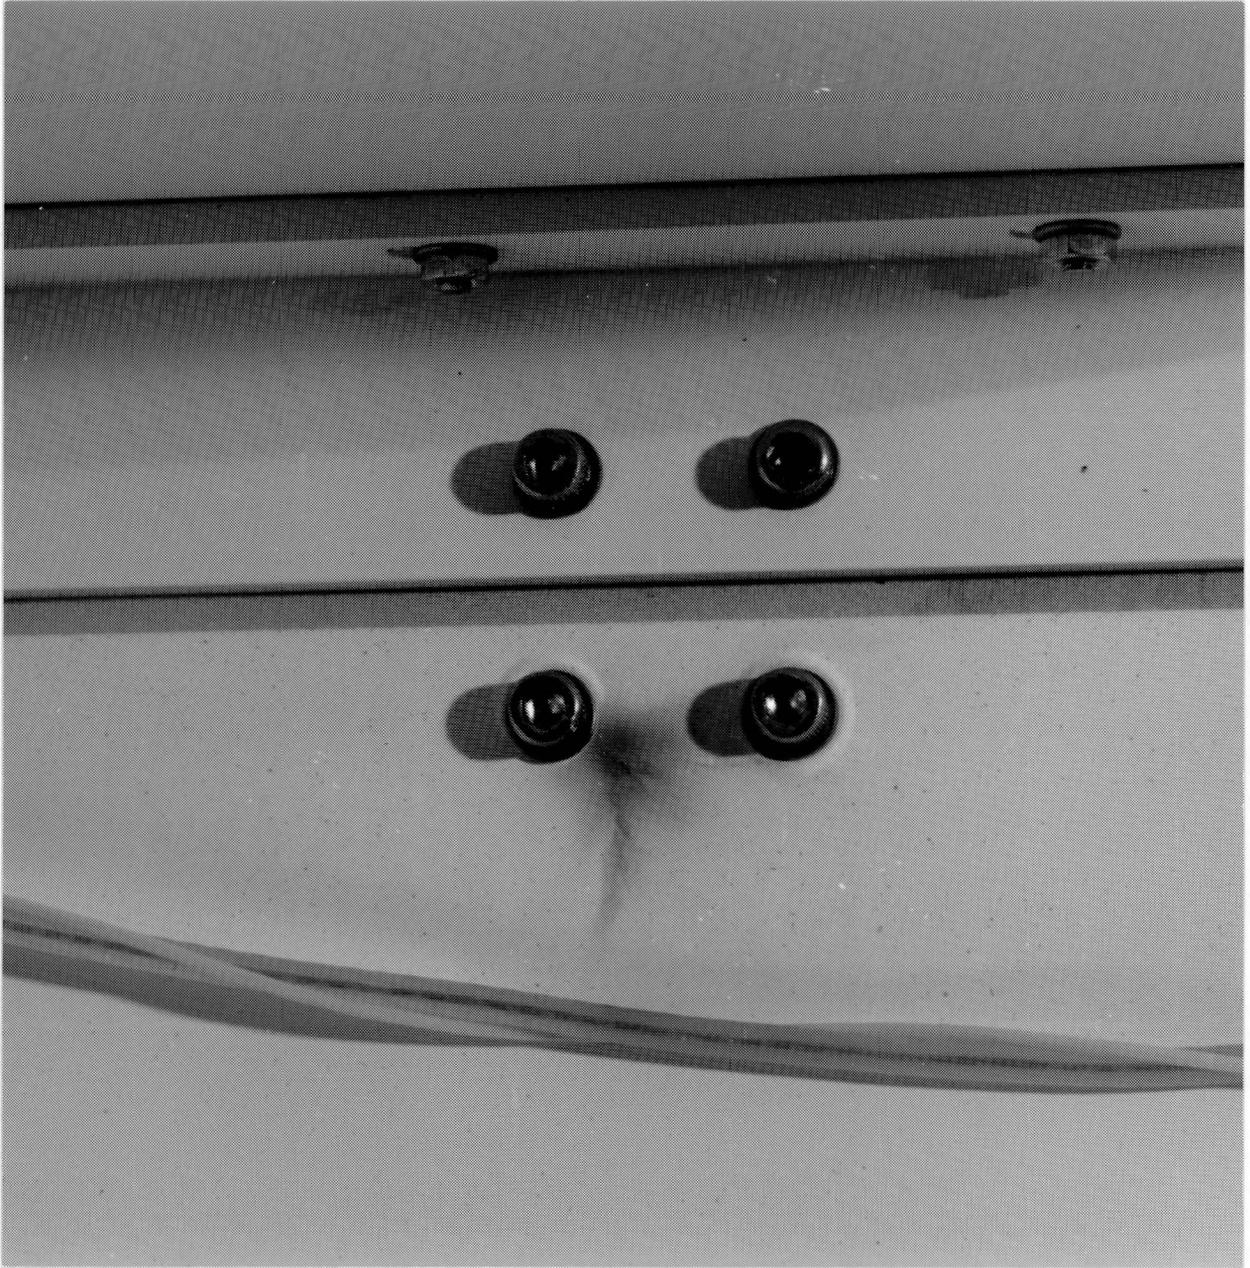
Figure E12-2. This view shows an ejecta spall pattern resulting from an impact (#8) into the lower left bolt head. View measures approximately 11 cm across.

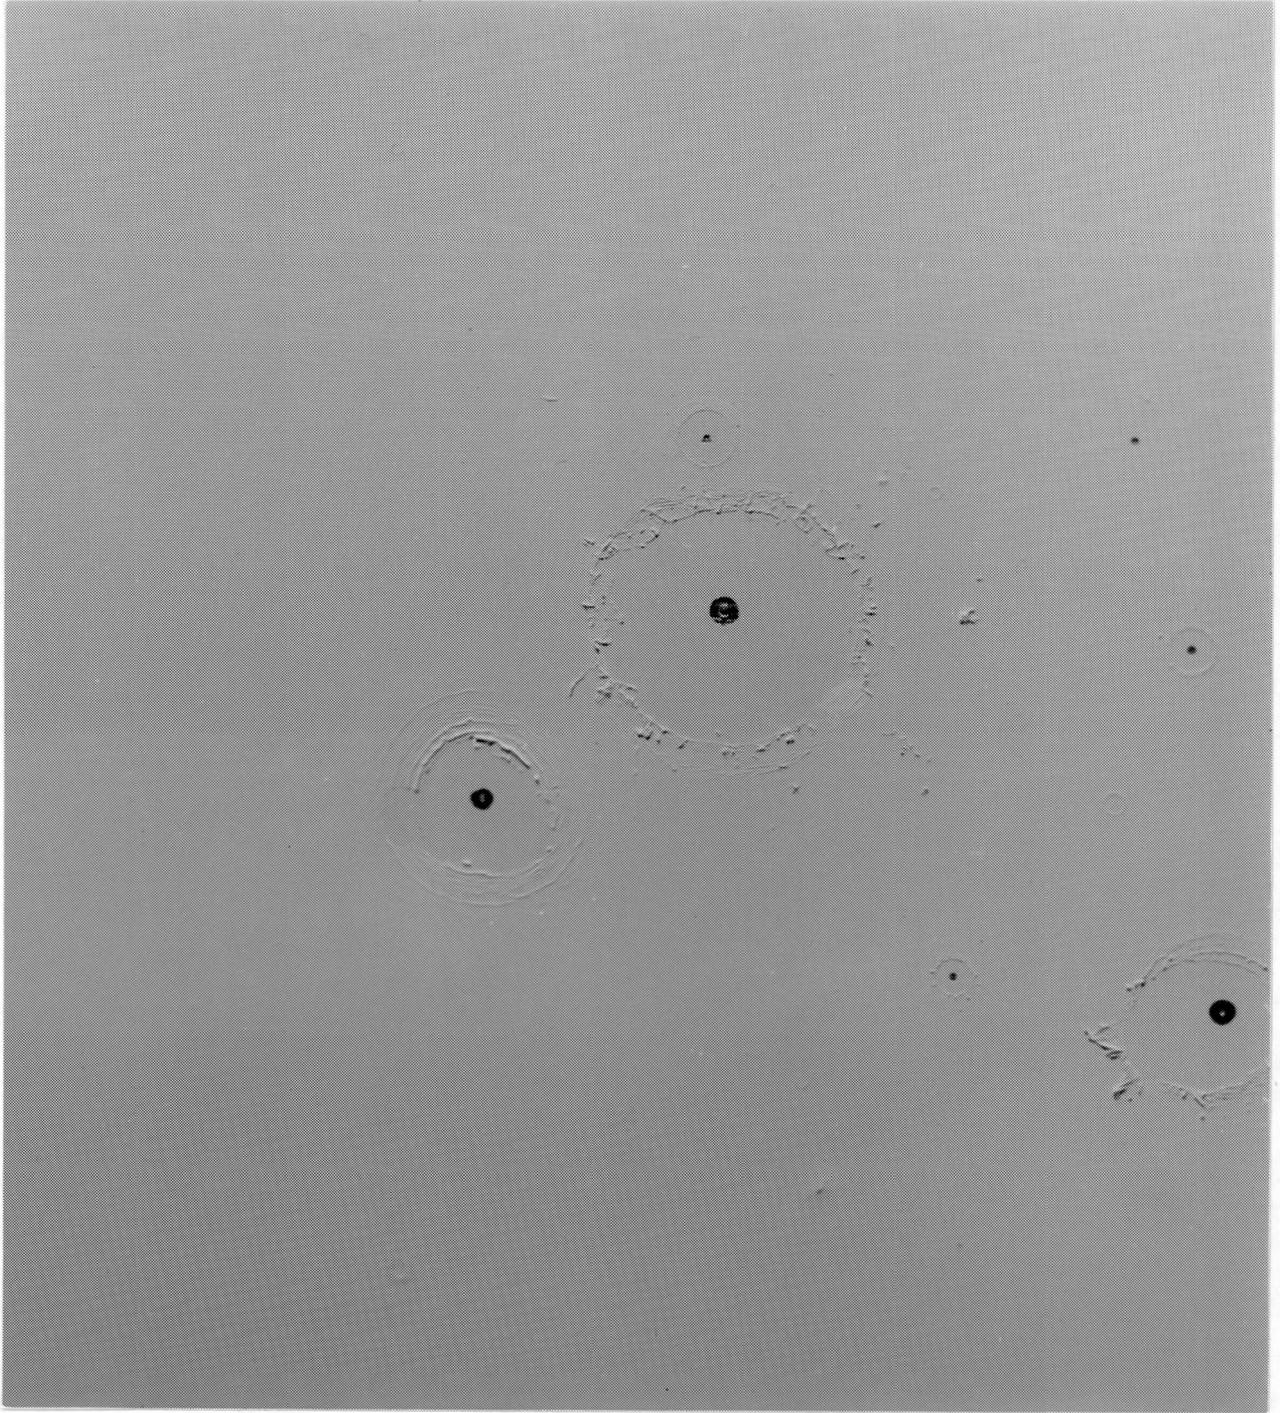
Figure F08-2. Impact features into the white-painted aluminum surface. Each crater extends through the paint into the aluminum substrate. Paint delamination features surround each impact. View measures approximately 8 cm across.

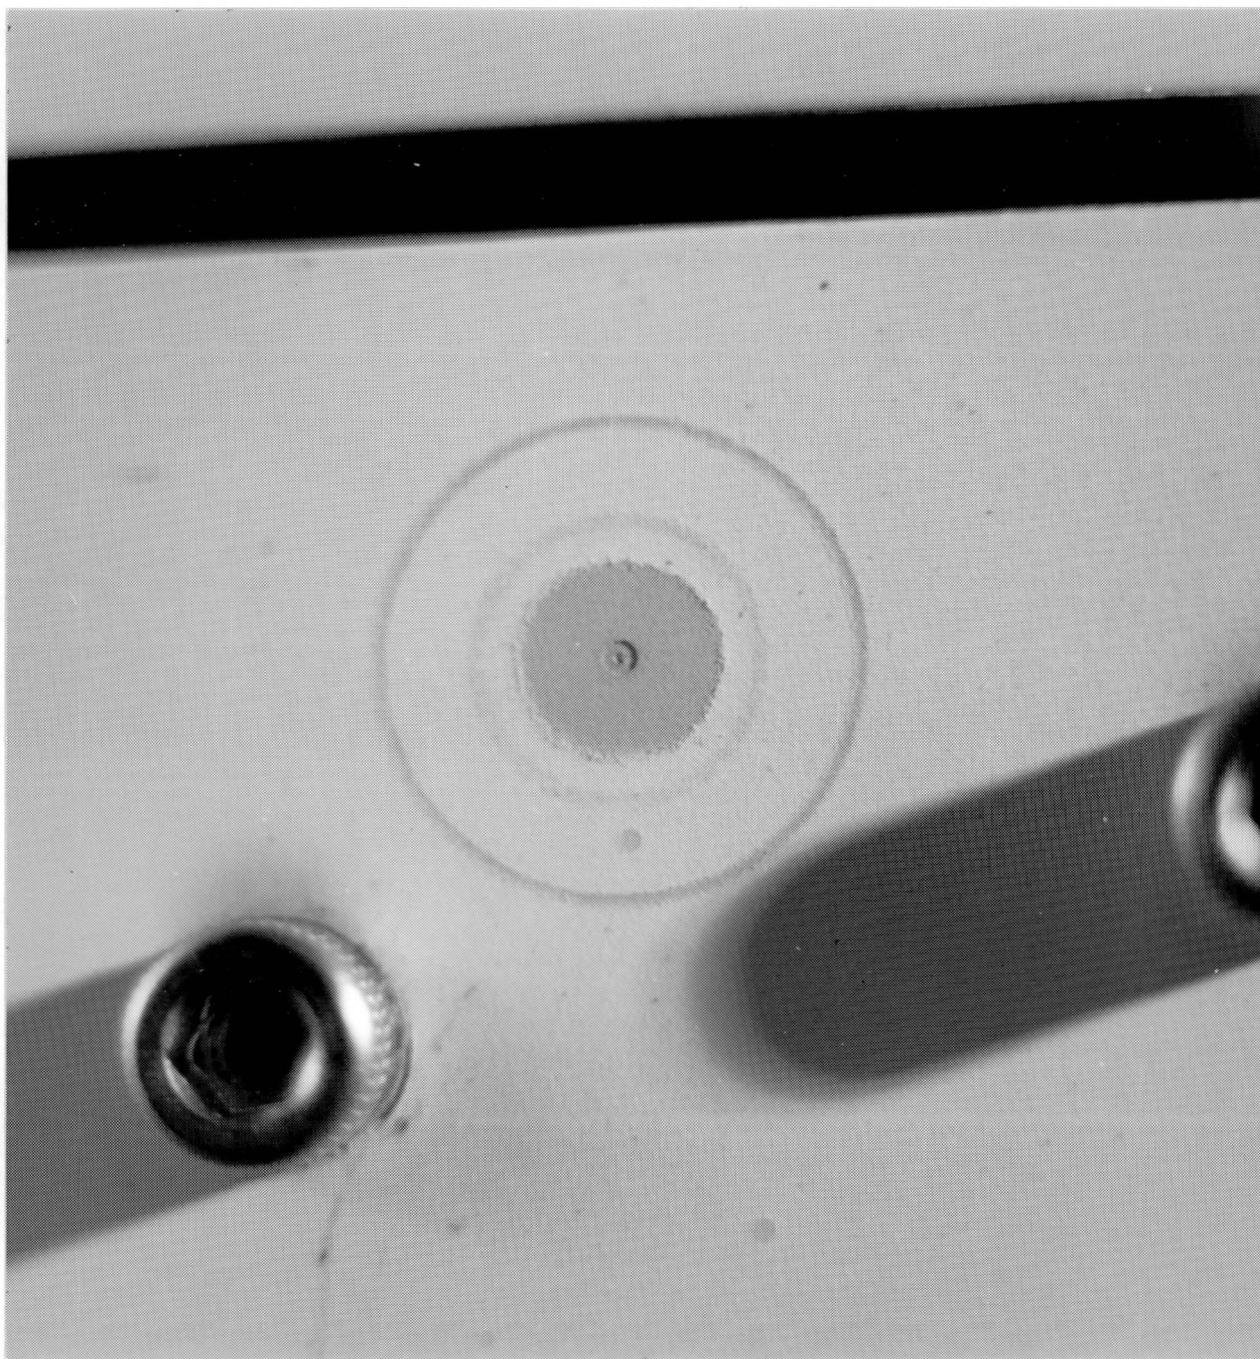
Figure F08-3. A concentrically-ringed impact feature into the white-painted aluminum surface. View measures approximately 4 cm across.

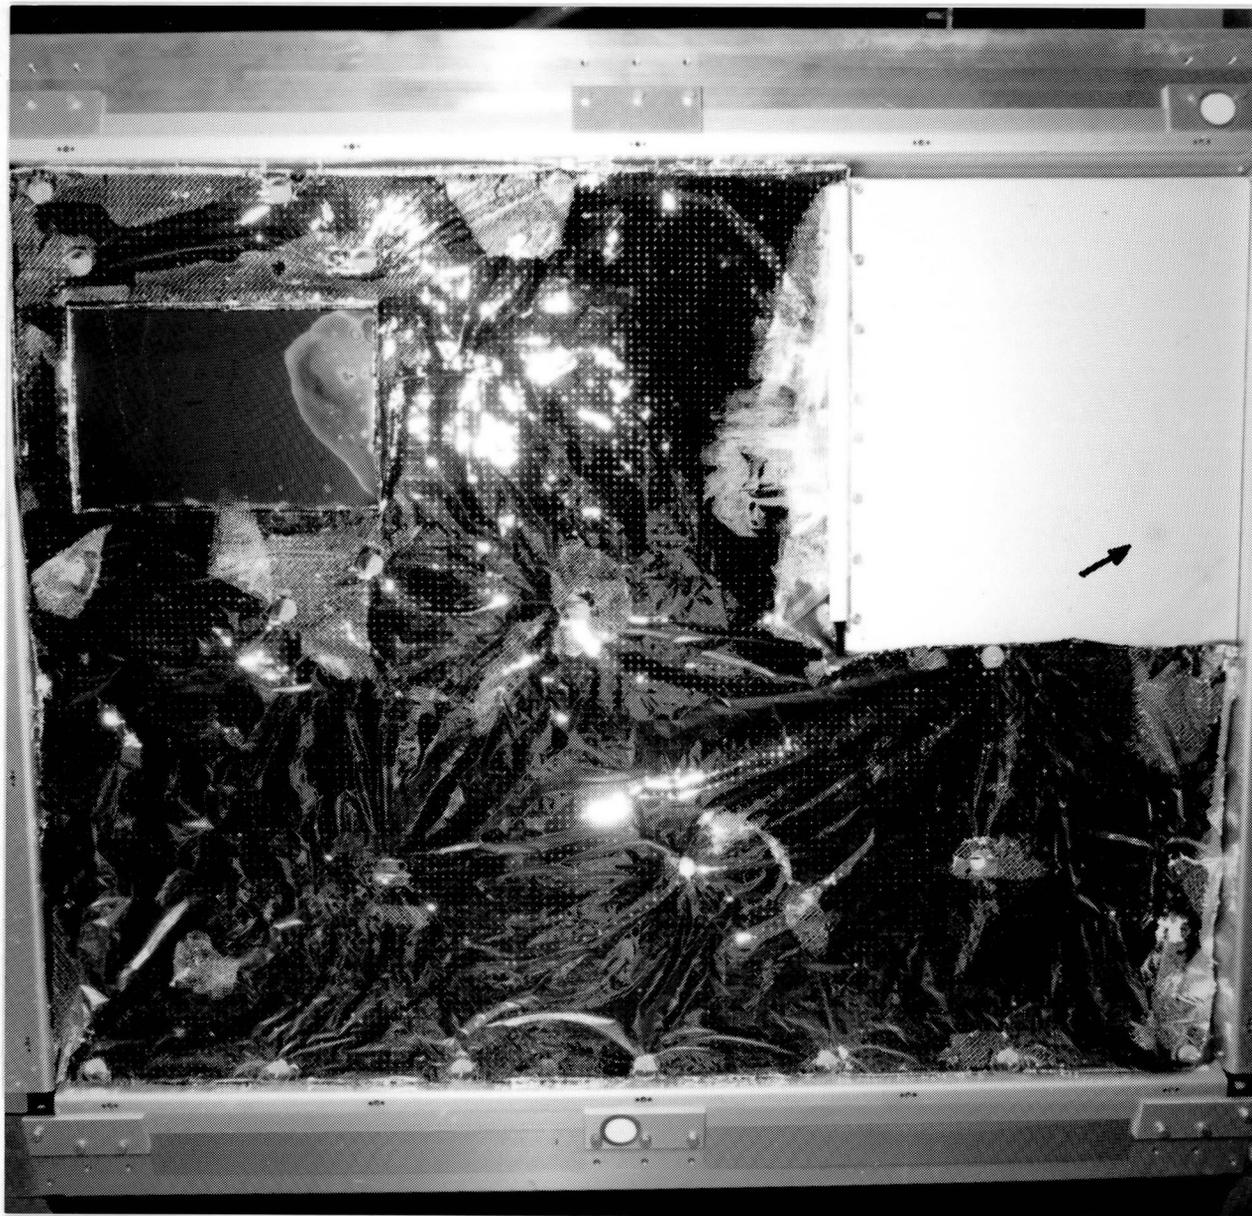
Figure F09-1. This pre-deintegration view shows the front of the entire F09 experiment tray, largely showing only the thermal blanket which remained once loosely-adhering foil samples had been removed. A arrow indicates the impact feature shown in Figure F09-2.

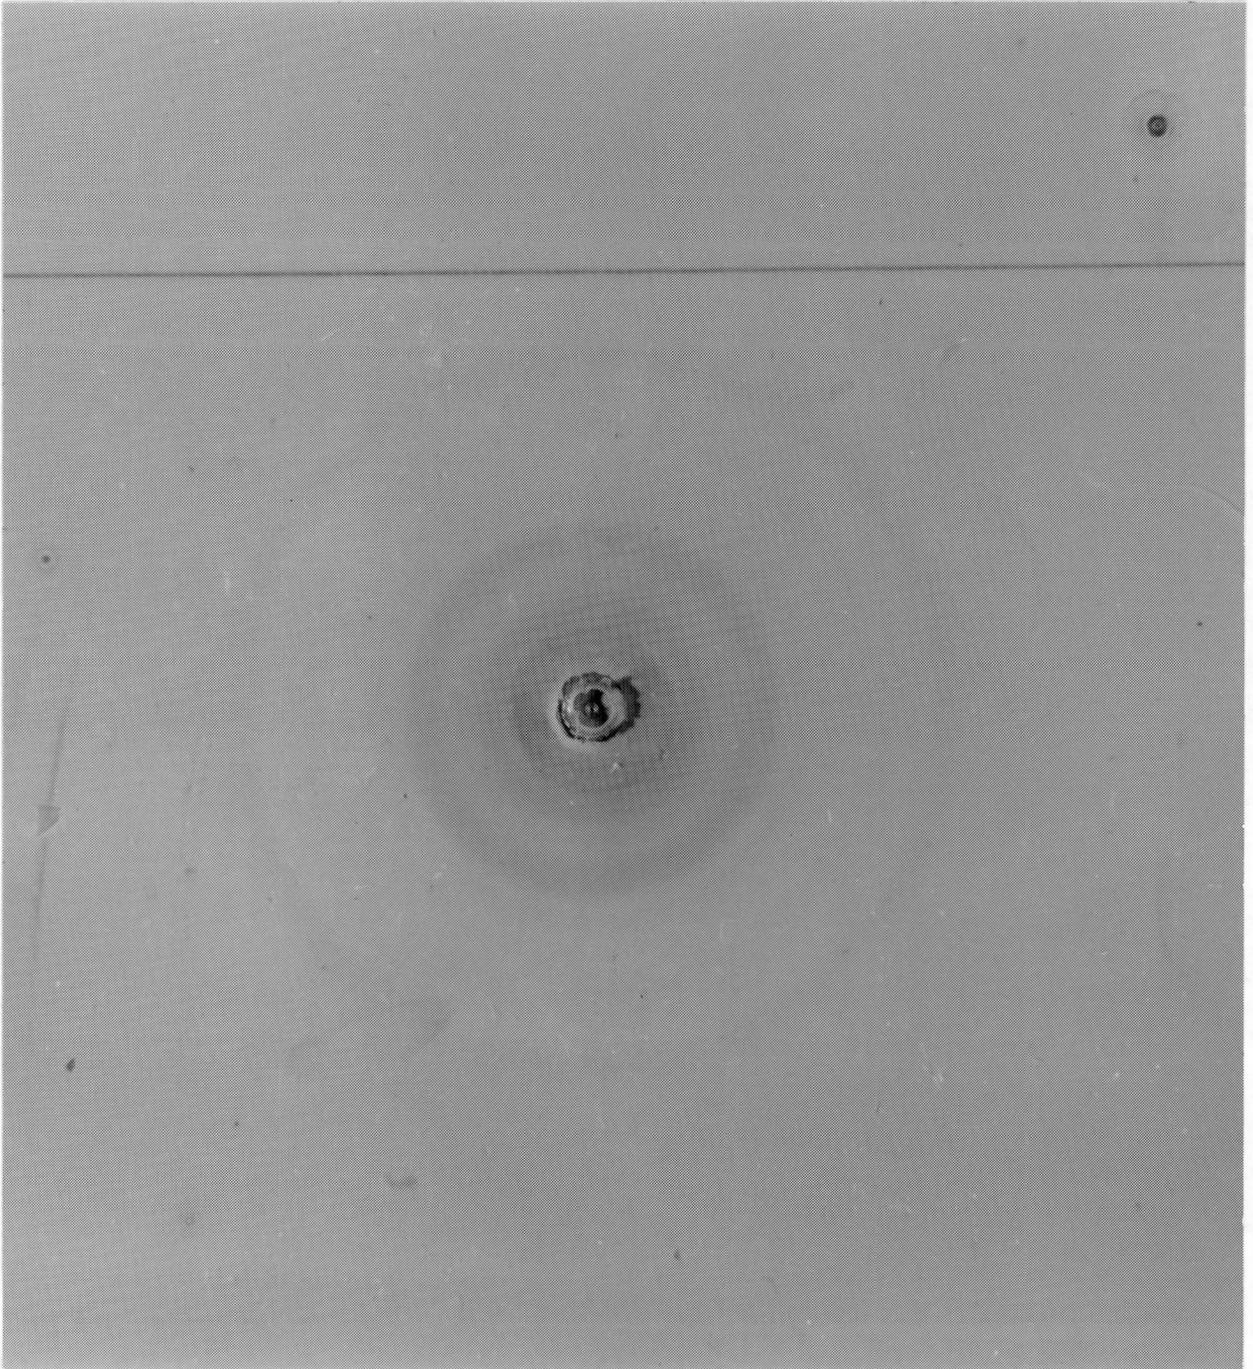
Figure F09-2. A concentrically-ringed impact feature into the white-painted aluminum surface. View measures approximately 8 cm across.

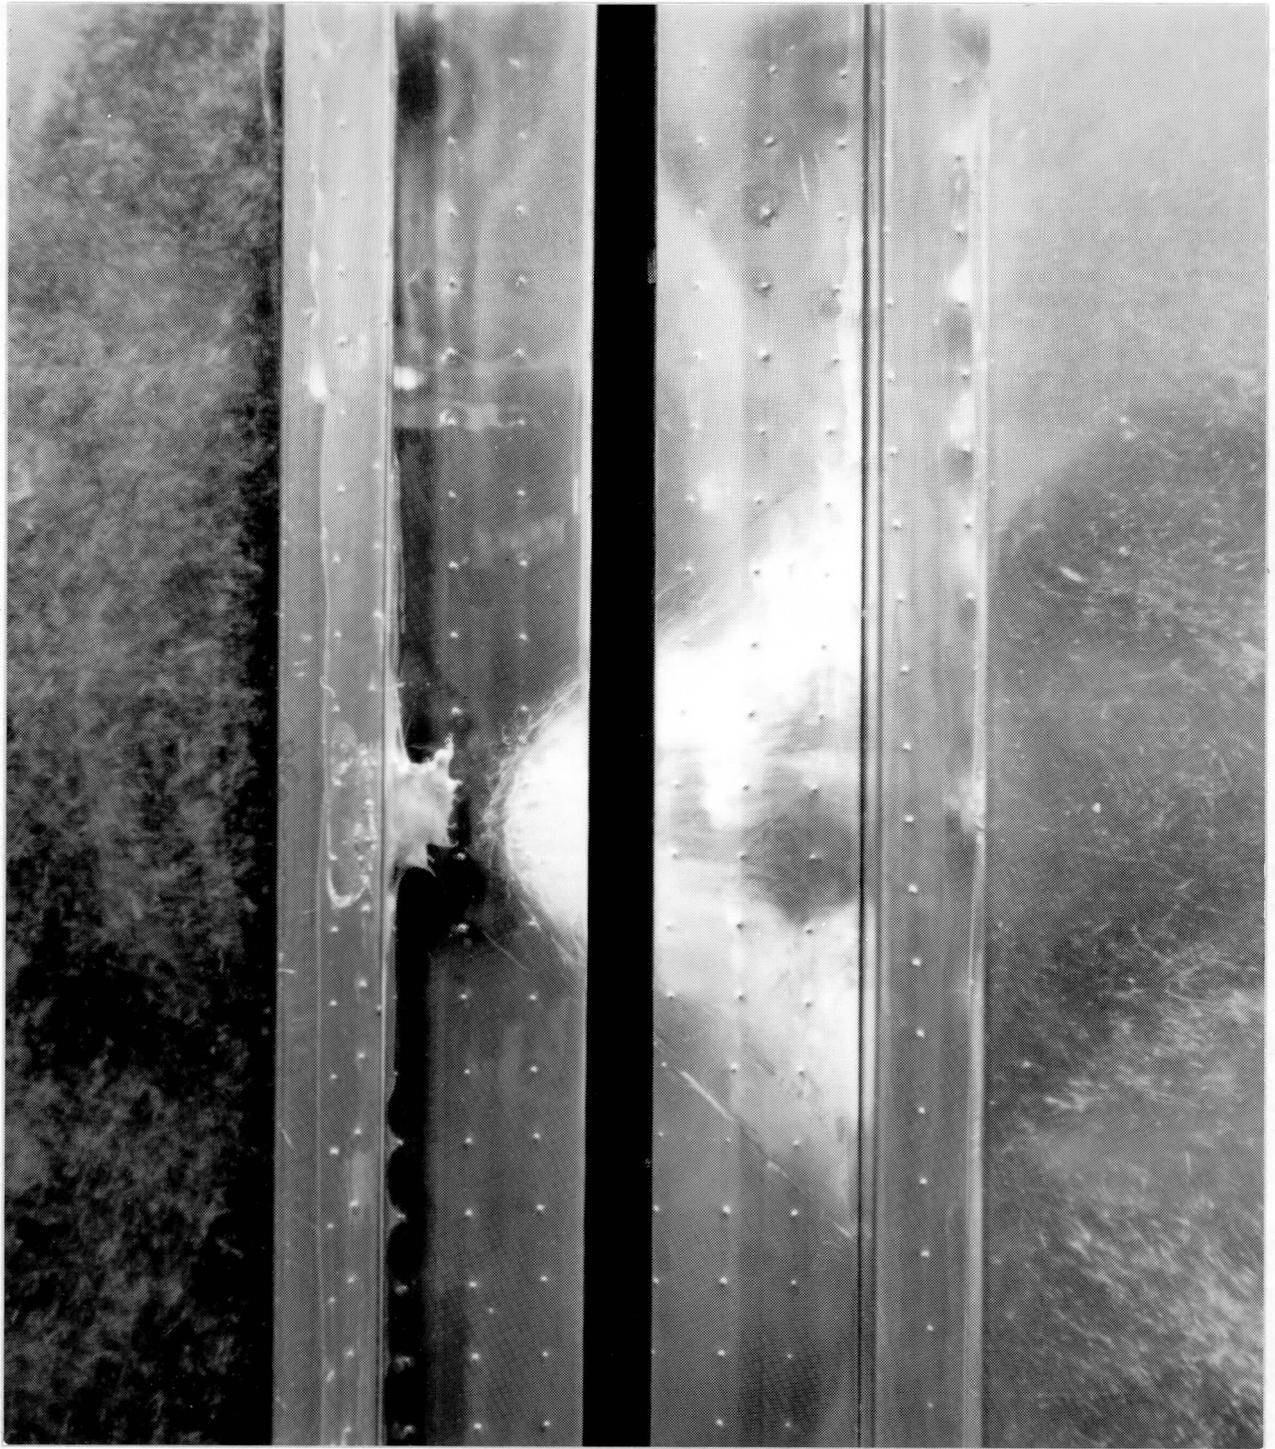
Figure H03-3. This is a side view of the largest impact feature on LDEF (LE000007.H03). The impactor hit the right side of the aluminum Z-frame on the left (Module "A"), and ejecta was deposited across the intervening space to the adjacent Z-frame on the right (Module "D"). This view measures approximately 10 cm across.

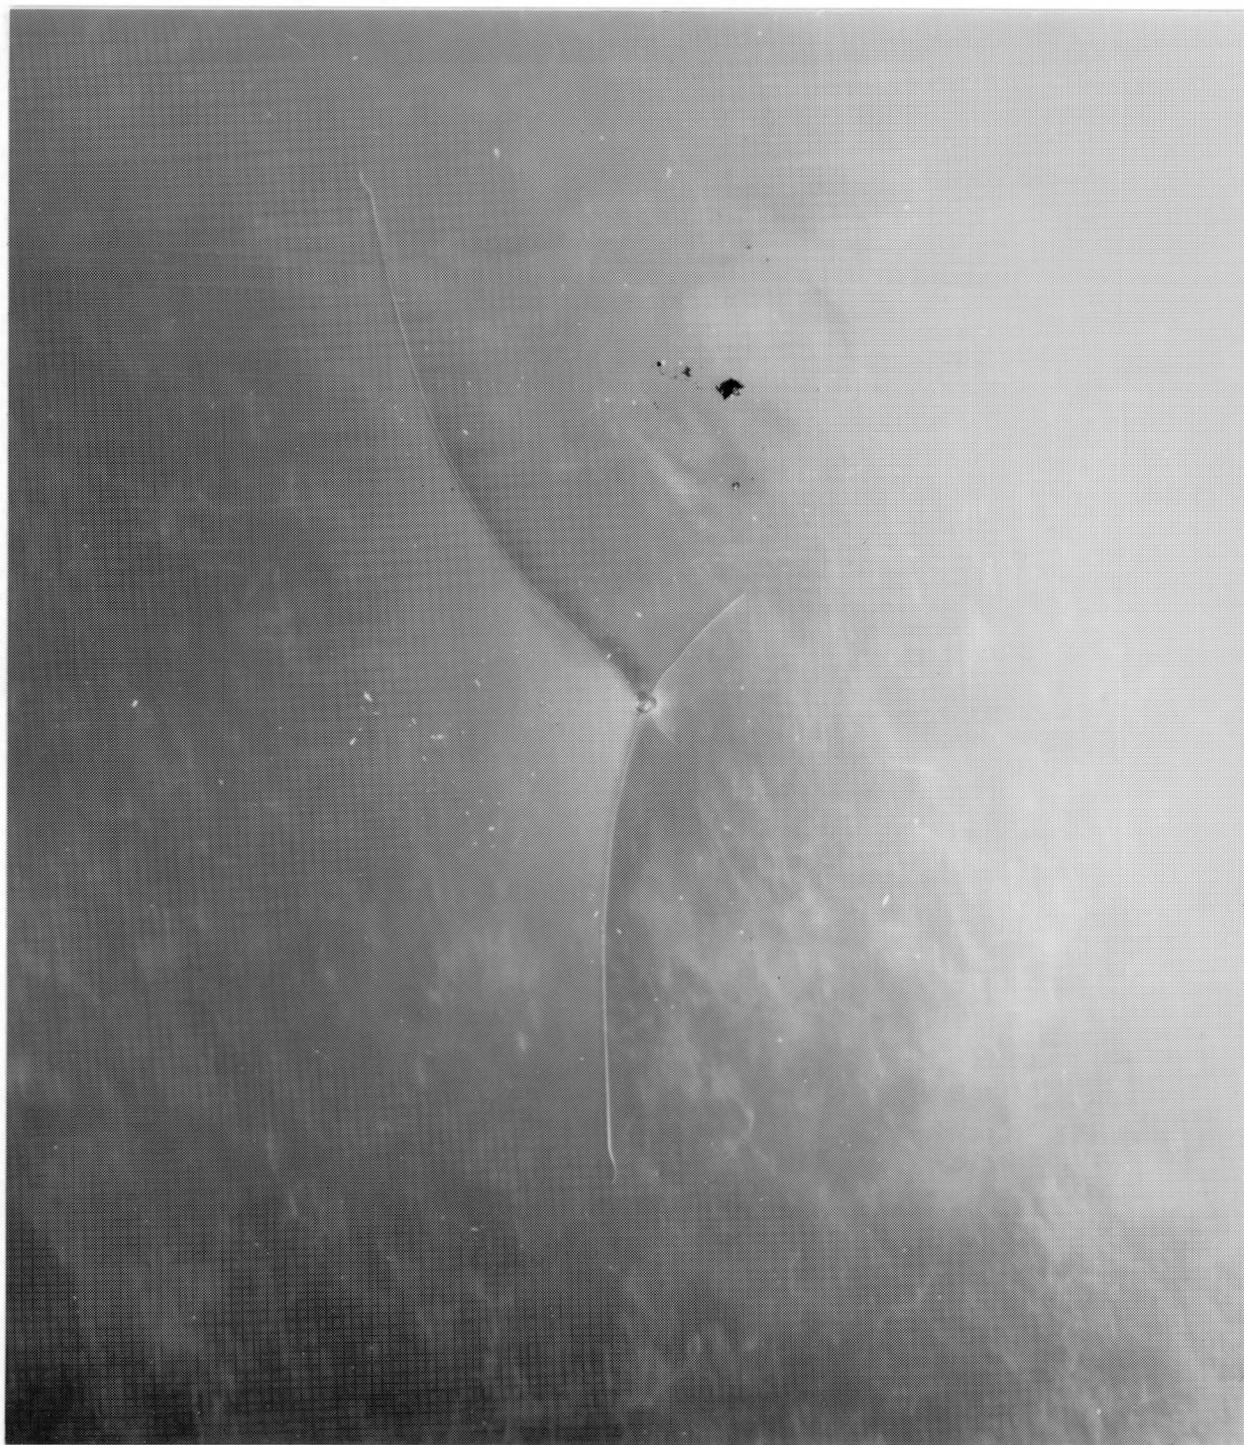
Figure H03-4. This view shows an impact penetration located in lexan detector stack "D", in a place where the thermal blanket had peeled back and exposed the lexan to the particulate environment. The impact penetrates eight layers of lexan, but the large crack only effected the top-most layer. This view measures approximately 8 cm across.
