METEOROID AND DEBRIS IMPACT FEATURES DOCUMENTED ON THE LONG DURATION EXPOSURE FACILITY

A Preliminary Report

Compiled by Members
of the LDEF Meteoroid
and Debris Special
Investigation Group

August 1990

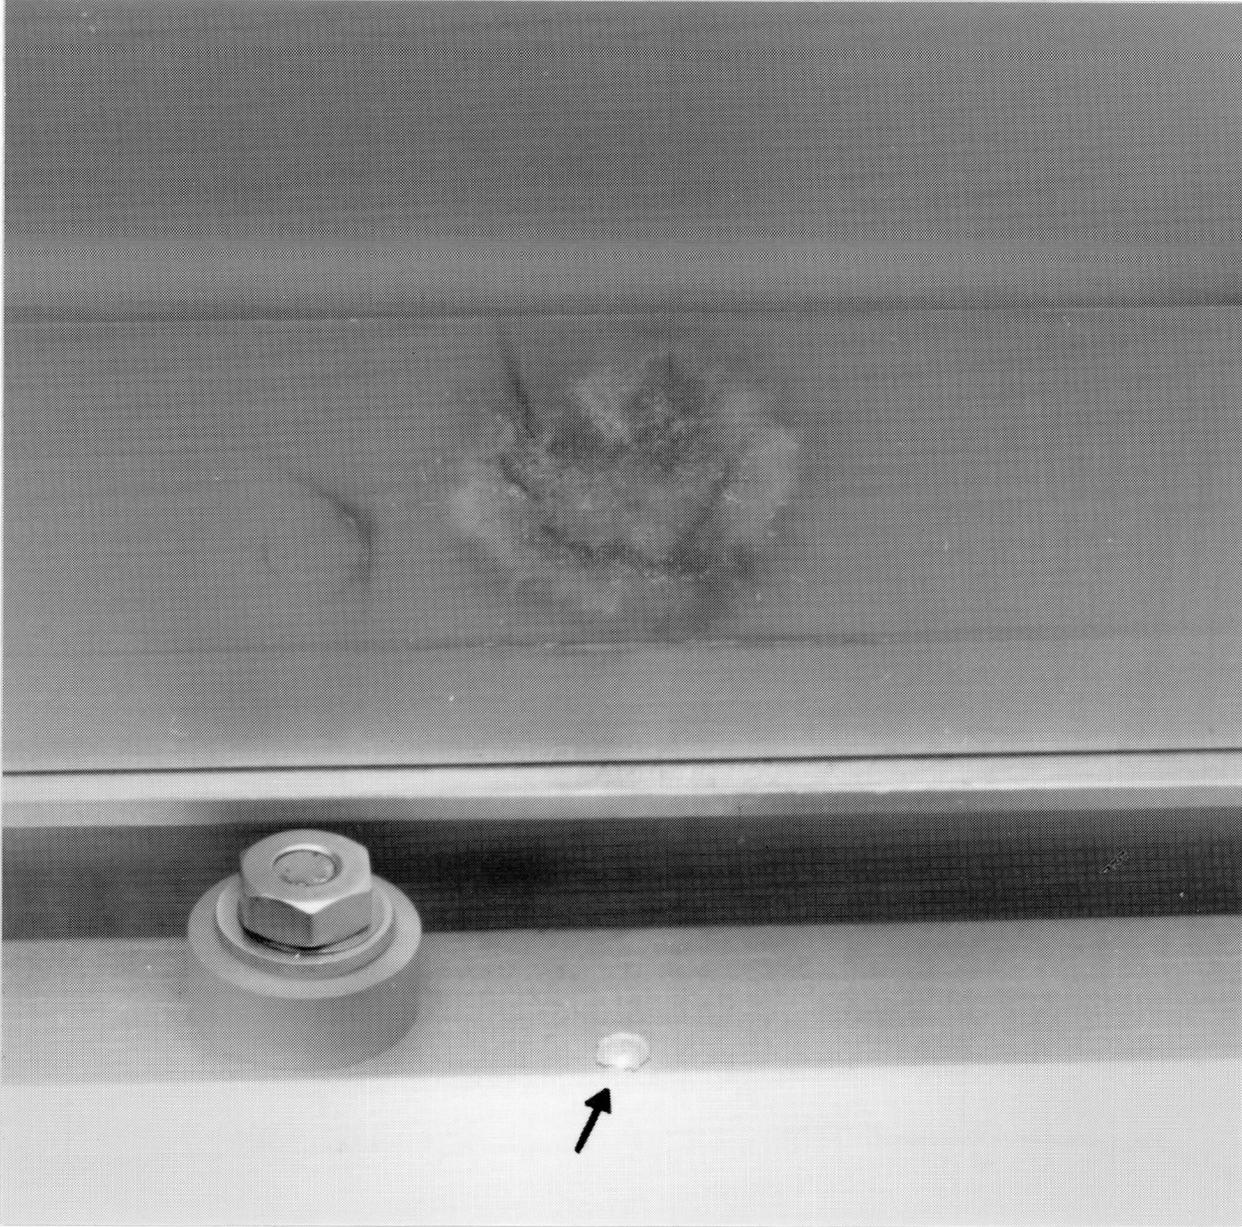
- Figure H09-1.** This post-deintegration view shows the front of the entire H09 experiment tray. The space-exposed interstellar-gas collector foils have been covered in this view.
- Figure H09-2.** View of a crater (indicated by arrow) located in aluminum with a large adjacent ejecta pattern. The feature was located inside one of the detector housings. This view measures approximately 12 cm across.

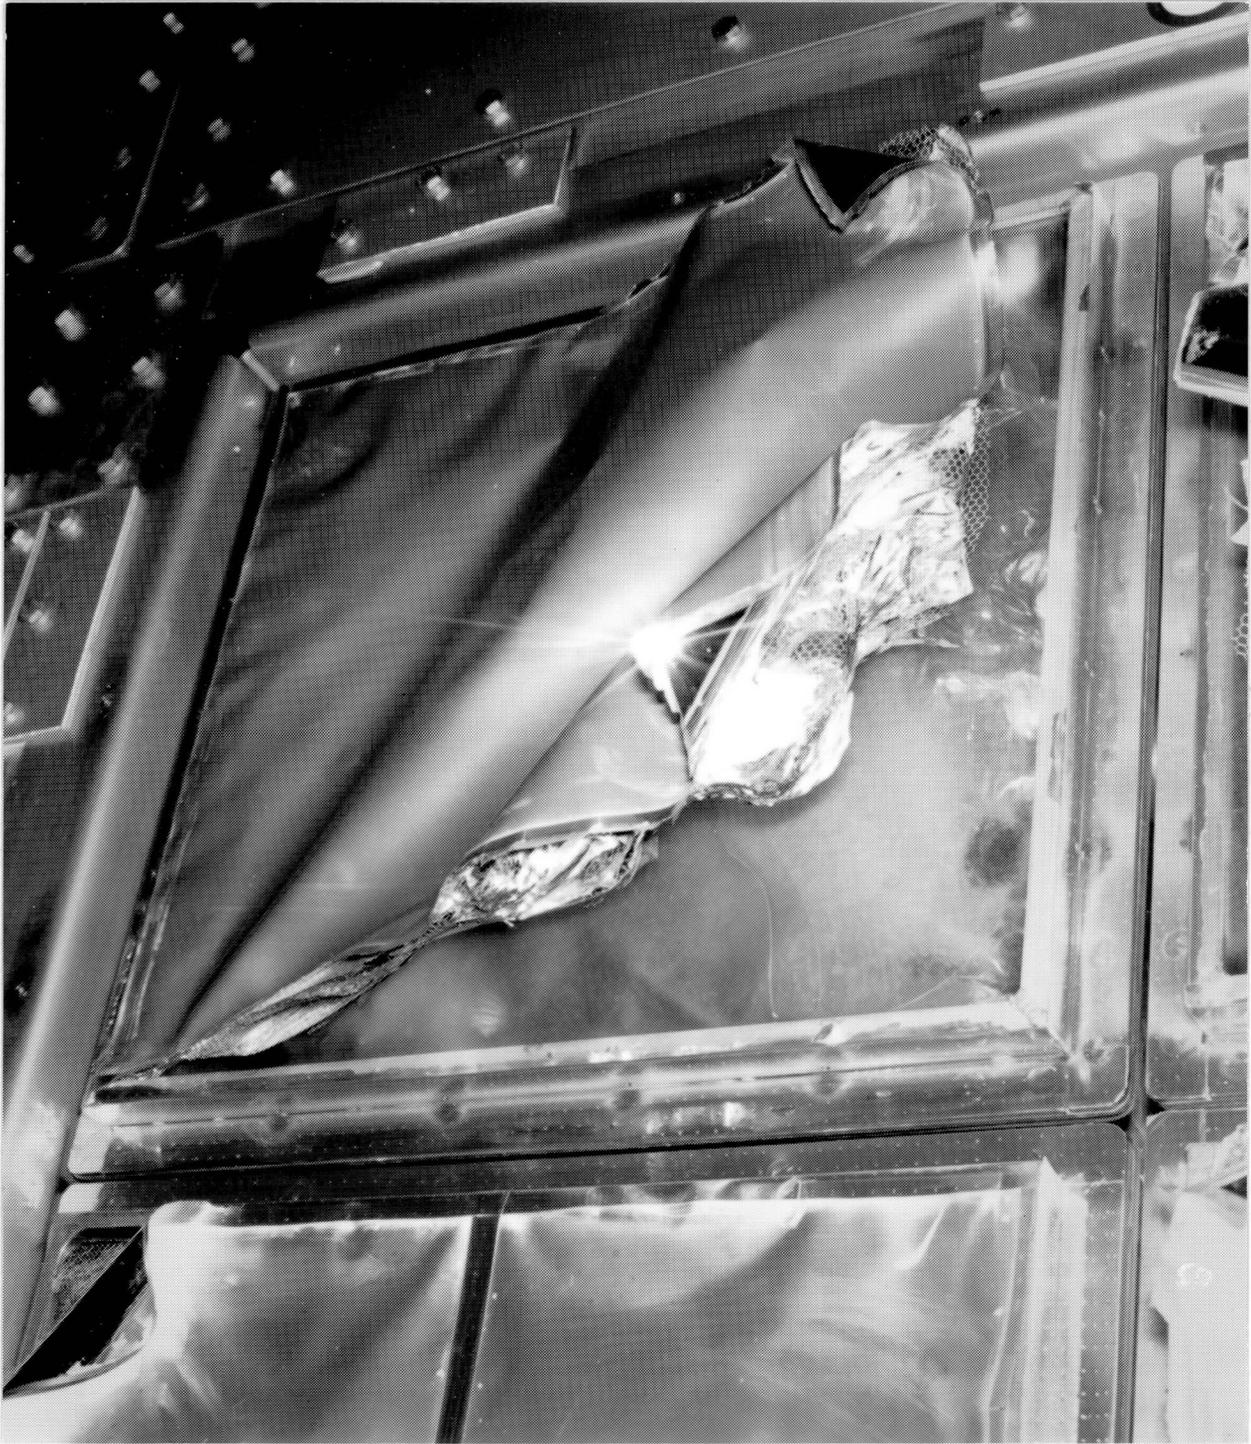
Figure H12-2. This pre-deintegration view shows one module of tray H12 with the thermal blanket partially peeled back exposing the lexan detector stack below.

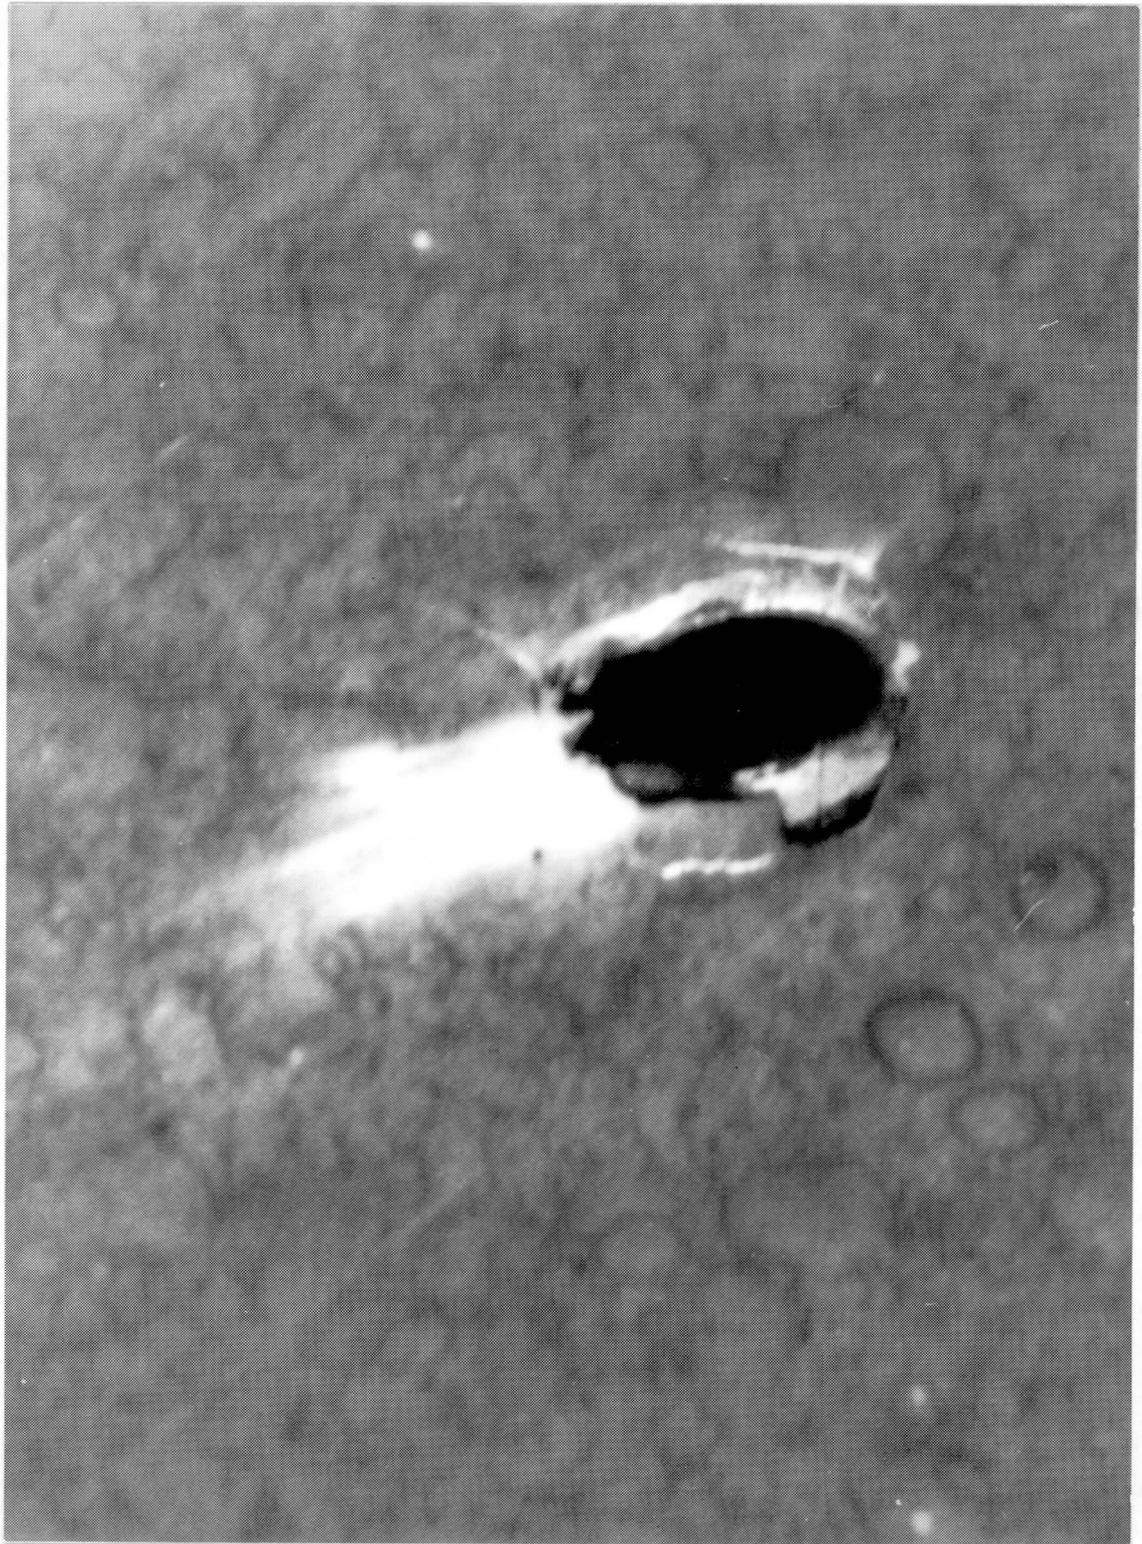
Figure H12-3. This is a view of a penetration hole through one of the H12 multi-layer thermal blankets. The streak adjacent to the hole may be indicative of an oblique impact. View measures ~2 cm across.

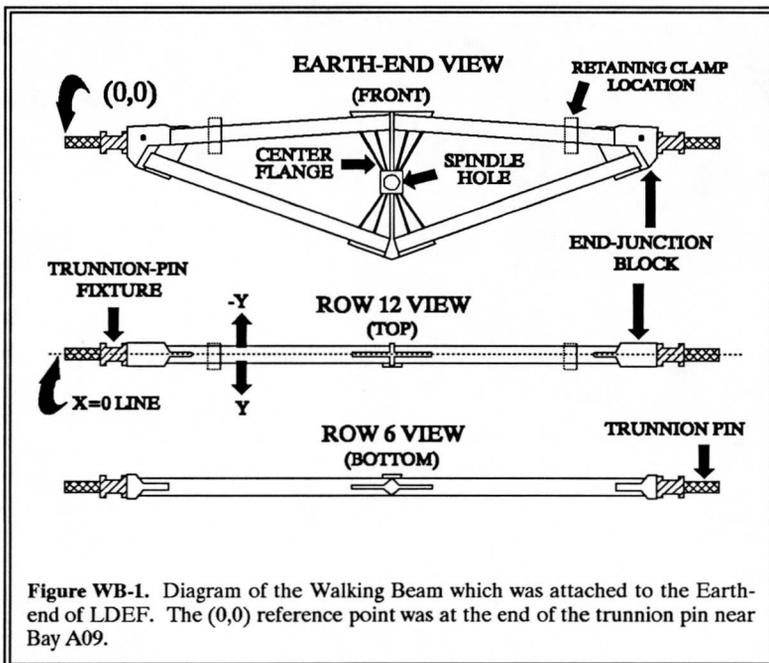
The M&D SIG survey of the Walking Beam and its associated hardware identified a total of 35 impact features. Twenty five of the 35 features were < 0.5 mm in diameter (two of which were located on the plate covering the spindle hole, two were located on the Row 3 trunnion-pin fixture, two were located on the retaining clamps [one on each], and 19 on the Walking Beam). Of the remaining ten features, nine were between 0.5 mm and 1.0 mm in diameter (eight on the Walking Beam [one of which was an elliptical feature measuring $\sim 0.8 \times 1.3$ mm in size] and one on the spindle-hole cover plate), and one was ~ 1.3 mm in diameter and was located on the retaining clamp near Bay G03. No impact features were identified on any of the bolts associated with the Walking Beam. Morphologically, all features were typical of craters produced in aluminum under controlled laboratory conditions.

There were no noticeable penetrations, bulges, or spallation features on the Walking Beam or its associated hardware.
